Silent STA Application
KRMF-LP 182553
Reno, NV

KRMF is requesting permission to temporarily go silent due to repairs needed on the Anywave PA unit. Due to its age and a separate incident with a past employee, we have experienced several hardware failures that necessitate shipping to Anywave for full repair. Our RMA# is TS2303-0575. After we receive the crate from Anywave for shipping, we hope to have it promptly returned and repaired as soon as possible.

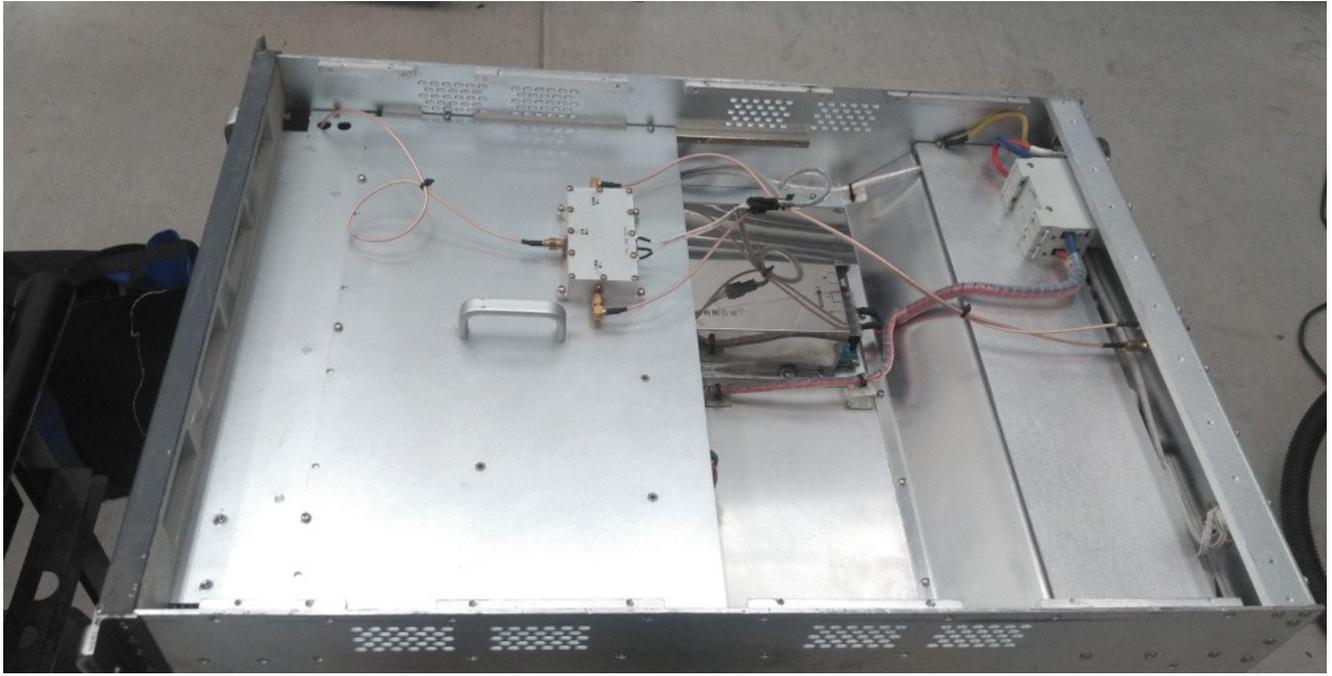
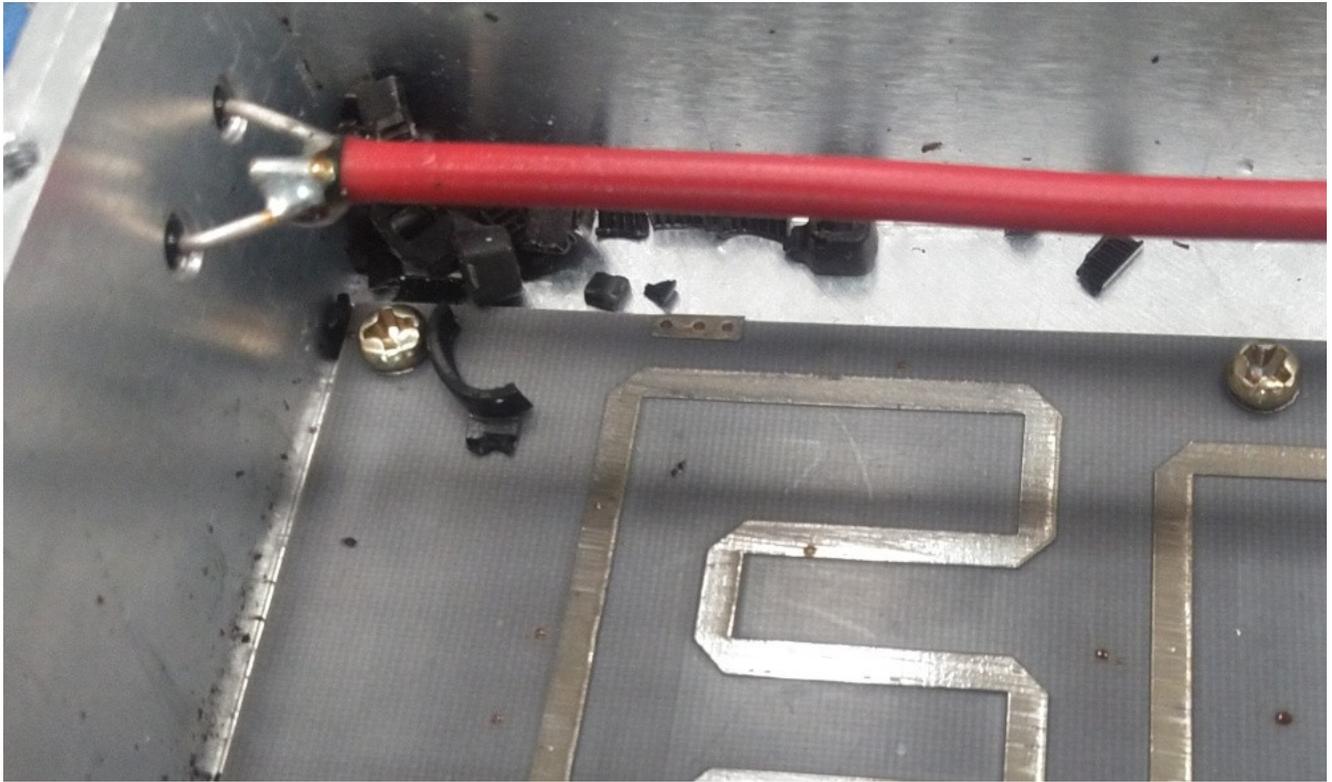
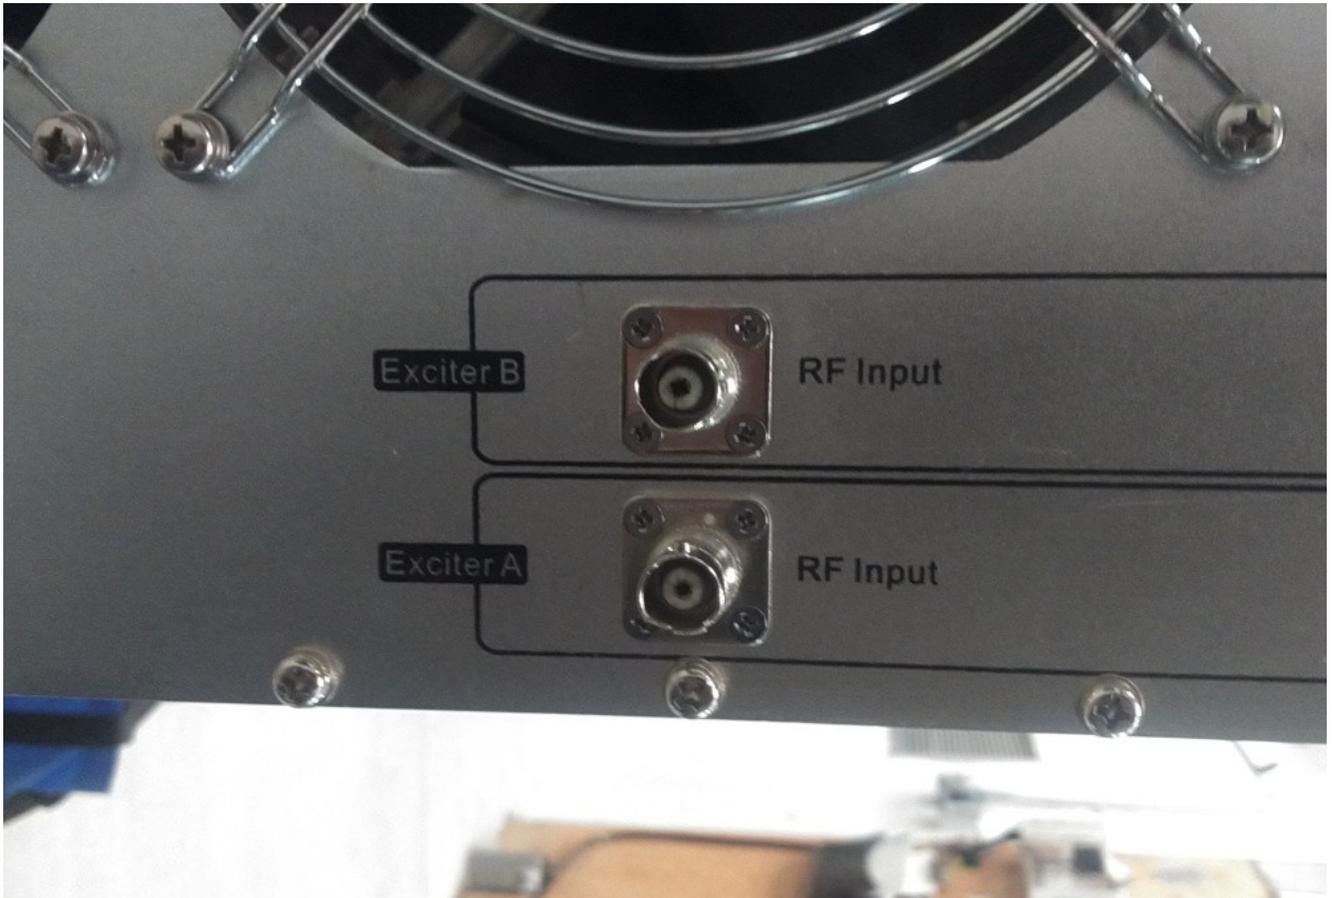
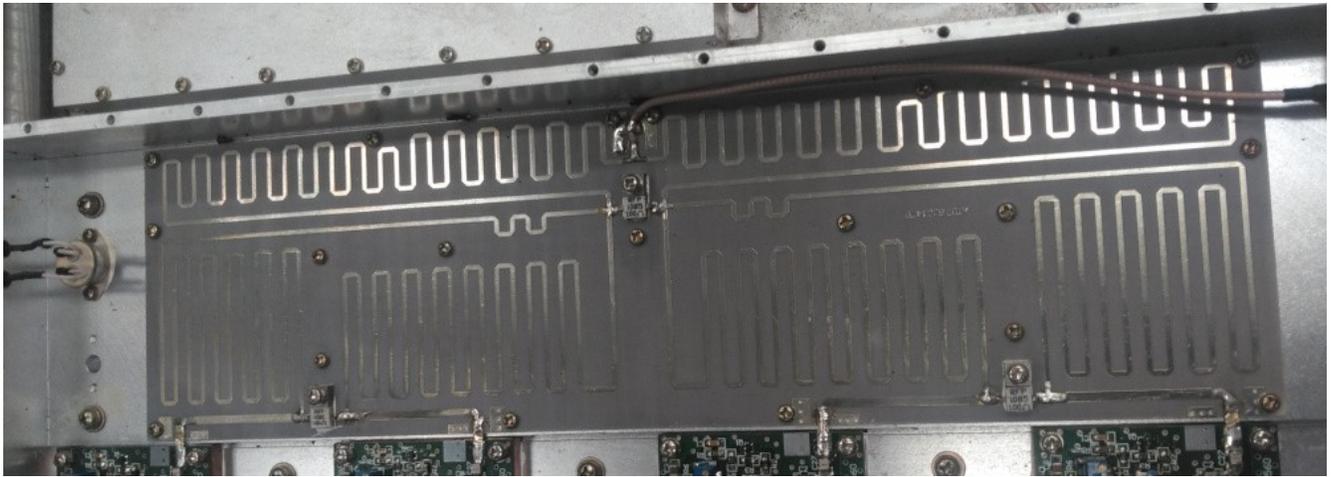
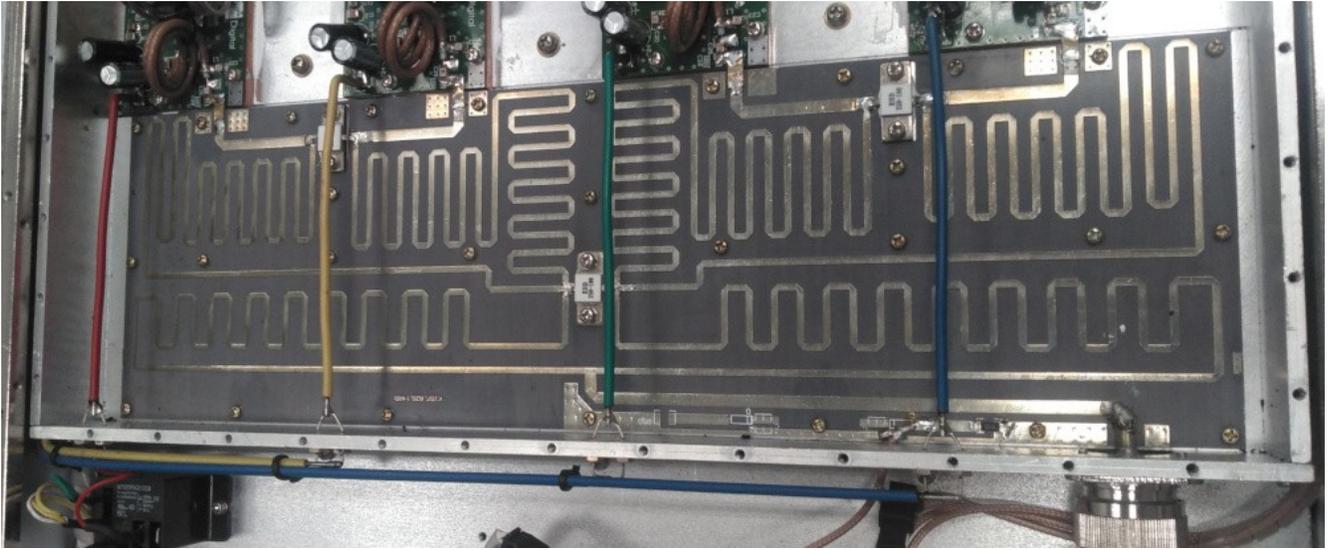
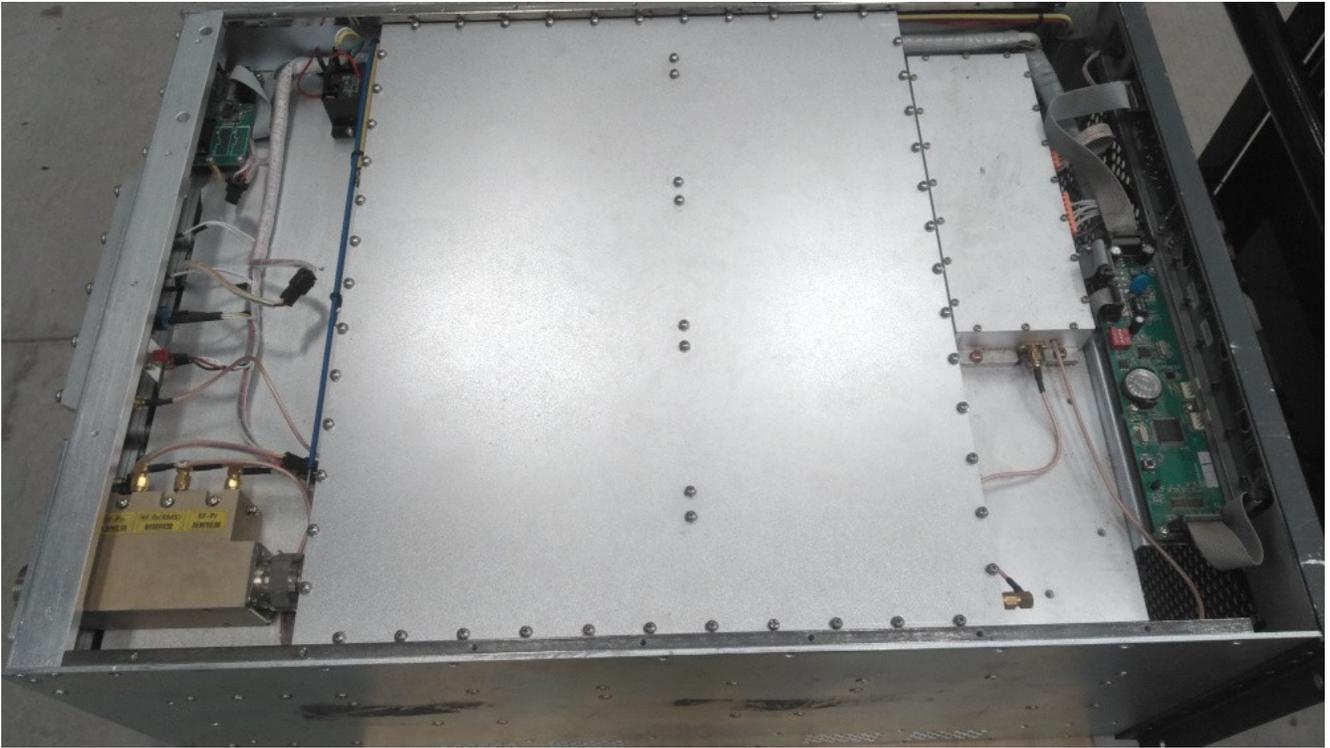
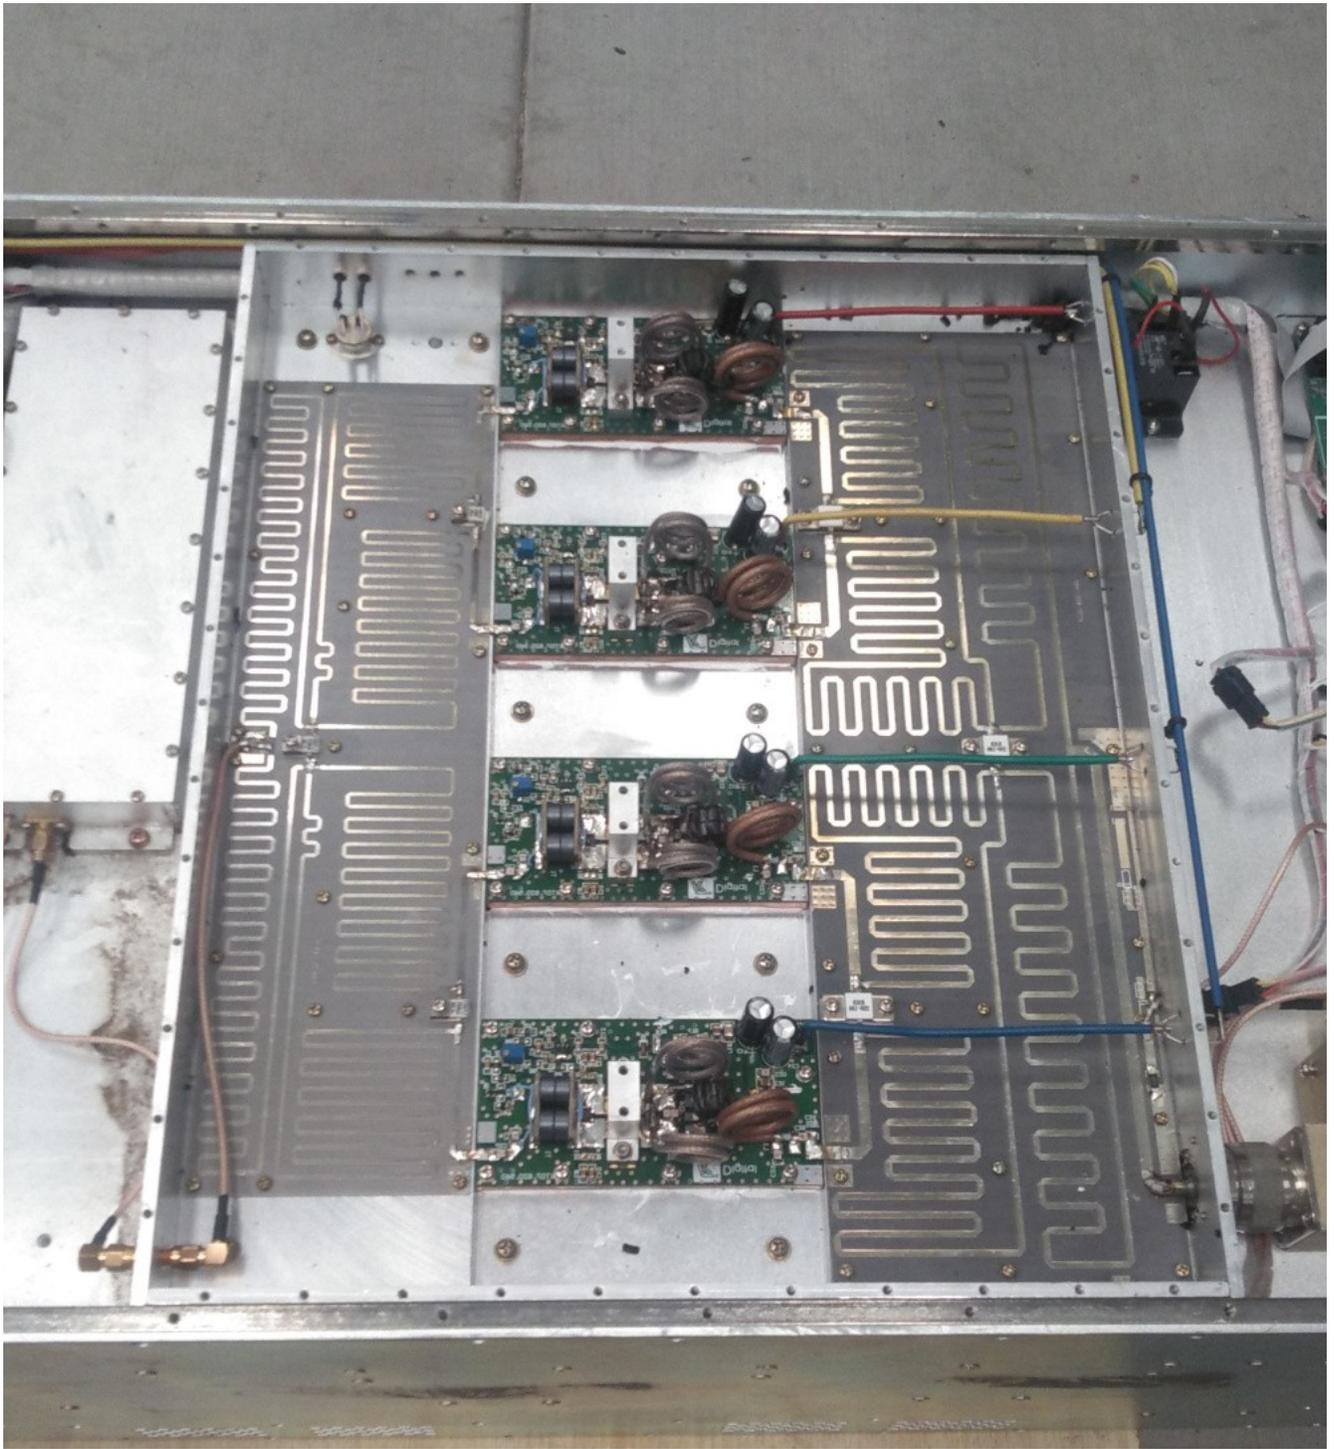
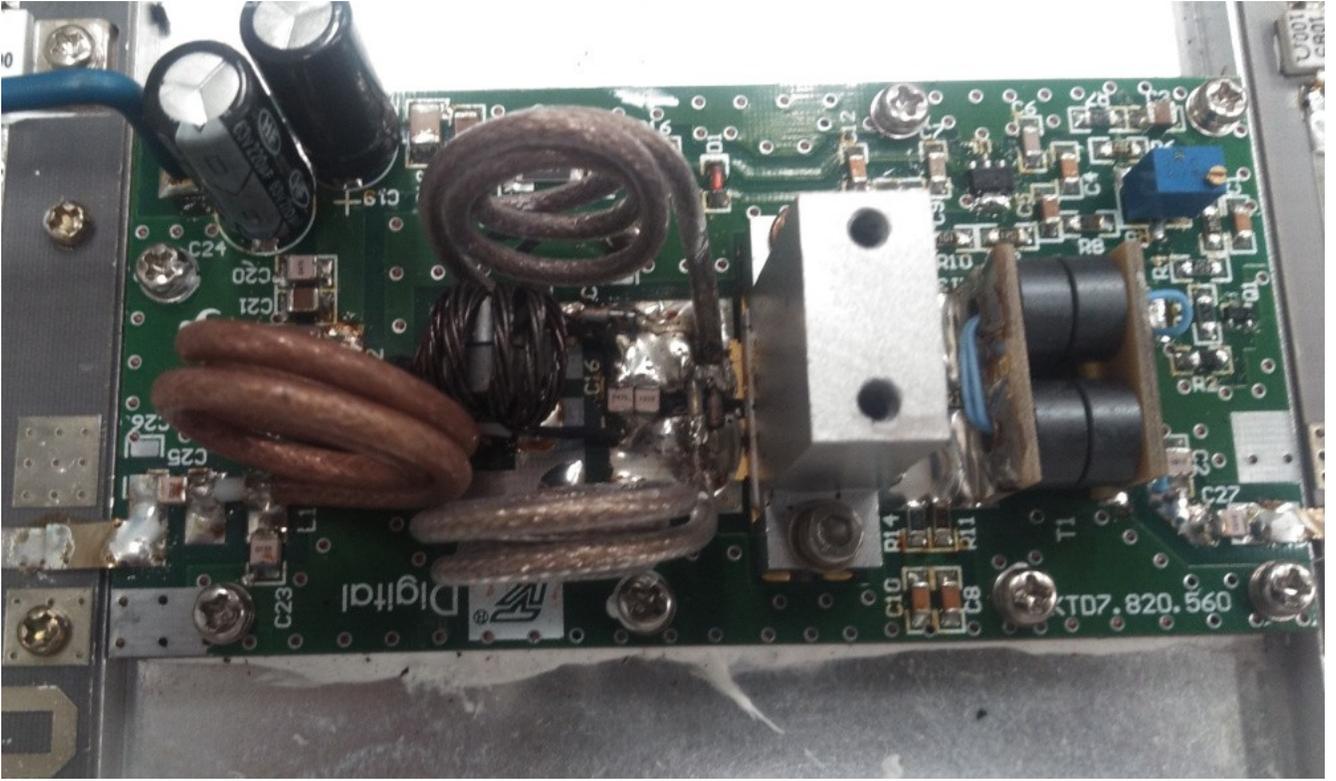
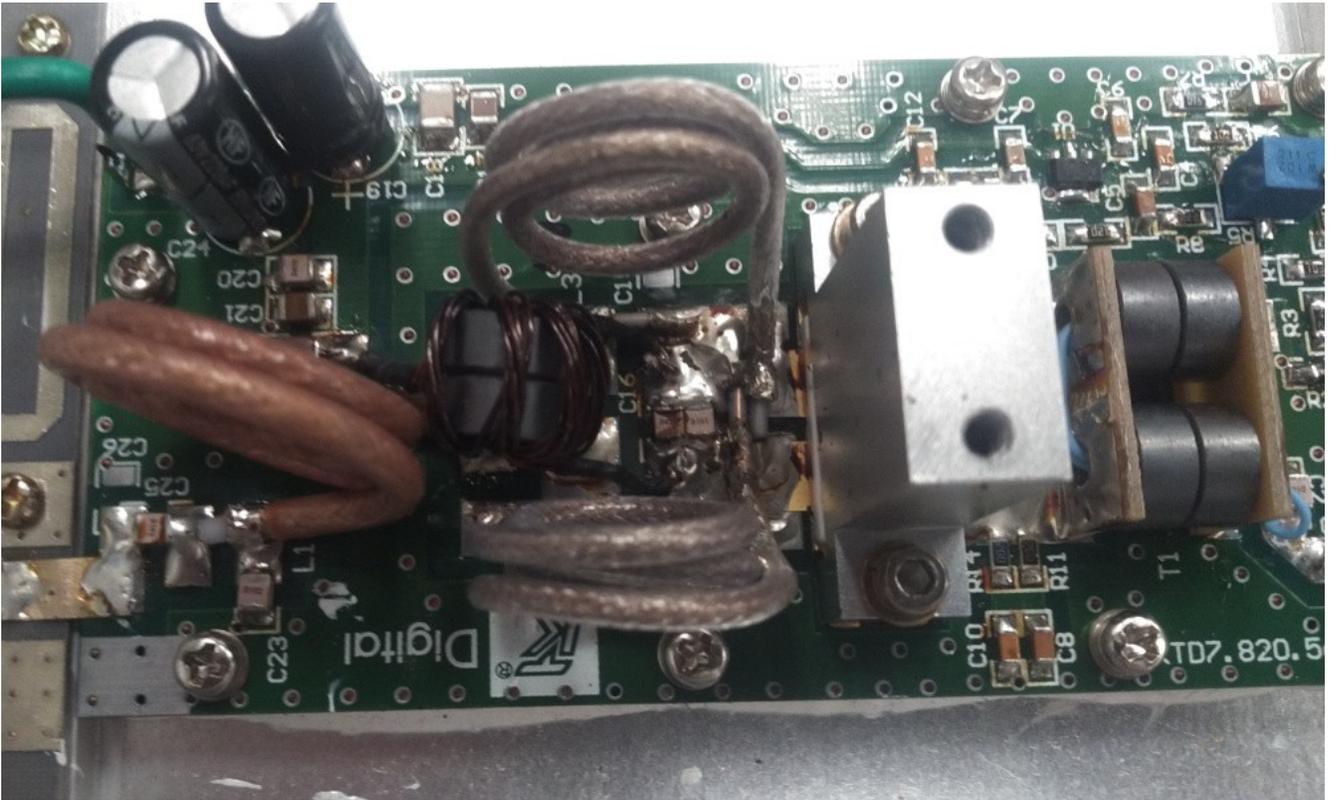
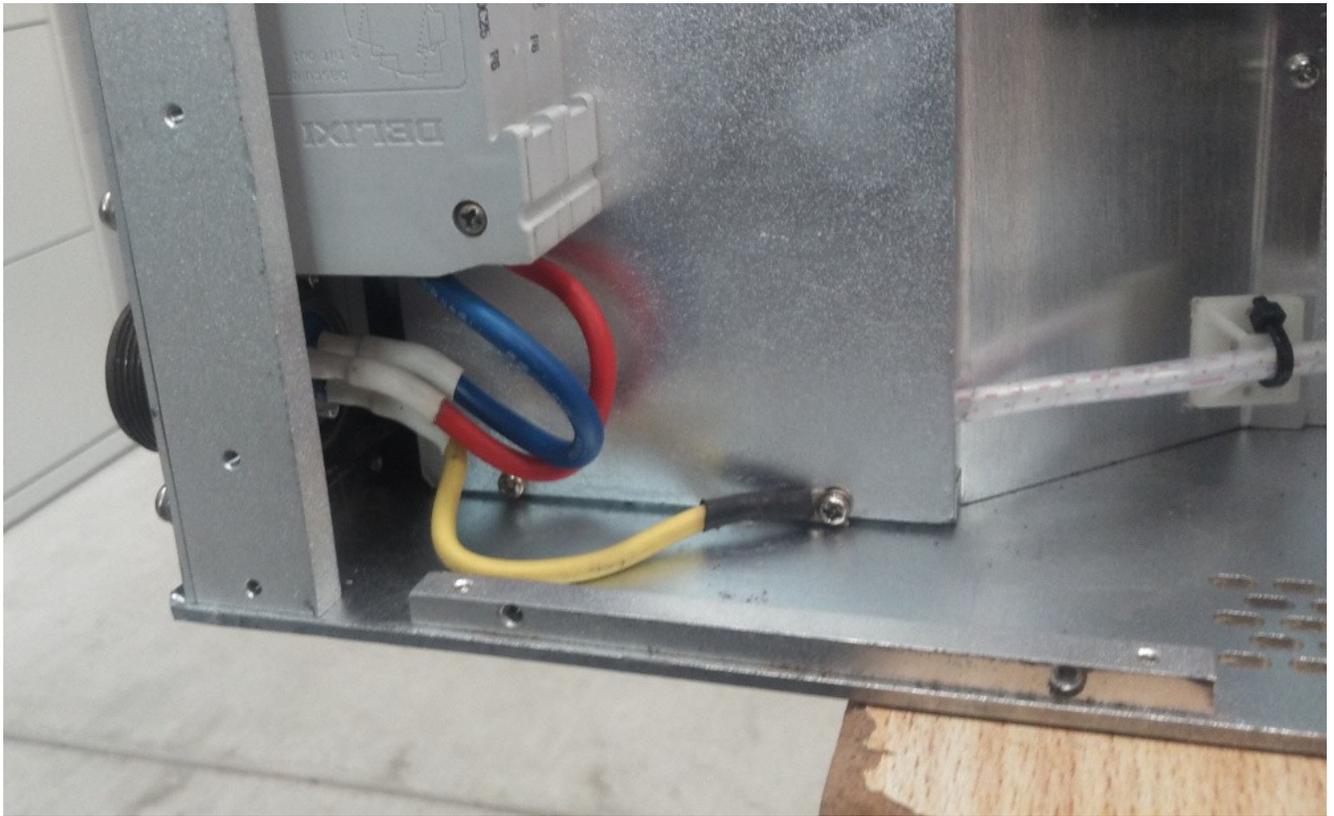
In the process of doing the work, it was observed that the bottom of the transmitter was caved in. Two connectors on the back panel (in addition to the power connector) were damaged (These were repairable). And almost every screw I encountered was loose, especially screws associated with the basic structure of the amplifier. Some internal hardware had also vibrated loose and disappeared. A thorough inspection was required to ensure none of this hardware had gotten into areas with circuitry. Apparently, this hardware fell out through cabinet openings some time during shipping and reinstallation. When reinstalled in the rack, it was also evident that the front panel was also slightly caved in.

The PA compartment was opened for inspection (56 screws!). Much to my surprise, I discovered that this amplifier has had a 'hot lunch'. If you look at the pictures of the PA pallets, you will see a big ferrite bead wound with litz wire. This is the input filter for the power to the RF devices (which are underneath the heat sink pillars, with the two screw holes in the end). You will see that the litz wire varies from very dark in color (most likely red, green or amber before 'cooking') to charred. I included two repeat views of the PA pallets with different lighting so you can get a better look. There is also a picture showing bits of the cable ties that held the ferrite bead to one of the coaxial cable phasing lines. You can see bits of a cable tie on one of the beads. I did not measure any shorts on the output side of the RF transistors or evidence of punch-through on the transistor input

gates. As indicated in discussions with the Anywave tech, the low PA idling current may be bias adjustment and not failed transistors. The abnormally low bias current (0.4 A) usually indicates failed transistors, but the absence of shorts or punch-through (input gate short) are encouraging signs things may not be as bad as they could be. The burnt chokes are also still securely soldered down and not showing excessive resistance. You can see where the inside of the PA cover has discolored spots from the burnt chokes.

On the input splitter and output combiner, there are some ballast and reject loads, in the form of the white squares visible in the pictures. These appear to be of the 'pass-through' type, and they measure a very low resistance between terminals, as expected. But every single one measures open circuit to ground. They should measure about 100 ohms, as indicated on the device labels. This is indicative of operating into a very awkward impedance load (or a short, or no load at all). The open loads on the input side is more mysterious, and rarely occurs. It is possible that if all four PA pallets have failed catastrophically that the input loads could be damaged. It is also possible I am measuring these wrong, even though I double checked my measurements.

No other internal damage was noted, except for loose hardware found throughout the amplifier, especially on the major structural mountings. To me, this is indicative of severe, sustained vibration during shipping.

Both of the RF input connectors are damaged. One connector was dented. The other one looks like it had been ripped. I identified a replacement for these connectors, but they were \$56 each. So I repaired the existing connectors. Although they are not perfect, they work fine.

...If the amp needs to be shipped back to Anywave (quite likely), they will supply the customer with a suitable crate..."
