KBKO 202A Kodiak
Special Operating Conditions

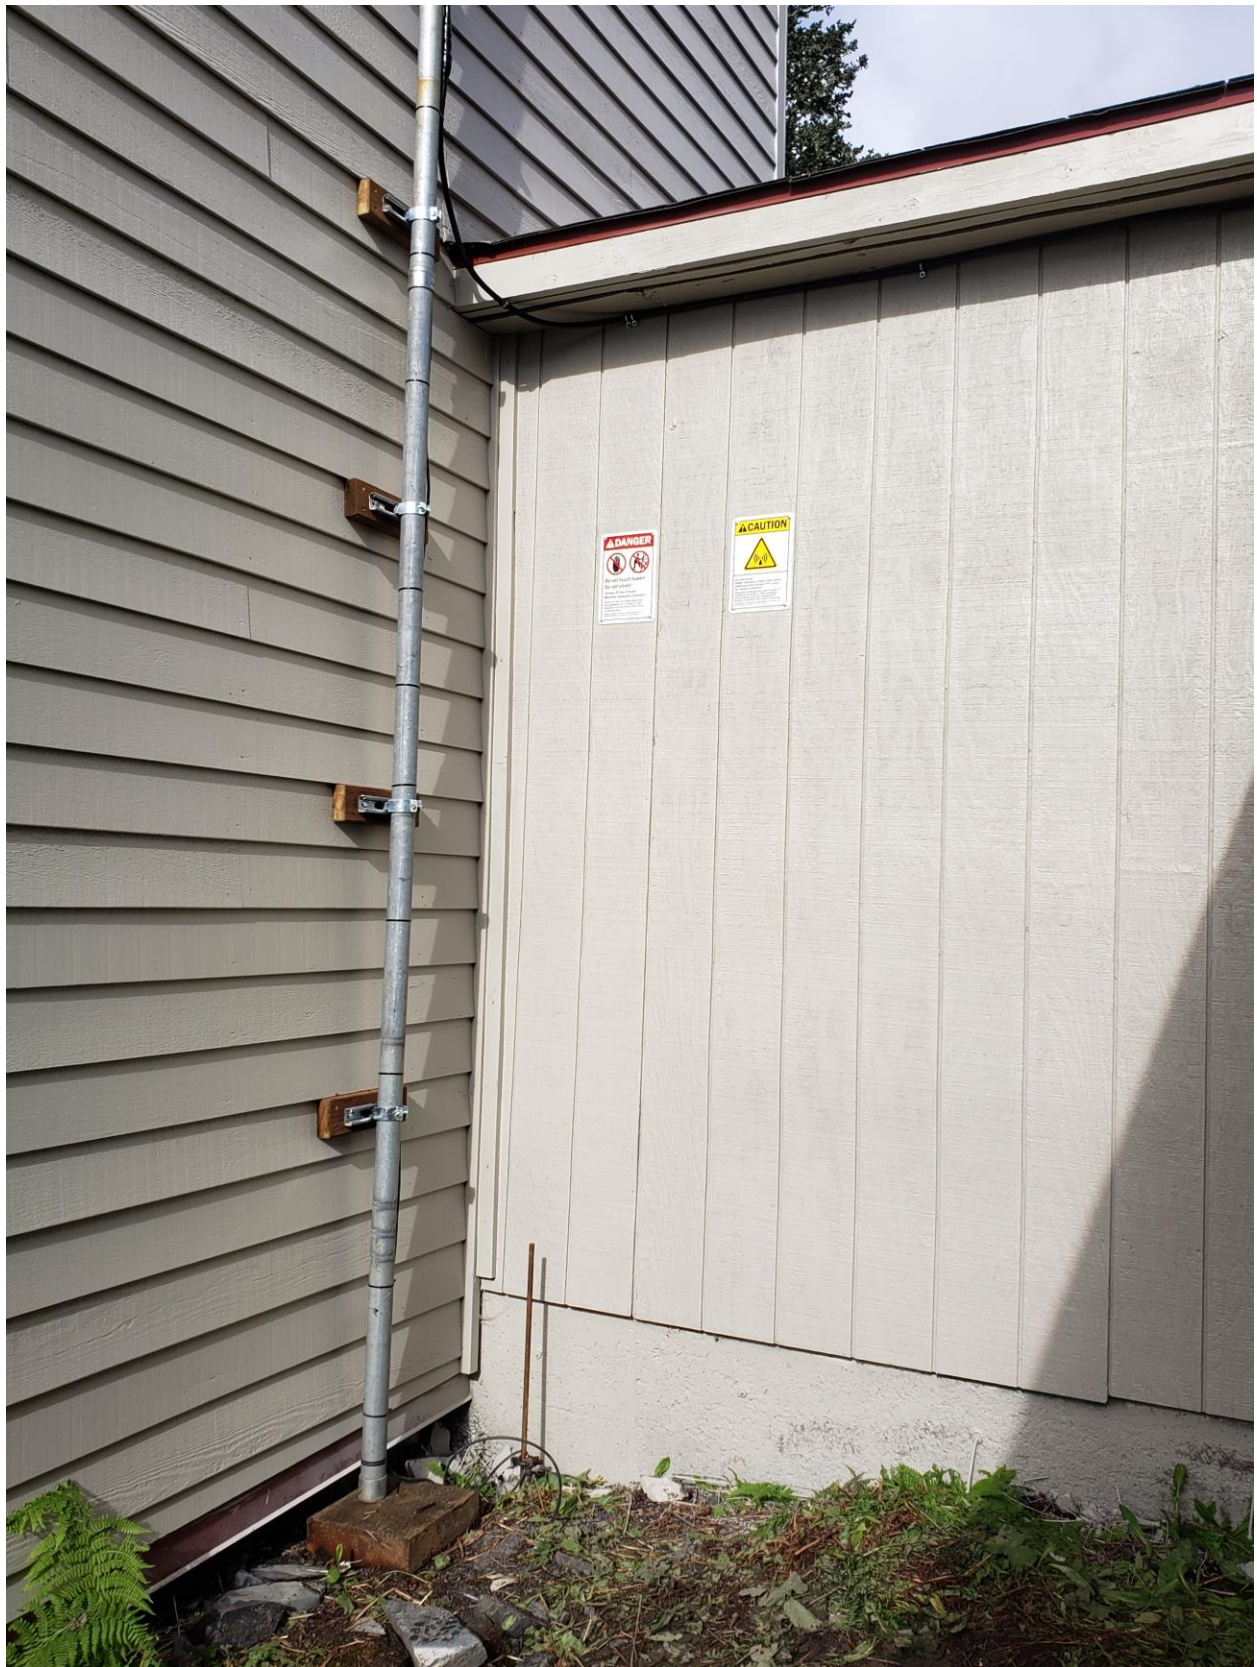
Figure 1: Signage at base of supporting pole, ground level

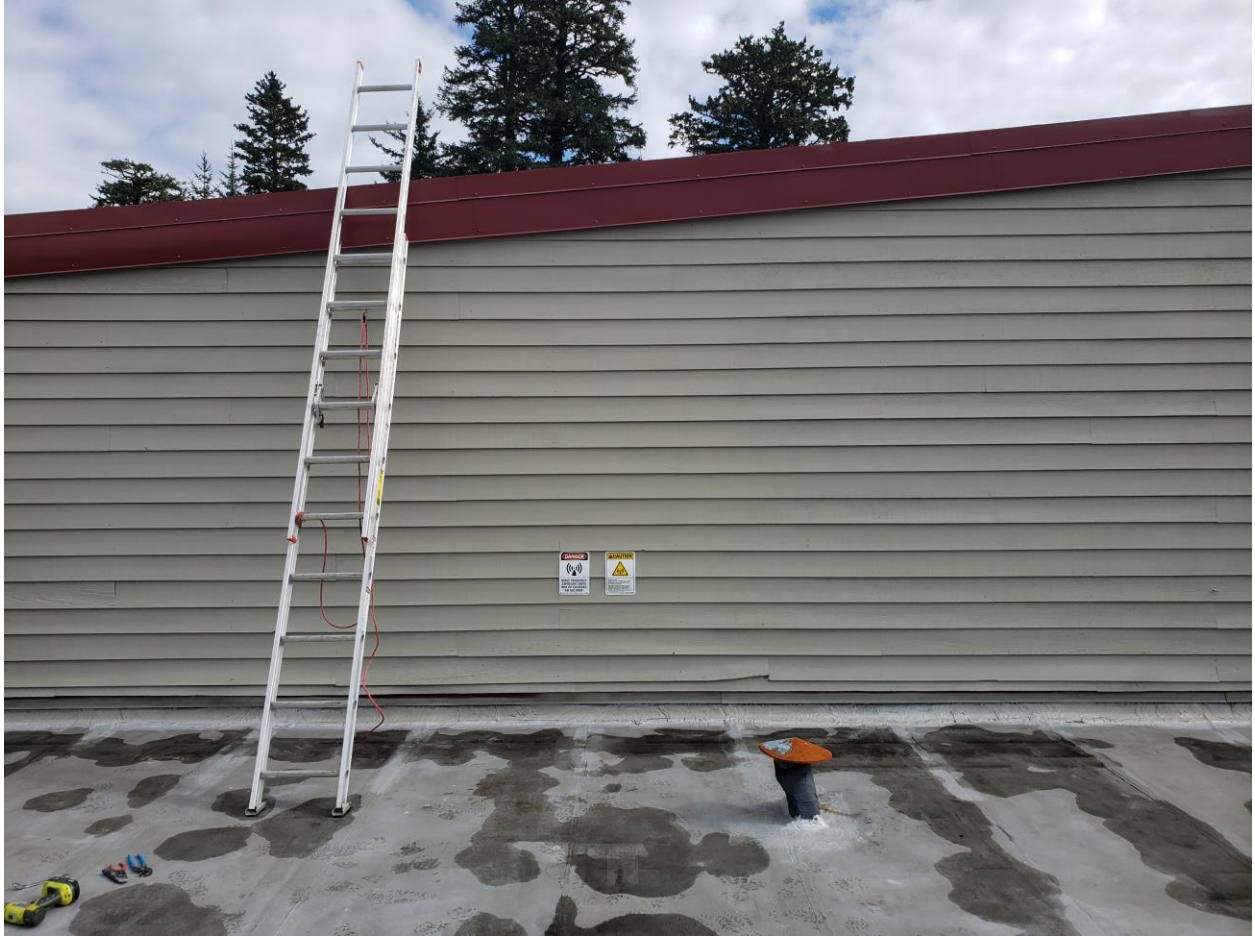
Figure 2: Signage on lower roof at most likely access point to upper roof

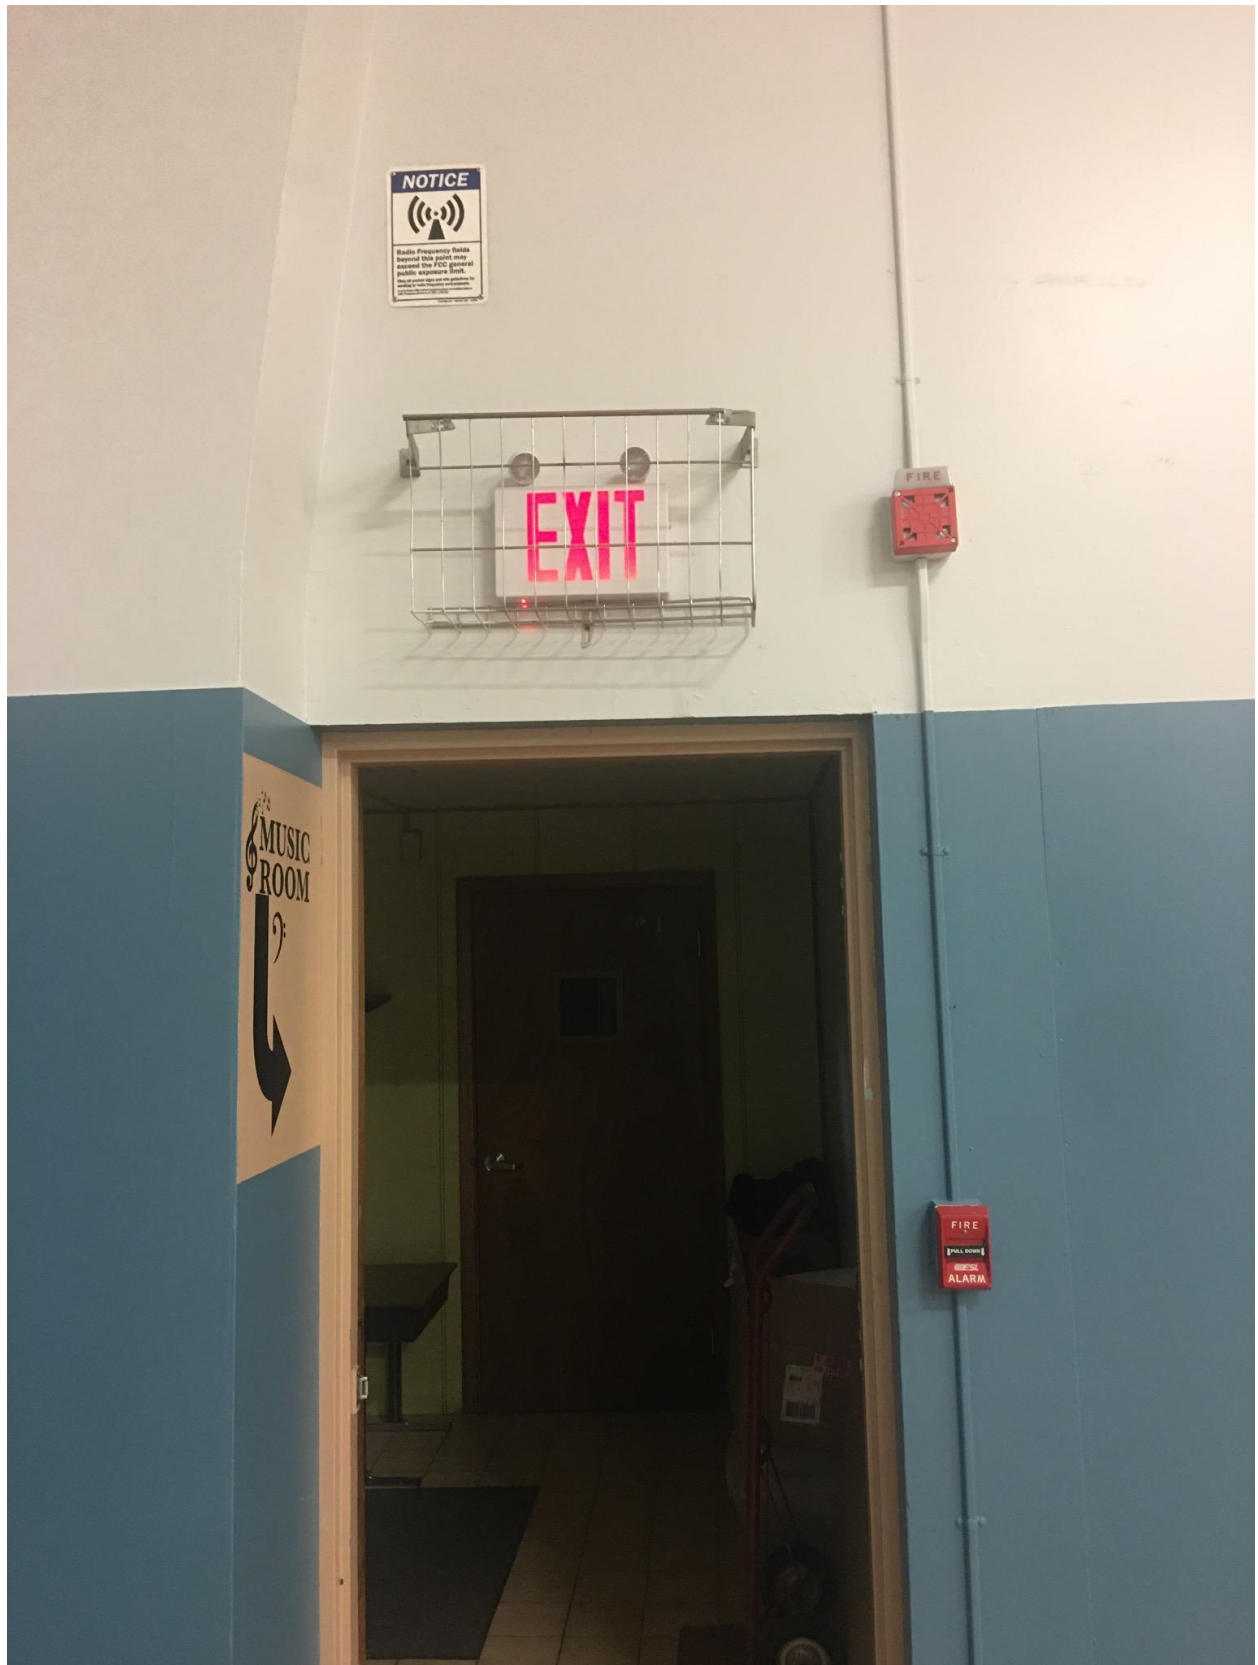
Figure 3: Signage on wall near gymnasium ceiling
