ENGINEERING STATEMENT IN SUPPORT OF A SPECIAL TEMPORARY AUTHORITY (STA) REQUEST

WOBL RADIO, INC.
RADIO STATION WOBL (AM)
1320 KHZ, CLASS B
FCC Facility ID: 73364
OBERLIN, OHIO

JULY 2018

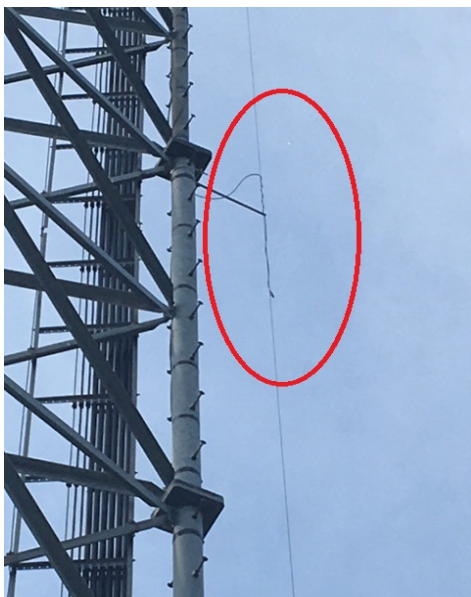
As Chief Engineer of WOBL-AM directly across the street from the above specified tower, I have discovered today at least two of the monitor points for this station are higher than FCC mandated levels. While no environmental factors have changed in the far field, an inspection of ASR 1054569 reveals a possible entanglement of a wire (or coaxial ground kit) in the NE leg's detuning skirt. Additional measurements taken at a point 90 degrees from both station and the tower show 140 mV radiating from WOBL-AM on 1320 kHz and over 320 mV re-radiating from the cell tower. Also no current is flowing in the detuning skirt. I spoke to Amy at the CC NOC earlier this evening so a ticket may have been generated, but I wanted to send this photo of the potential problem along with these details. Please copy us all on the steps CC will undertake to correct this issue.

Crown Castle has dispatched a crew to remove the shorted cable on the detuning skirt highlighted in the photo above, however that did not correct the issue completely. As noted below:

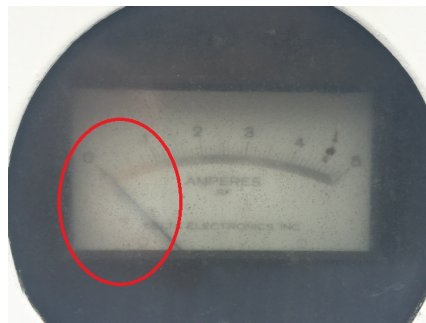
Yes, wire that was probably shorting skirt was removed. Still no current in skirt as it was always low, Bob Jr. had requested a higher resolution meter, but that never happened. We were not on site when cell tech did job and do not know what or if anything was done other than wire removal. 90 degree comparison do show significantly less RF from tower now however. Other cut coaxes are visible too.

Zero Current in detuning skirt

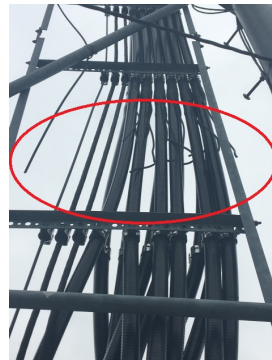
Visible cuts in Coax and cable grounds
