Engineering Report  
**Survey of Radiofrequency Energy Exposure Levels**  
**Oakbrook Terrace Tower Building**  
19 & 22 May 2017  
Prepared by Univision Communications, Inc.  
WVIX(FM) Lemont, IL

**A. Introduction and Background**

**Univision Radio License Corporation  
WVIX(FM) Lemont, IL  
93.5 MHz 3.5 kW**

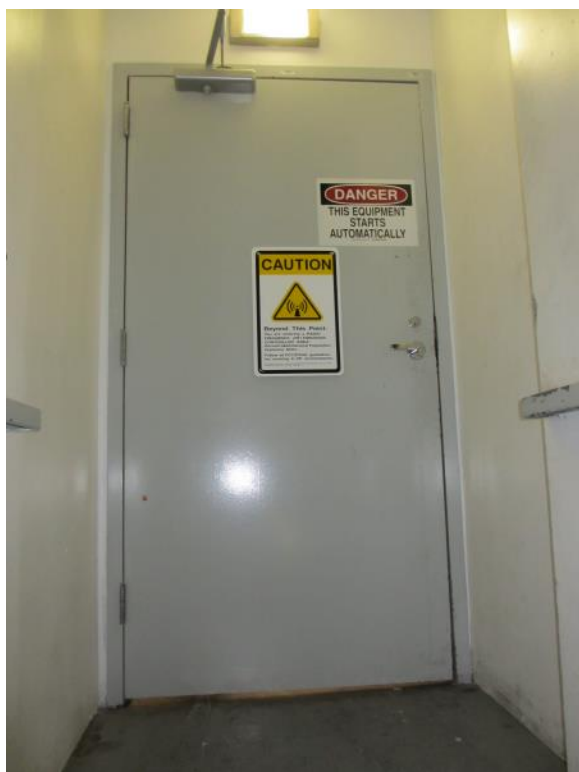
**Photo 2: Penthouse Entry Door**

Strict access controls are in effect at the building. Entry to the penthouse area, containing the WJKL main and WLEY-FM auxiliary transmitters, is restricted by a locked door, with an RFE advisory notice sign prominently displayed. The roof is accessed by a locked hatch at the end of a climbing ladder, inside that penthouse. The hatch is marked with RFE warning signs and interlocked to disable the WLEY-FM auxiliary transmitter, should the hatch be opened. Workers seeking roof access must register at the building security desk, before they are given keys to the penthouse, must sign an advisory/waiver document, and carry personal RFE monitoring devices whenever they are on the roof.

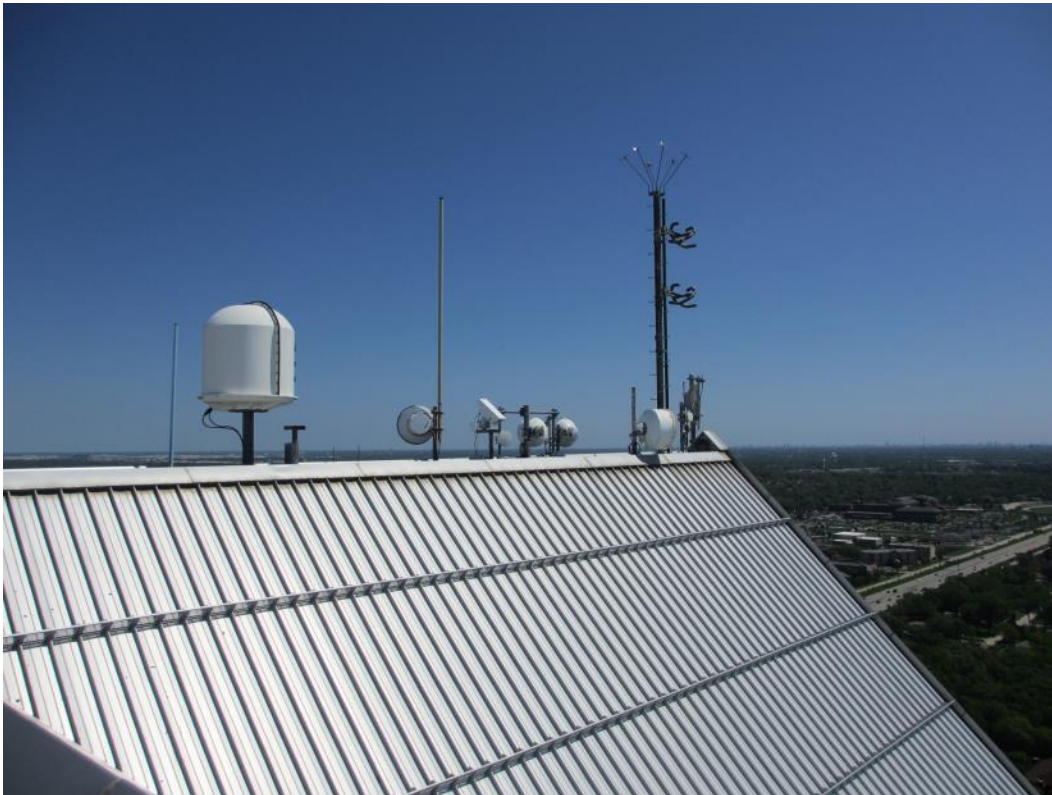
**Photo 4: Eastern Portico**

The east portico roof supports the WJKL/WVIX antenna and multiple communications antennas, many of which have been retired from service but not removed.

The RFE levels in the immediate vicinity of the 2-element WJKL/WVIX antenna, mounted on a pole located just before the eastern edge of the portico, exceed the protection guideline value for controlled areas. Specifically, the area from the microwave dish antenna, visible in line with the bottom of the WJKL/WVIX pole, to the eastern end of the portico, cannot be entered when the stations are in operation. The inner boundary of this area was temporarily marked with red vinyl tape and can be seen on the next picture. At the point marked by red tape, the bidirectional spatially averaged RFE level measured 63% of the protection guideline value.

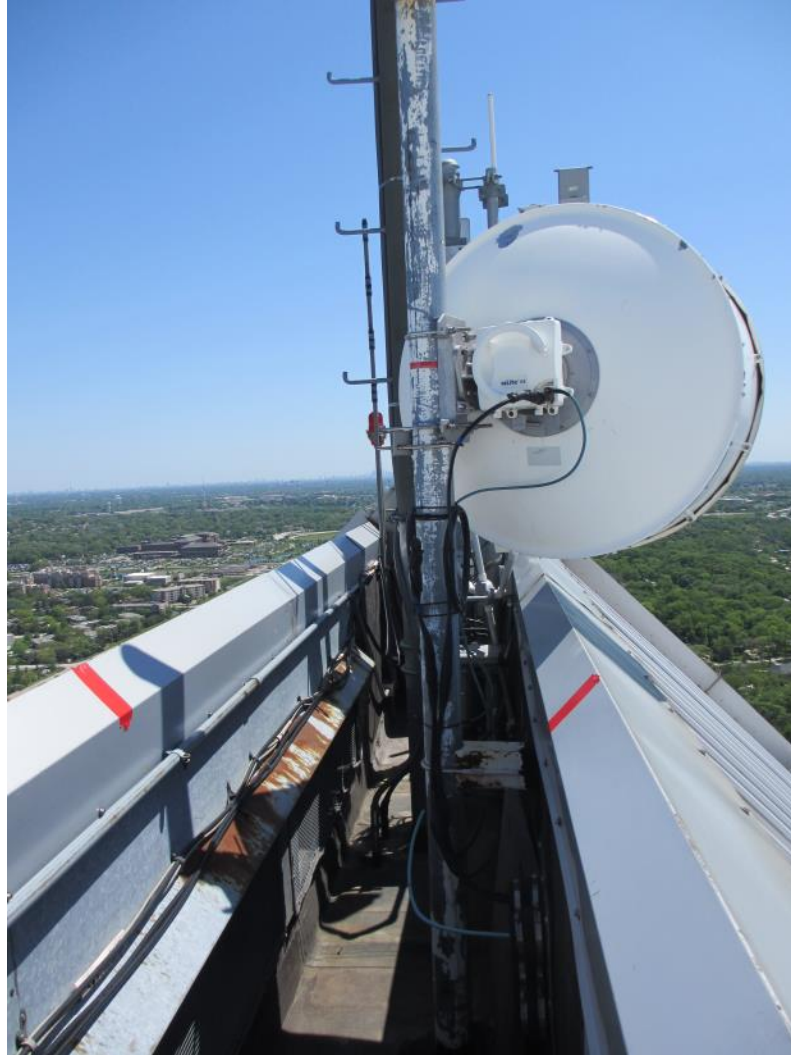
**Photo 5: East Portico Excessive RFE Threshold Location**

On the roof, only one area, immediately surrounding the WJKL/WVIX antenna pole, was found to have an measured RFE level approaching and exceeding the protection guideline value. While spatial maxima slightly in excess of that value were found elsewhere on the roof, the fields were found to be highly scattered and spatial average measurements showed levels well within the guideline value. The boundary of the area on the east portico of the roof, where RFE levels became exceed the protection guideline value, was temporarily marked with red

electrical tape. The site lessor will be advised to install permanent marking. At no location surveyed within the building was the measured RFE level found to exceed ten percent (10%) the FCC's guideline values for "uncontrolled" (general public) areas.

From the access hatch to the boundary point marked by the red vinyl tape and back, the following measured RFE levels were found:

1. 2 meter constant elevation spatial maximum: 83%
2. 2 meter vertical sweep spatial maximum: 96%
3. 2 meter vertical sweep average: 33%

These data were obtained for walks out to the boundary point and back to the roof hatch. It is notable that the RFE levels were highly scattered – the stored maxima could not be duplicated by probing the instrument around with its display in real-time data mode.

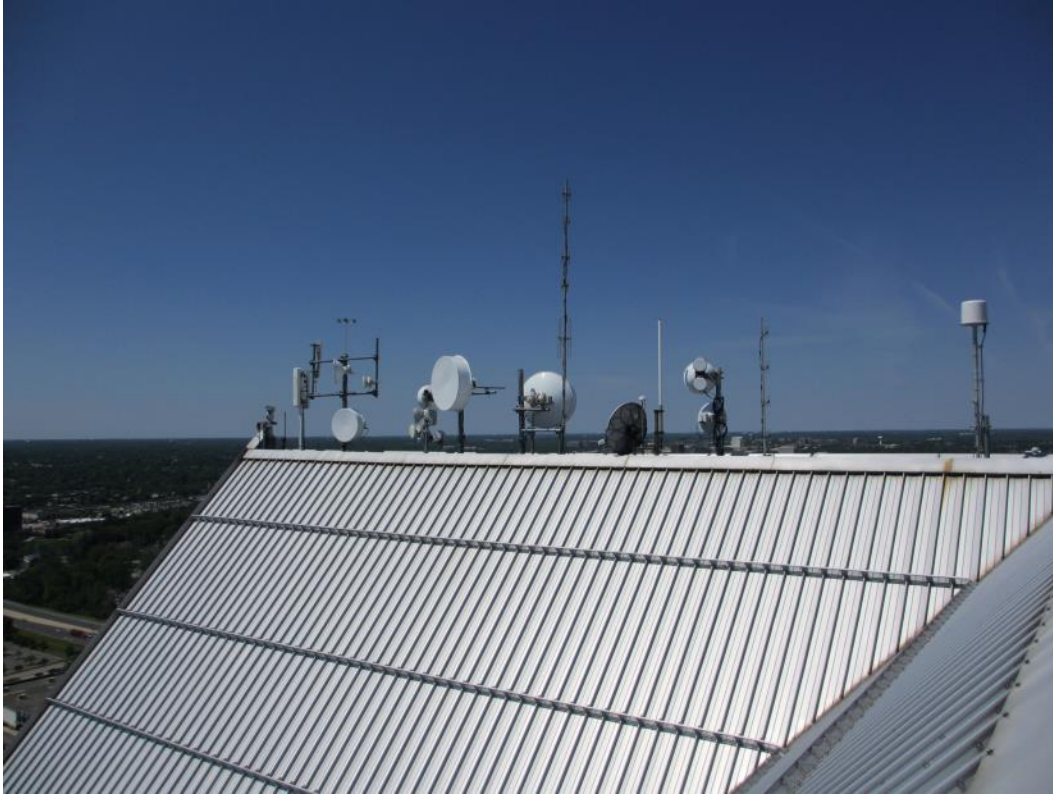
**Photo 6: South Portico**

The east portico roof supports the multiple communications antennas, many of which have been retired from service, but no broadcast transmitting antennas.

From the access hatch to the outer edge of the portico, the following measured RFE levels were found:

1. 2 meter constant elevation spatial maximum: 93%
2. 2 meter vertical sweep spatial maximum: 57%
3. 2 meter constant elevation average: 17.5%

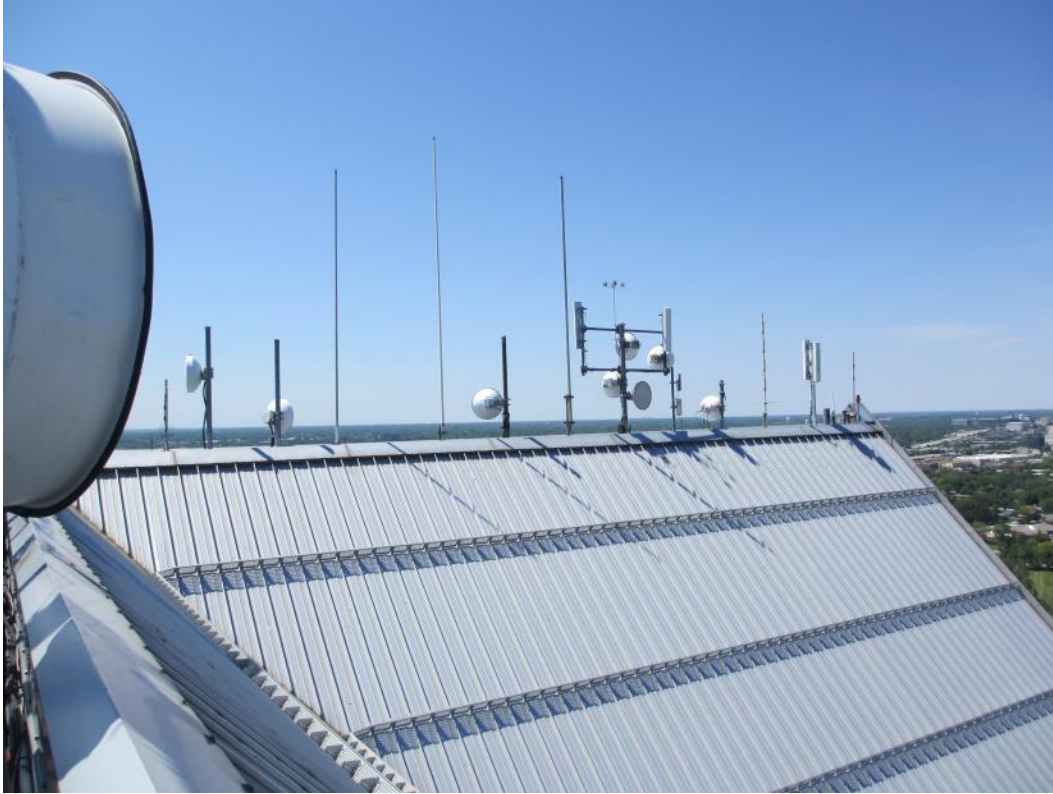
**Photo 7: Western Portico**

Like the south portico, the west portico roof supports the multiple communications antennas, many of which have been retired from service, but no broadcast transmitting antennas.

From the access hatch to the outer edge of the portico, the following measured RFE levels were found:

1. 2 meter constant elevation spatial maximum: 25%
2. 2 meter constant elevation average: 4.8%
3. 2 meter vertical sweep spatial maximum: 25.6%
4. 2 meter vertical sweep average: 3.6%

The differences between maximum and average values are indicative of the scattered fields atop the portico.

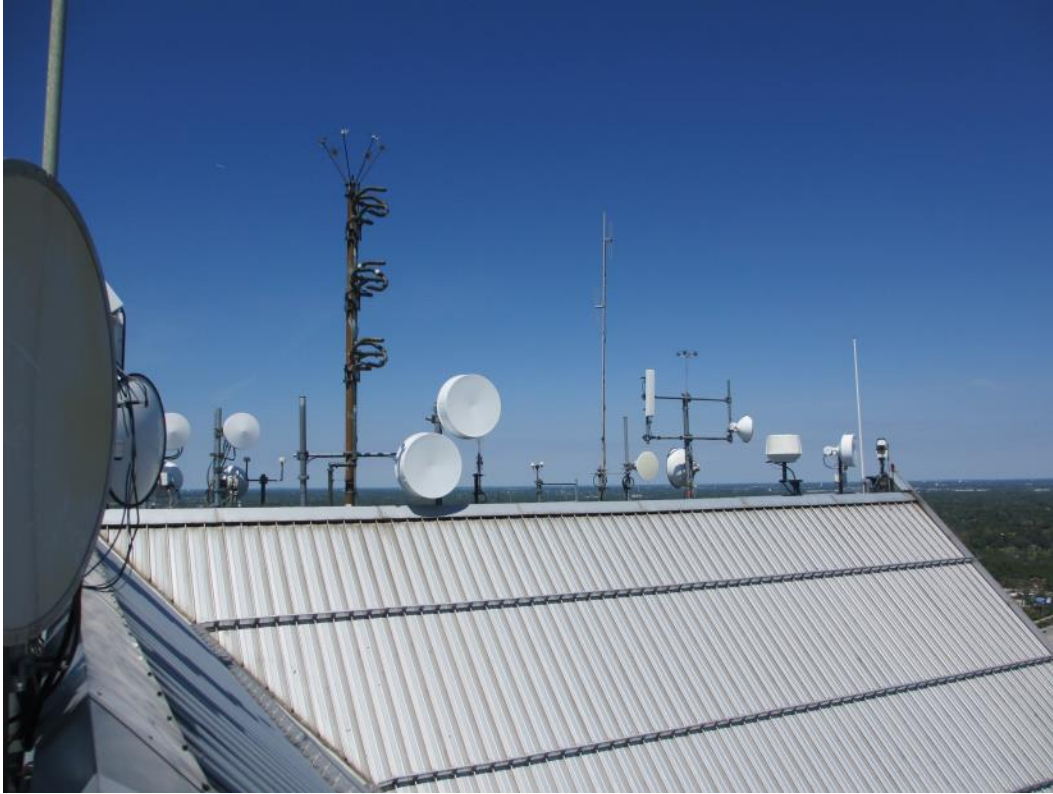
**Photo 8: Northern Portico**

The north portico roof supports the WLEY-FM auxiliary antenna and multiple communications antennas, many of which have been retired from service but not removed.

From the access hatch to the outer edge of the portico, the following measured RFE levels were found:

1. 2 meter constant elevation spatial maximum: 115%
2. 2 meter constant elevation average: 20%
3. 2 meter vertical sweep spatial maximum: 113%
4. 2 meter vertical sweep average: 13%

The differences between maximum and average values are indicative of the scattered fields atop the portico. With the exception of a location near a land-mobile antenna, the excessive spot RFE levels noted above could not be replicated with the instrument in the real-time display mode. At the land-mobile antenna location, shown in the following photo, bidirectional spatial average measurements were conducted, yielding a measured RFE level of 44% of the protection guideline value.

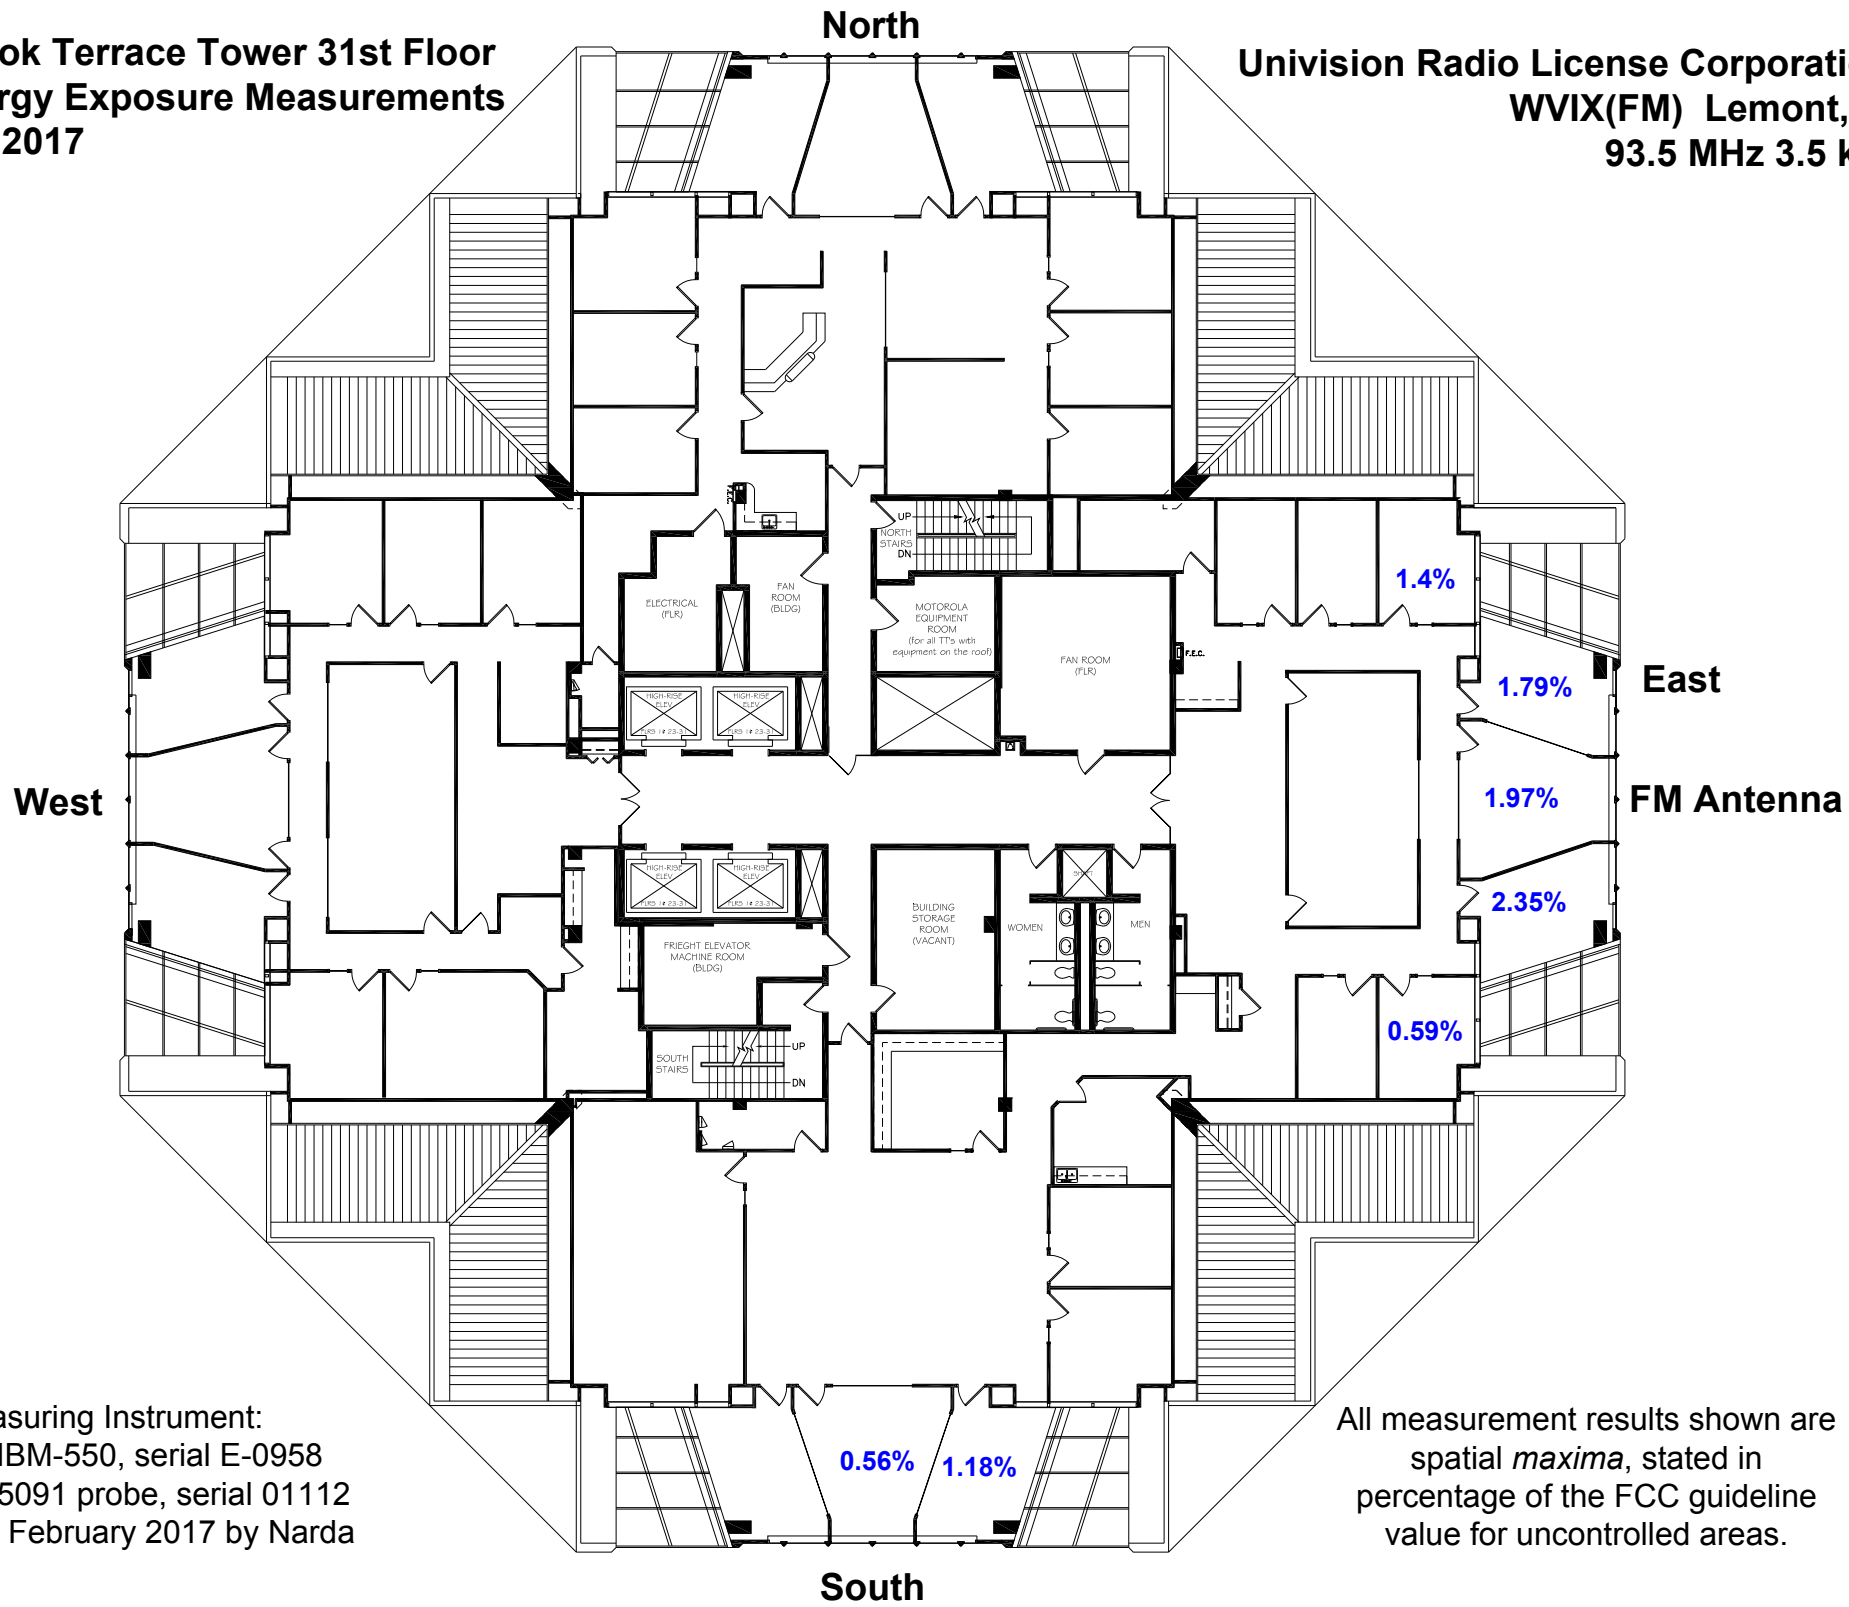
**Oakbrook Terrace Tower 31st Floor  
RF Energy Exposure Measurements  
19 May 2017**

Attached hereto is an accurate plan of the building's 31<sup>st</sup> floor, showing the office spaces surveyed and the spatial maxima results obtained in each. In the east portico, the measured RFE levels ranged from 0.6% to 2% of the guideline value for uncontrolled areas. In the south portico, the measured levels were lower. Access to the northern portico was not possible, however, the nature of the antenna location and building construction is such that RFE levels within the north portico spaces are likely to mirror those of the south portico. The western portico area was surveyed, but the RFE levels encountered were of such low value and great scattering that they were considered inconsequential and not quantified.
