**SYSTEM FIELD REPORT
TRANSMISSION LINE AND ANTENNA**

**Radio Station WSCI-FM
Charleston, SC
89.3 MHz**

Antenna Type: Dielectric
Antenna Model: DCRM10CFE68RDT100F10
Transmission Line: Dielectric 4 $\frac{1}{16}$ " rigid transmission line
Line Length: Approximately 1510 ft. in Length
Line Section Lengths: 20 foot

Date of Service: September 30, 2016

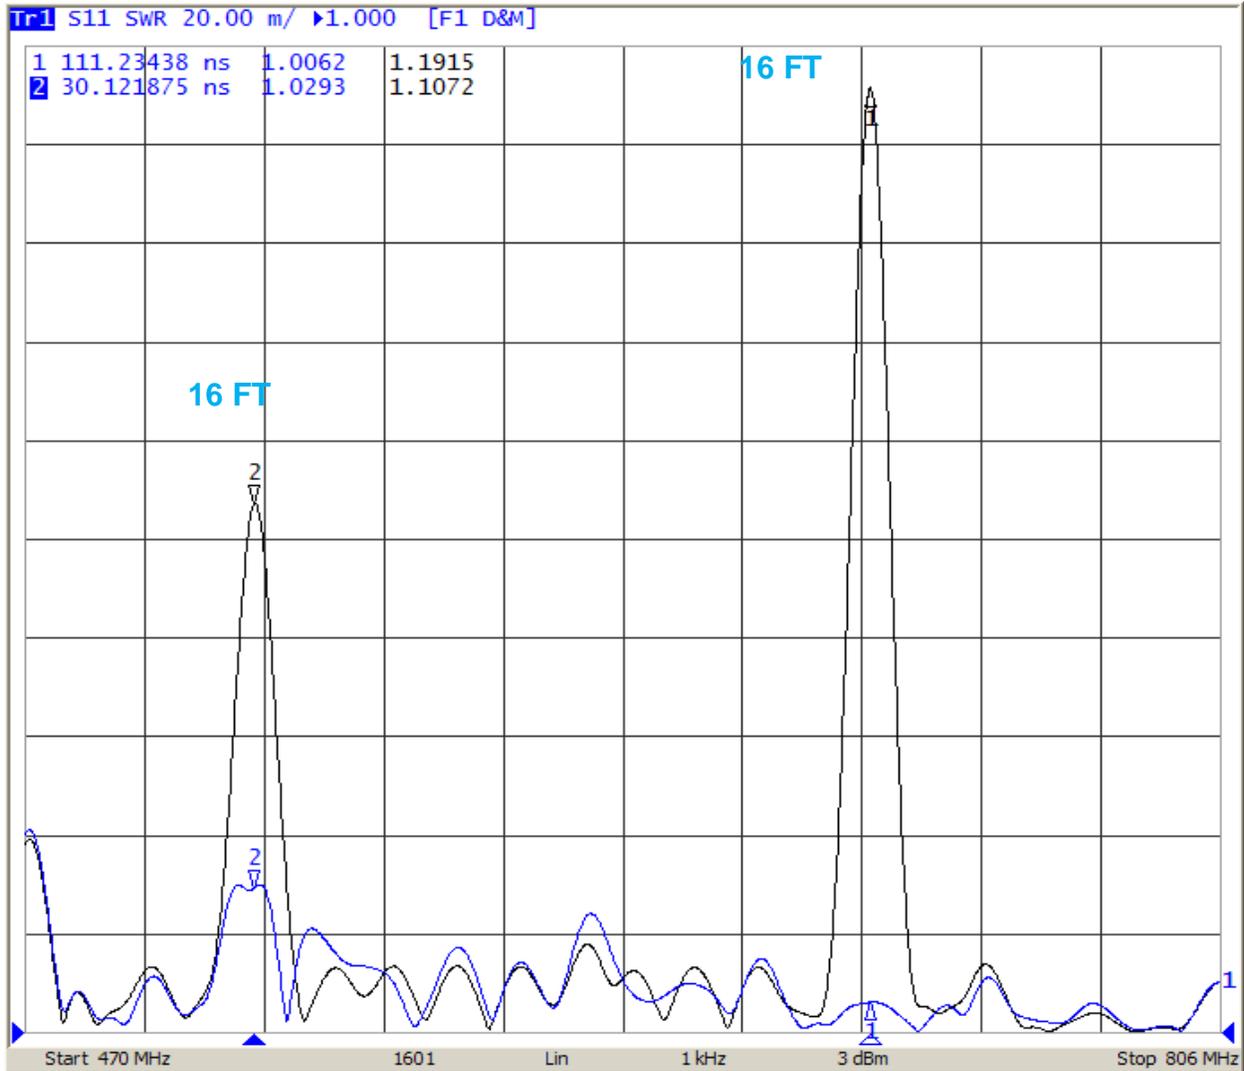
WSCI-FM Charleston, SC
TDR in VSWR 470 to 806 MHz
(Line Loaded)

TDR display from the test adapter to 0.125 uS in the run
 Memory Trace = Before Line Repairs
 Data Trace = After Line Repairs

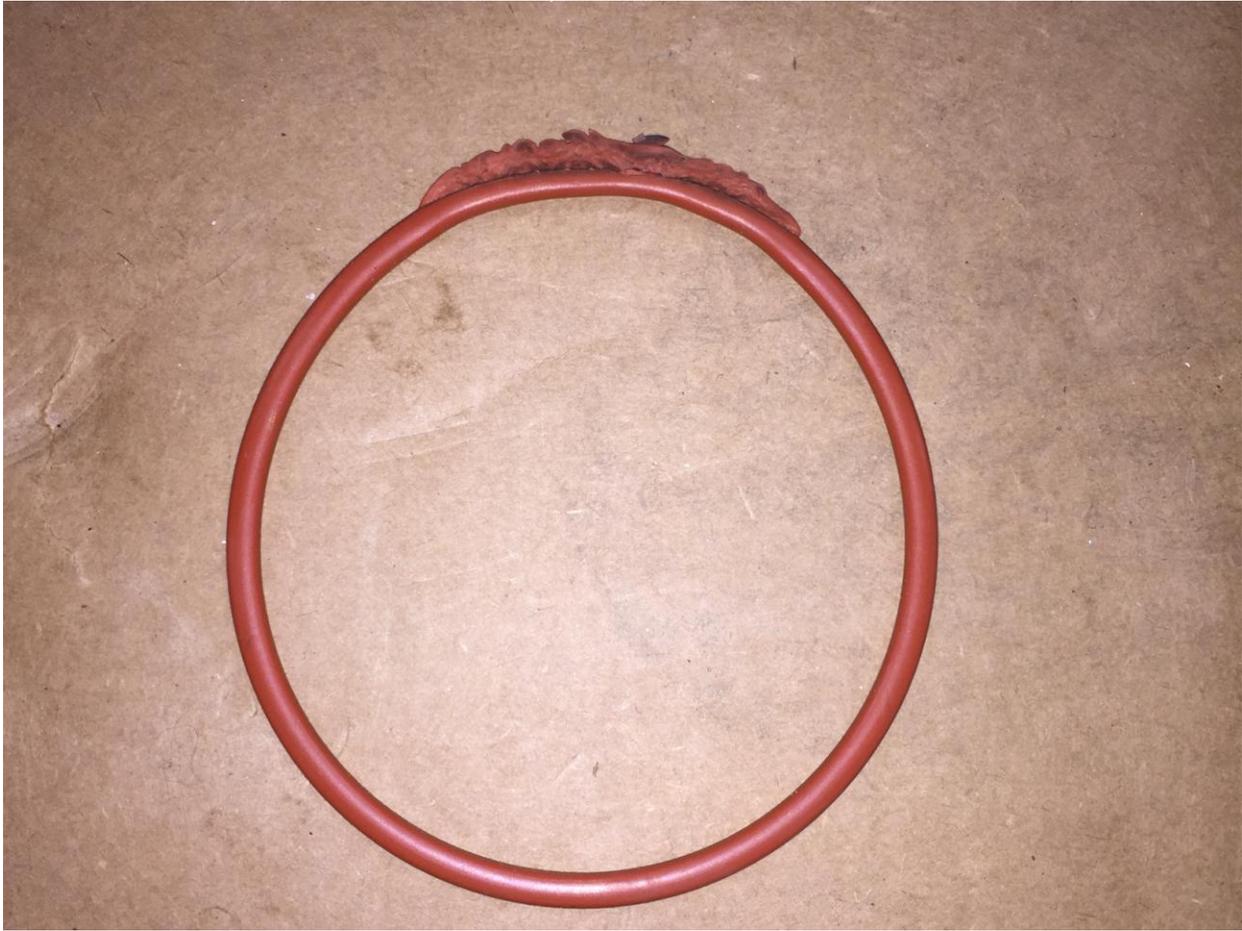
found 3 pinched o-rings, 1 bad elbow & 1 bad
field soft solder flange on old transmission line
run.

One of pinched o-rings

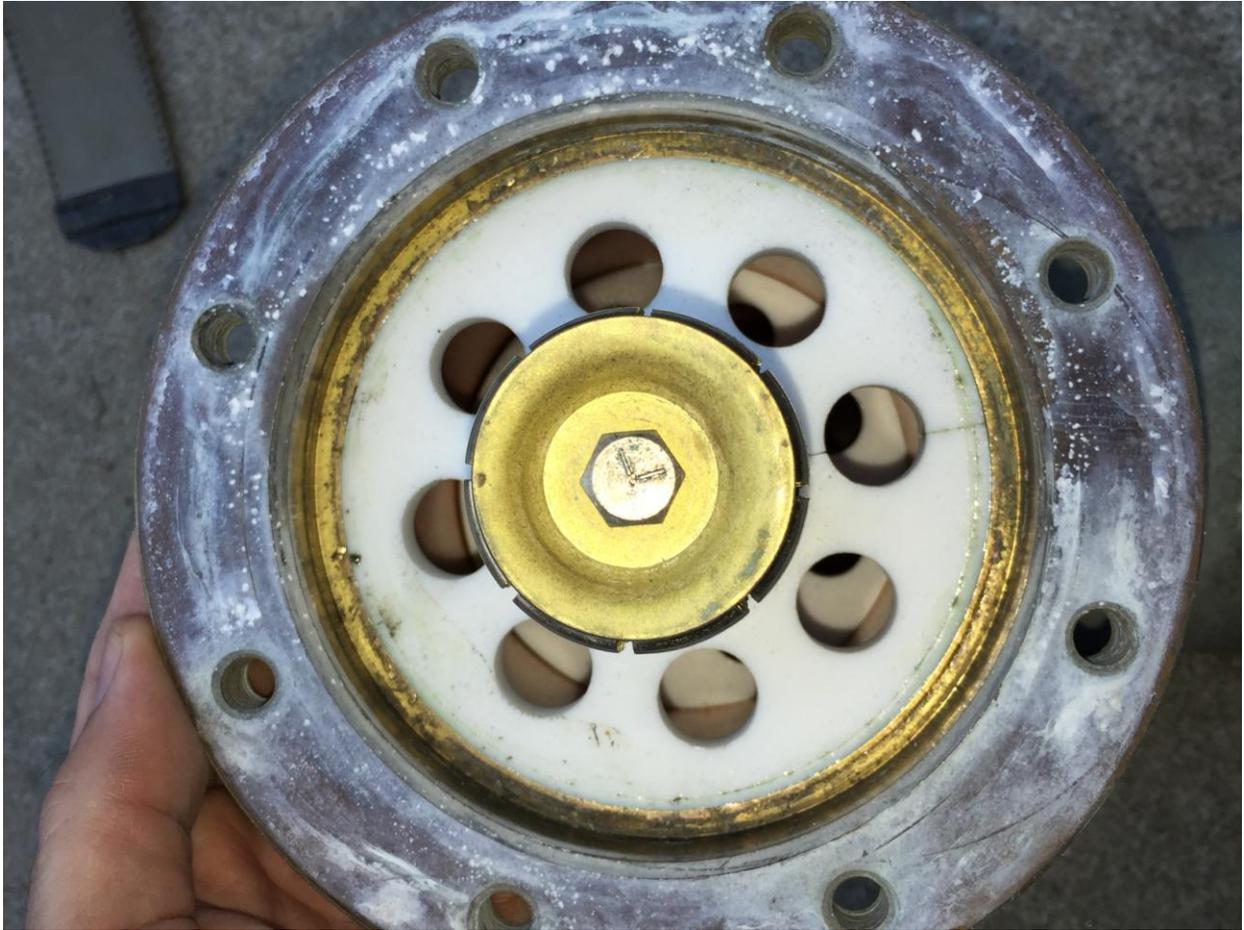
Unibolt elbow with contaminated RF lip
