RFR STUDY

The following RFR measurements were collected by the undersigned on February 16, 2014, at the Hogback Mountain, Montana, high-powered communications site which is home to the following broadcast facilities:

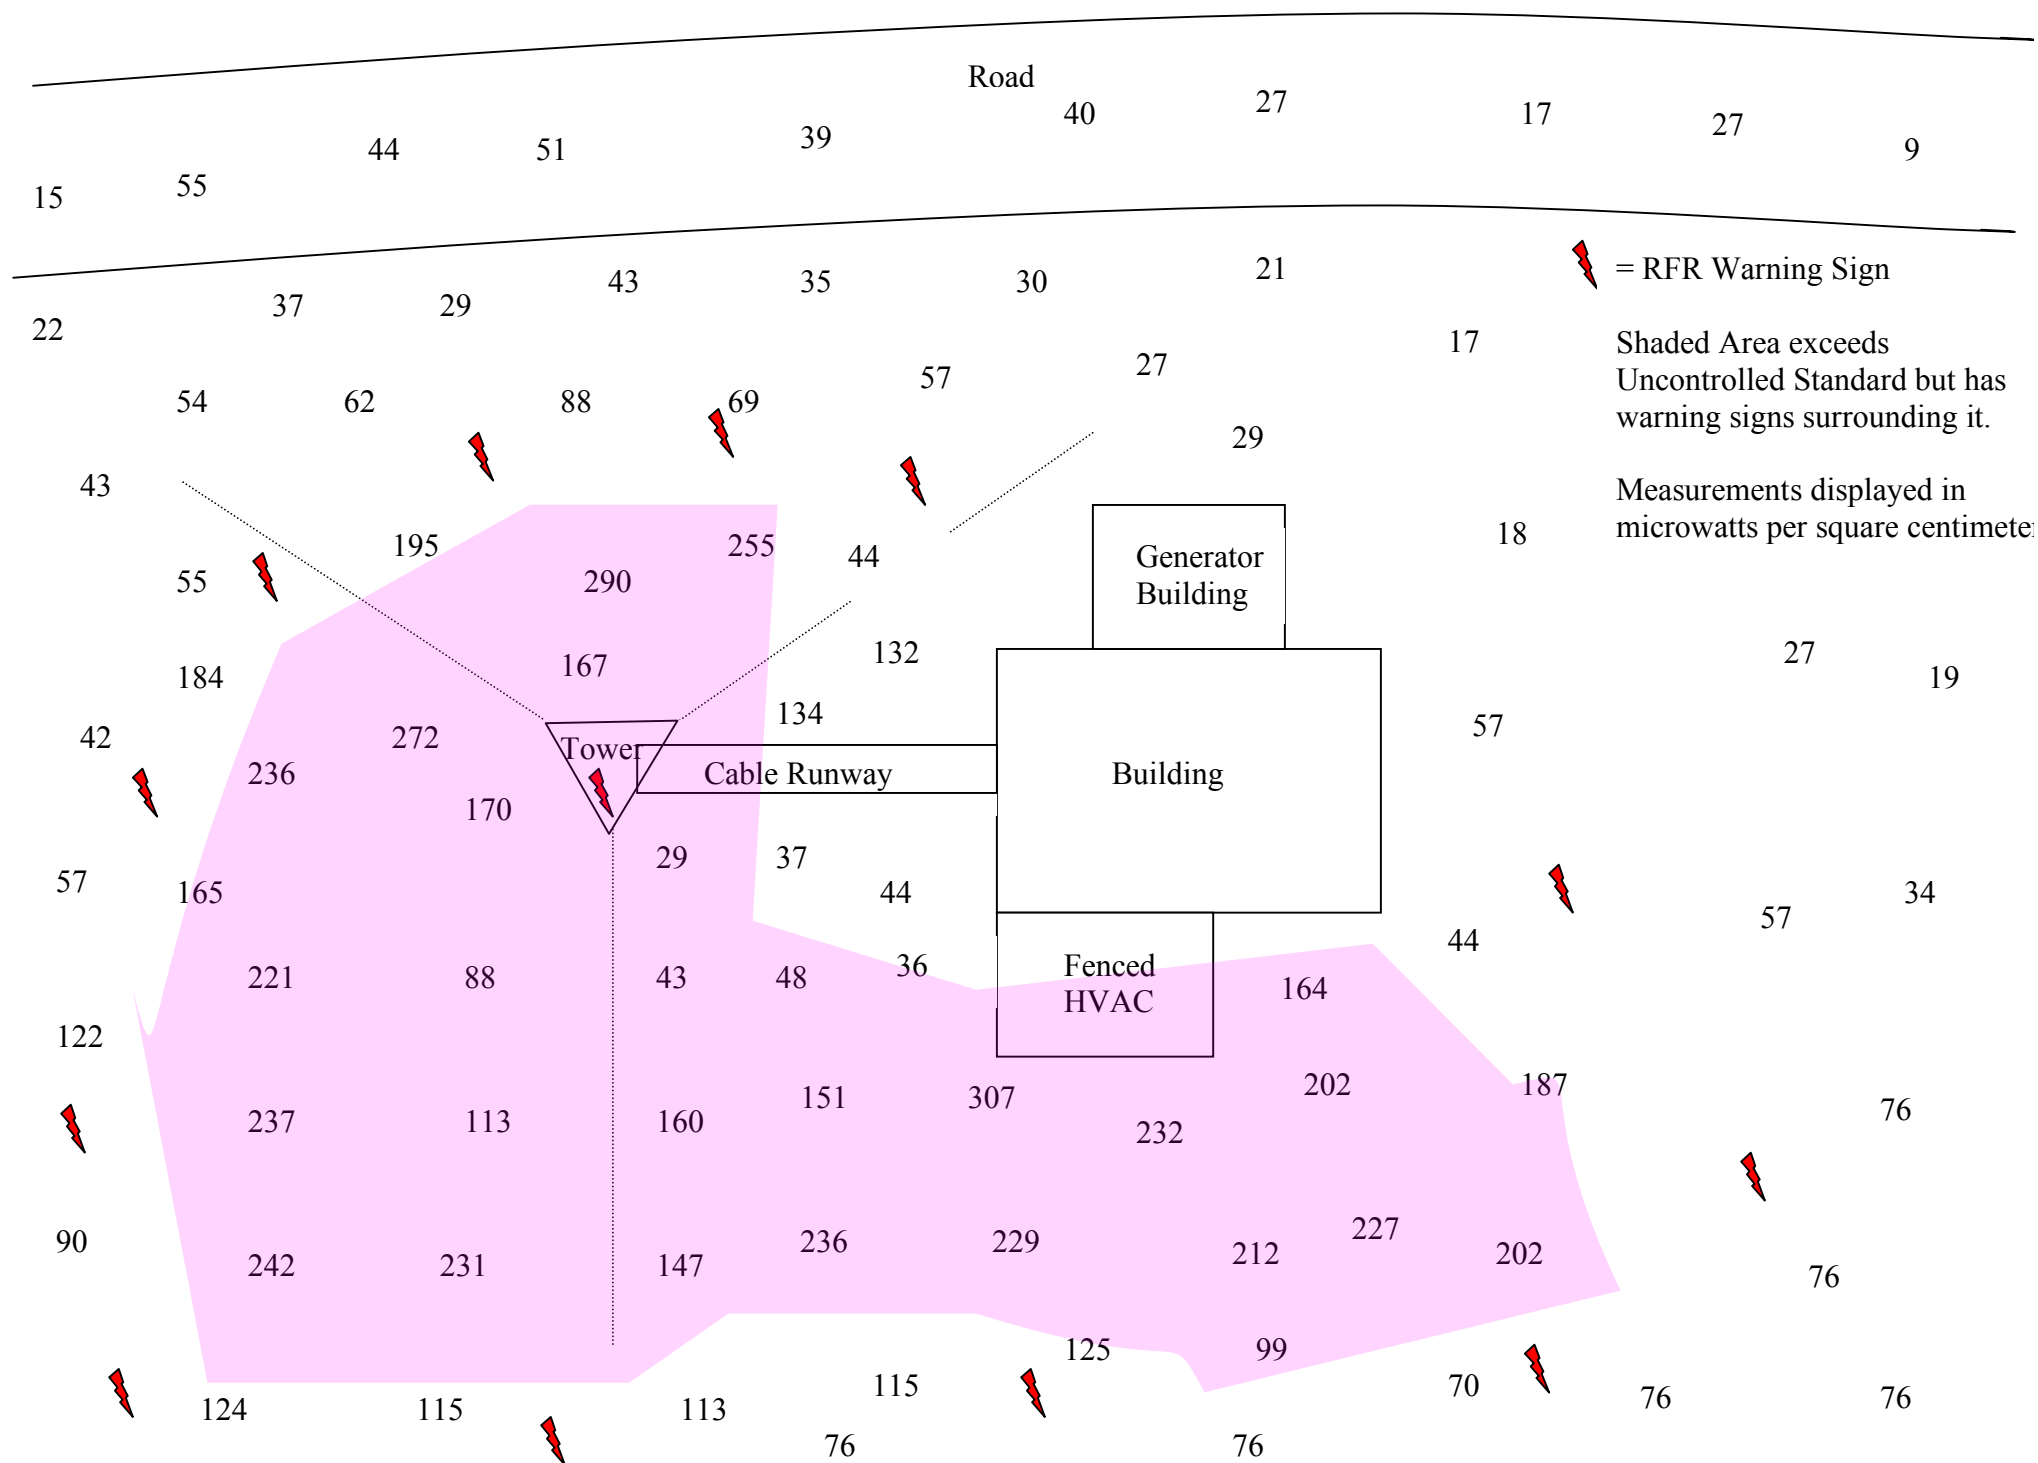
Uncontrolled Standard, or 200 micro watts per square centimeter. However, there is an area within 5 meters and 25 meters of the tower below its northeast face that exceeds the Uncontrolled Standard. The highest measurement recorded was 307 micro watts per square centimeter, which is 54% higher than the Uncontrolled Standard.

The permittee/licensee has installed warning signs encircling the area beneath the tower where RFR levels were measured in excess of the Uncontrolled Standard. The attached sketch of the antenna site’s RFR measurements includes the locations of the various warning signs. The permittee/licensee certifies that the antenna site is located on a remote

mountain top. The nearest house or structure is located some 14 miles from the antenna site. The site is inaccessible to car from November through July due to snow. Also, there is no evidence of the public spending any time at the antenna site where the Uncontrolled Standard is exceeded (no litter, fire rings, camp sites, parking areas). Therefore, the facility complies with the Bulletin with regard to RFR exposure.
