Compliance with C.F.R. 74.1204

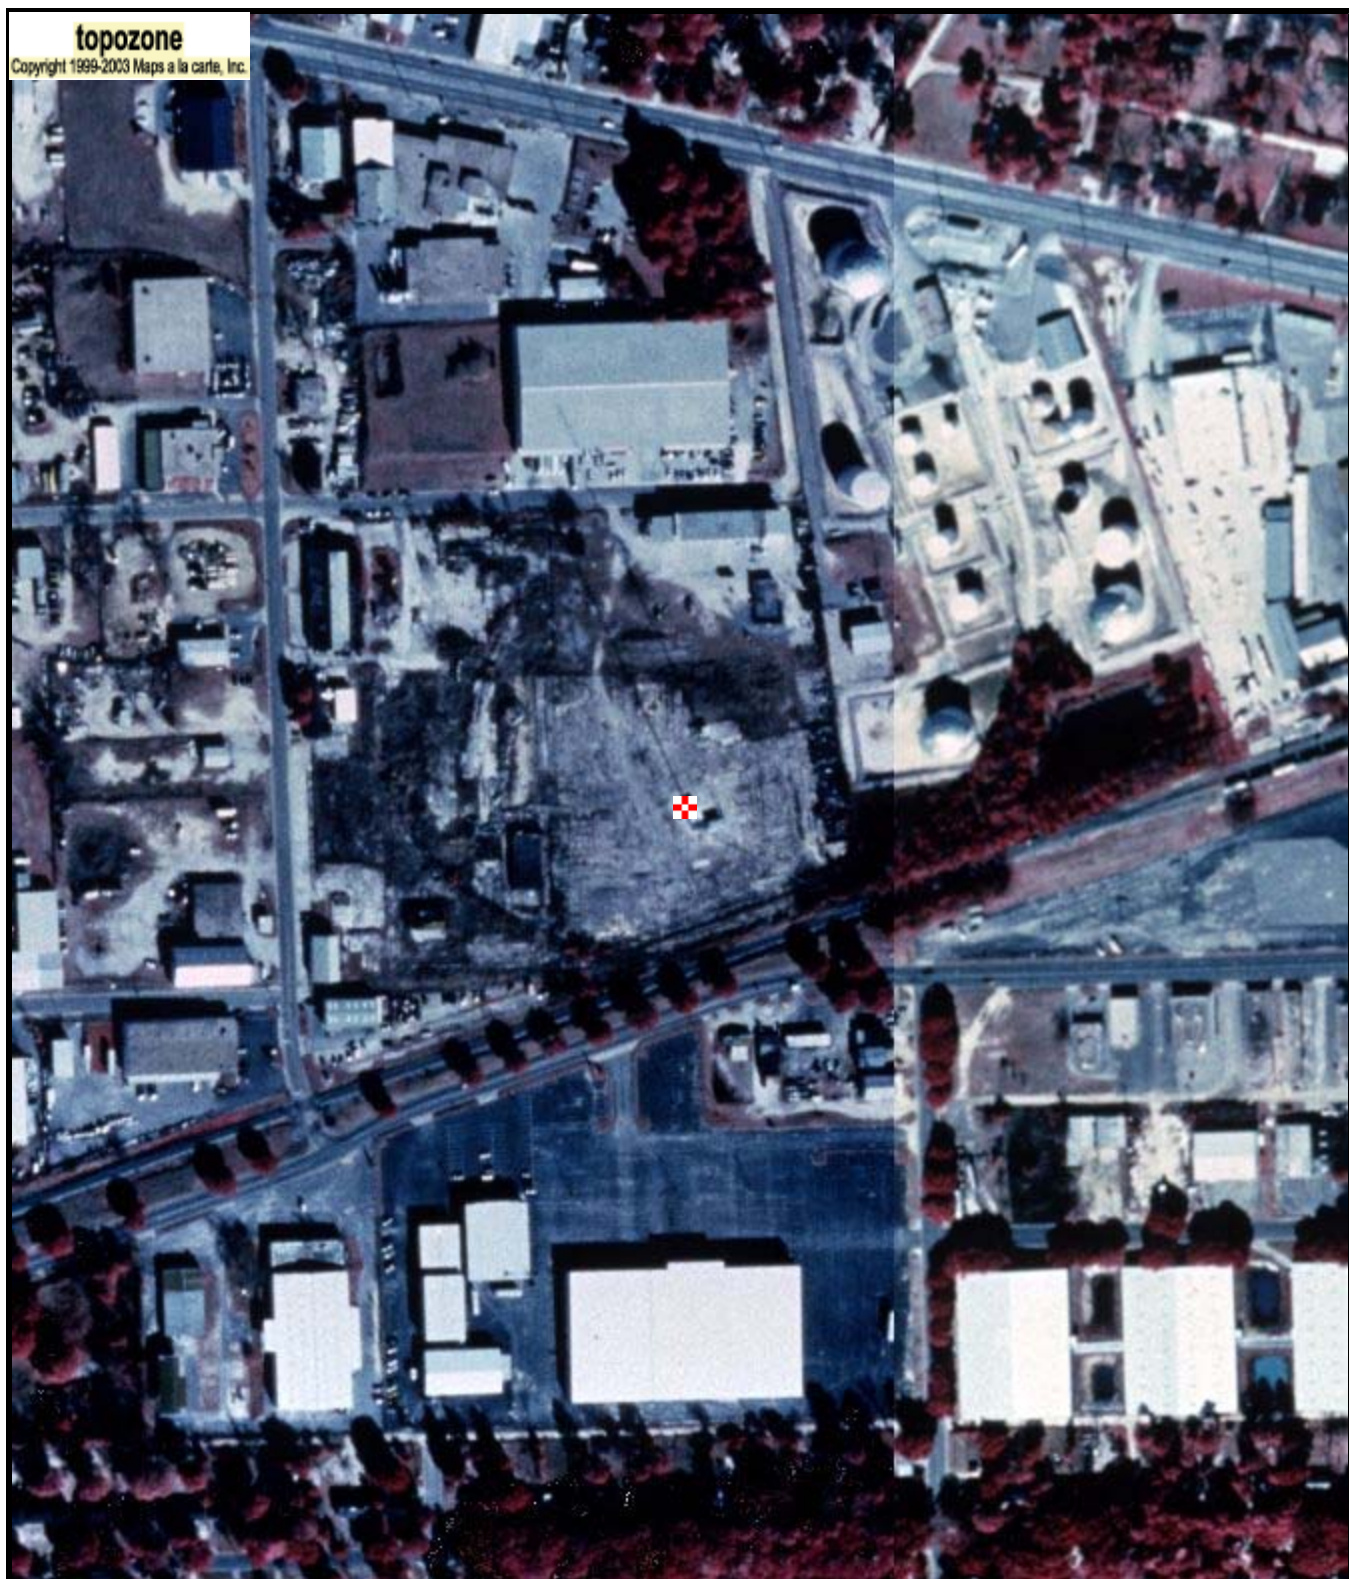
Due to the lack of clarity of the topo map, in order to determine that there are no structures nearby that could be tall enough to enter the interference aperture, an aerial photograph of the site (obtained from Topozone.com) was examined. The aerial photo has been attached to this exhibit to demonstrate the lack of nearby structures.

Therefore, EMF respectfully maintains its request of a waiver of C.F.R 74.1204 based on no population within the area of predicted interference.
