Prepared for The University of Utah
K299CB – Saint George, Utah
LMS File Number 0000146777

FIELD MEASUREMENTS OF RADIOFREQUENCY ELECTROMAGNETIC POWER DENSITY

Webb Hill – St. George - Washington County – Utah
University of Utah and Frandsen Site RFR Signage
June 2022

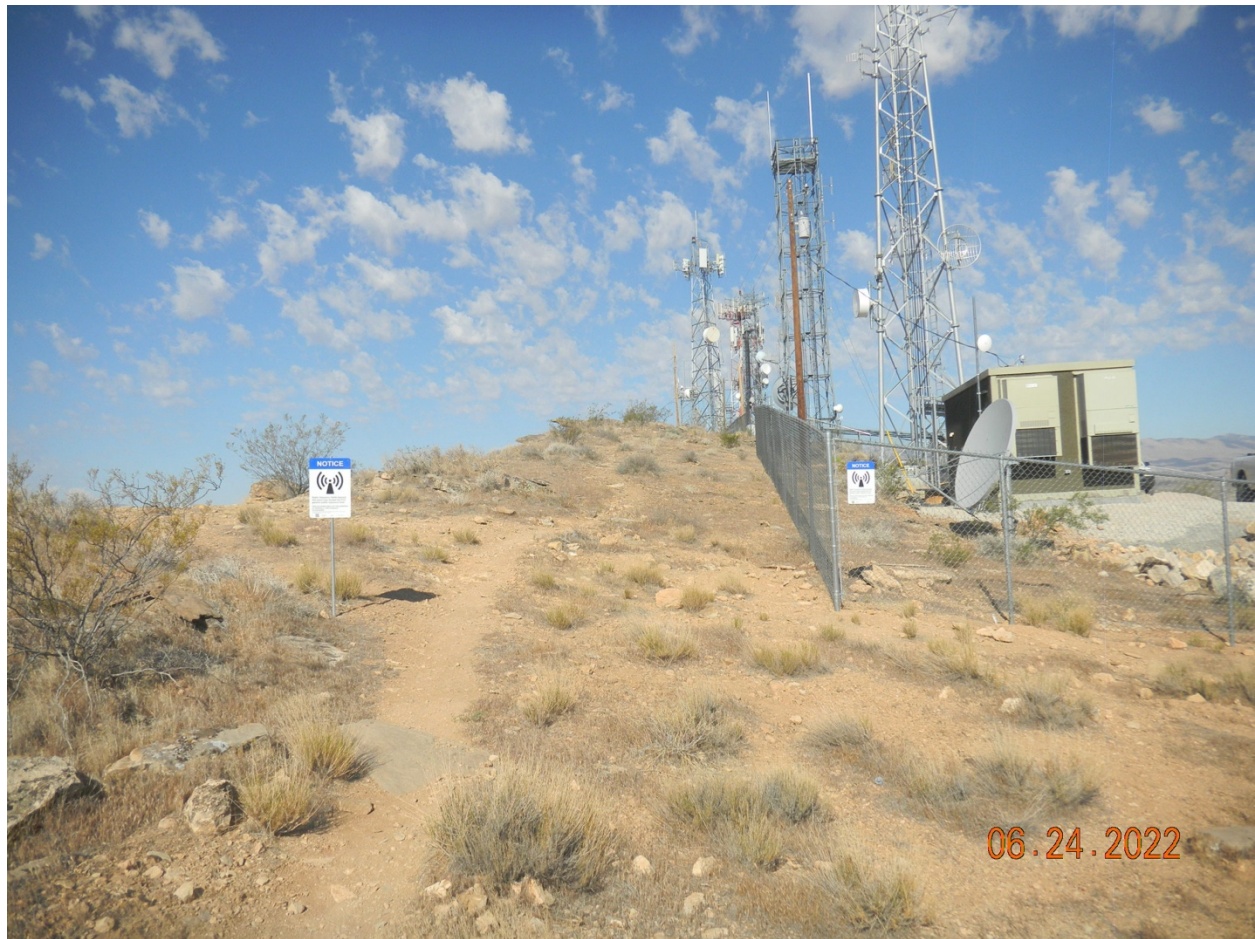
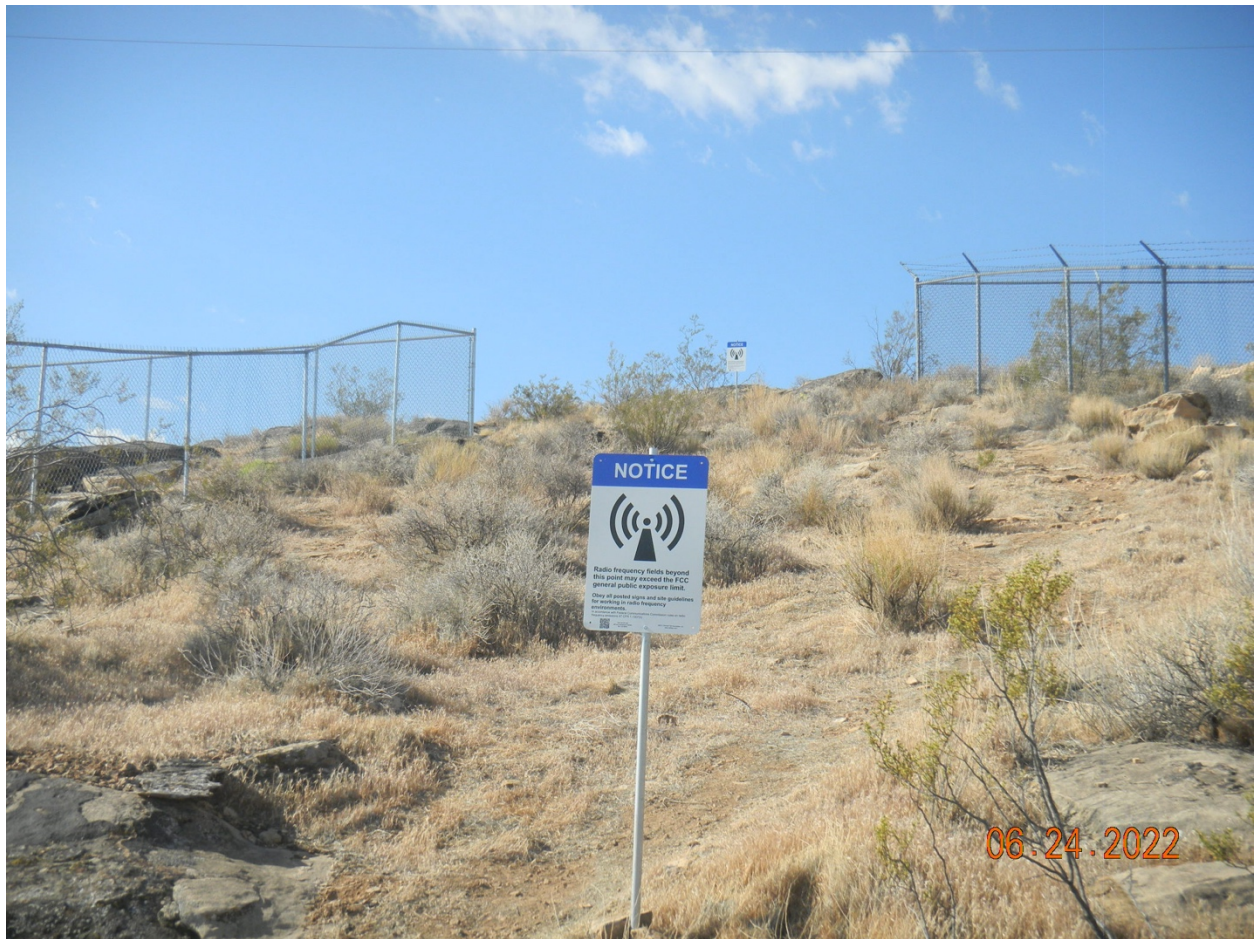
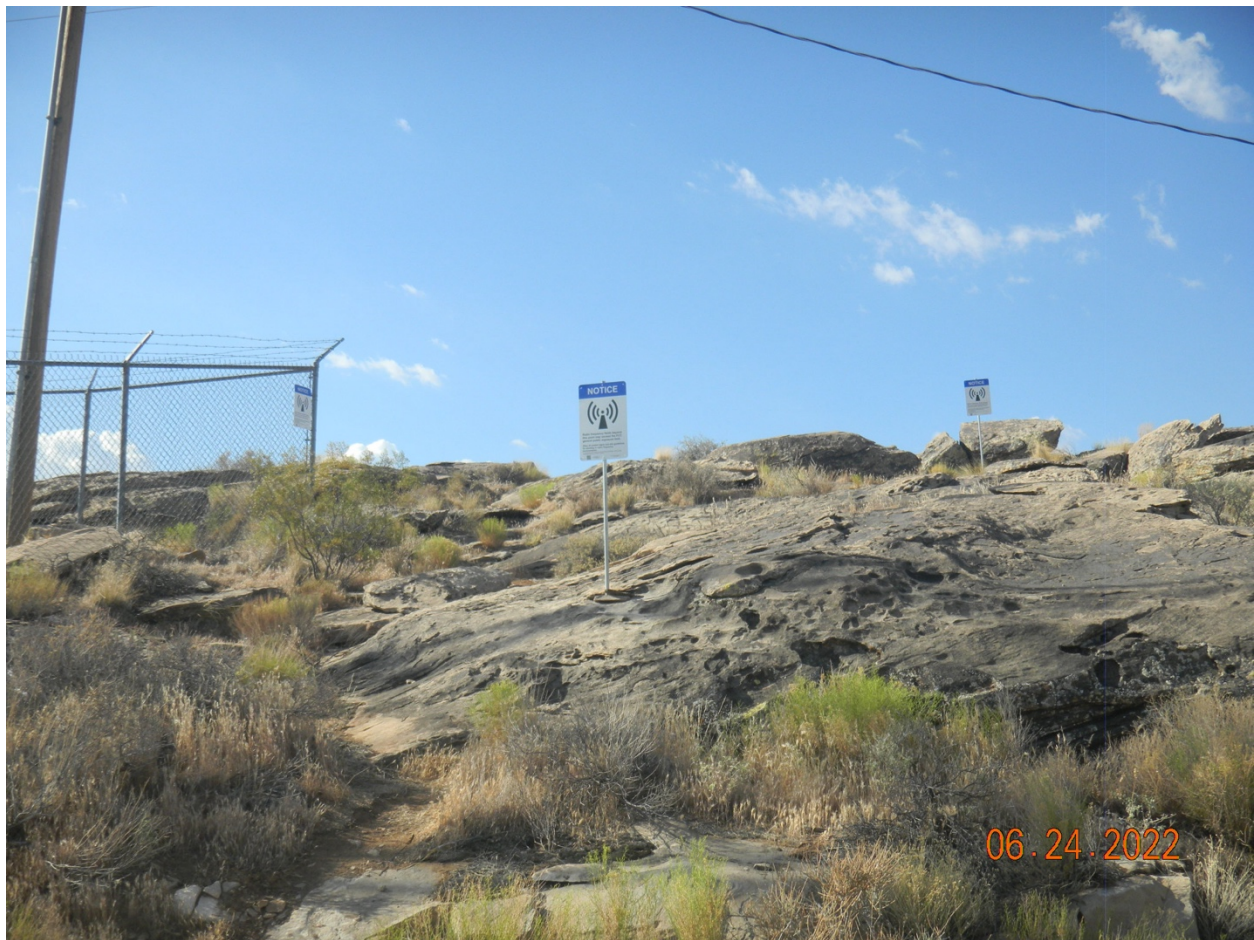
Attached also are photographs representative of the sign installations.

In an abundance of caution, the applicant has erected warning signs around the perimeter this area warning that the radiofrequency field may exceed the General Public/Uncontrolled standard.
