SOLEDAD-KFMB FM SYSTEM
COMBINER RE-CHANNALIZATION

Soledad Mt.
La Jolla, CA
(Transmit Facility)

Combiner:
9-Channel, Re-Channelized and Converted to 7-Channels
with Input Directional Couplers

Electric Test Date: 19May21 – 23May21

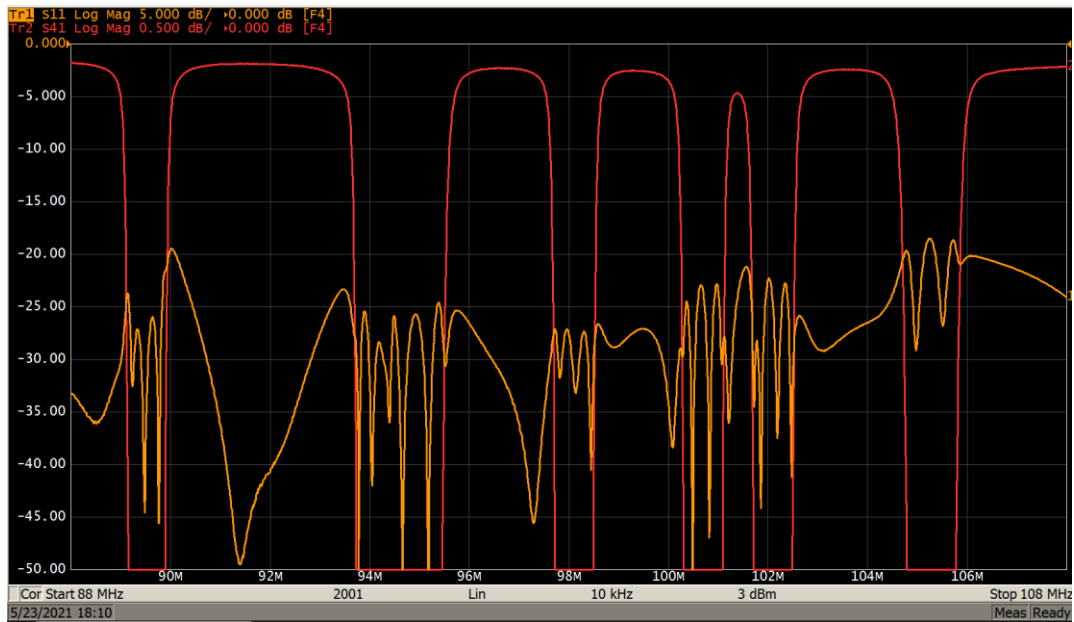
Broadband Port VSWR

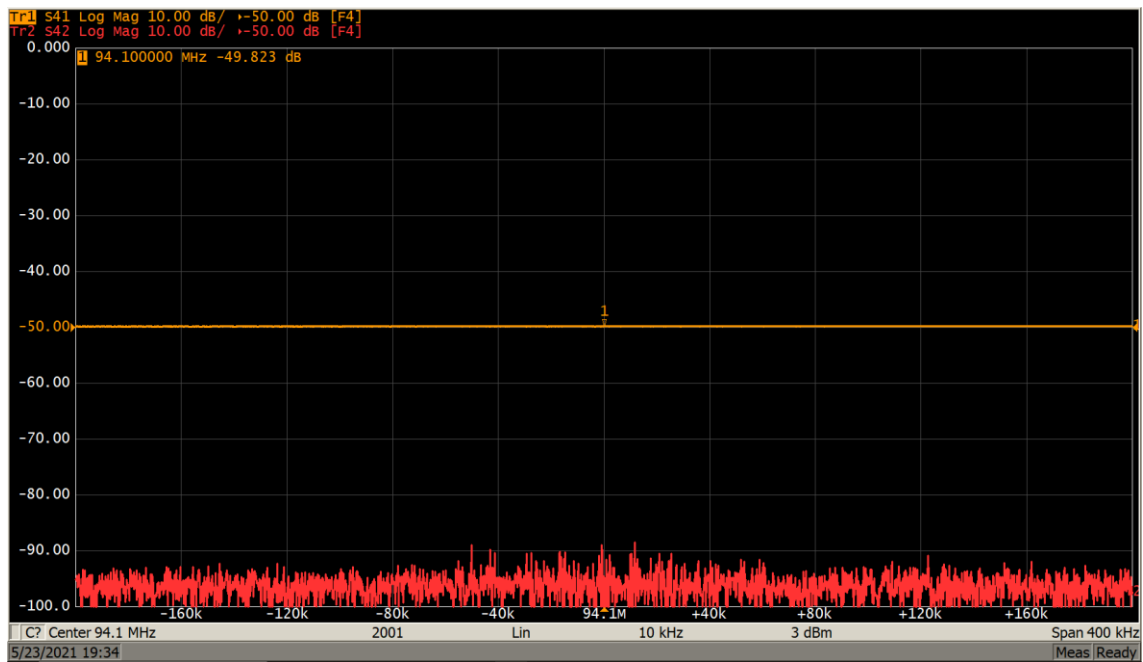
94.1 FWD CPLR, Coupling and Directivity
