Radio Frequency Exposure Study and Occupational Access Plan

Community Radio Inc. - Gibraltar Peak

3035 Gibraltar Rd., Santa Barbara, CA

May 31, 2013

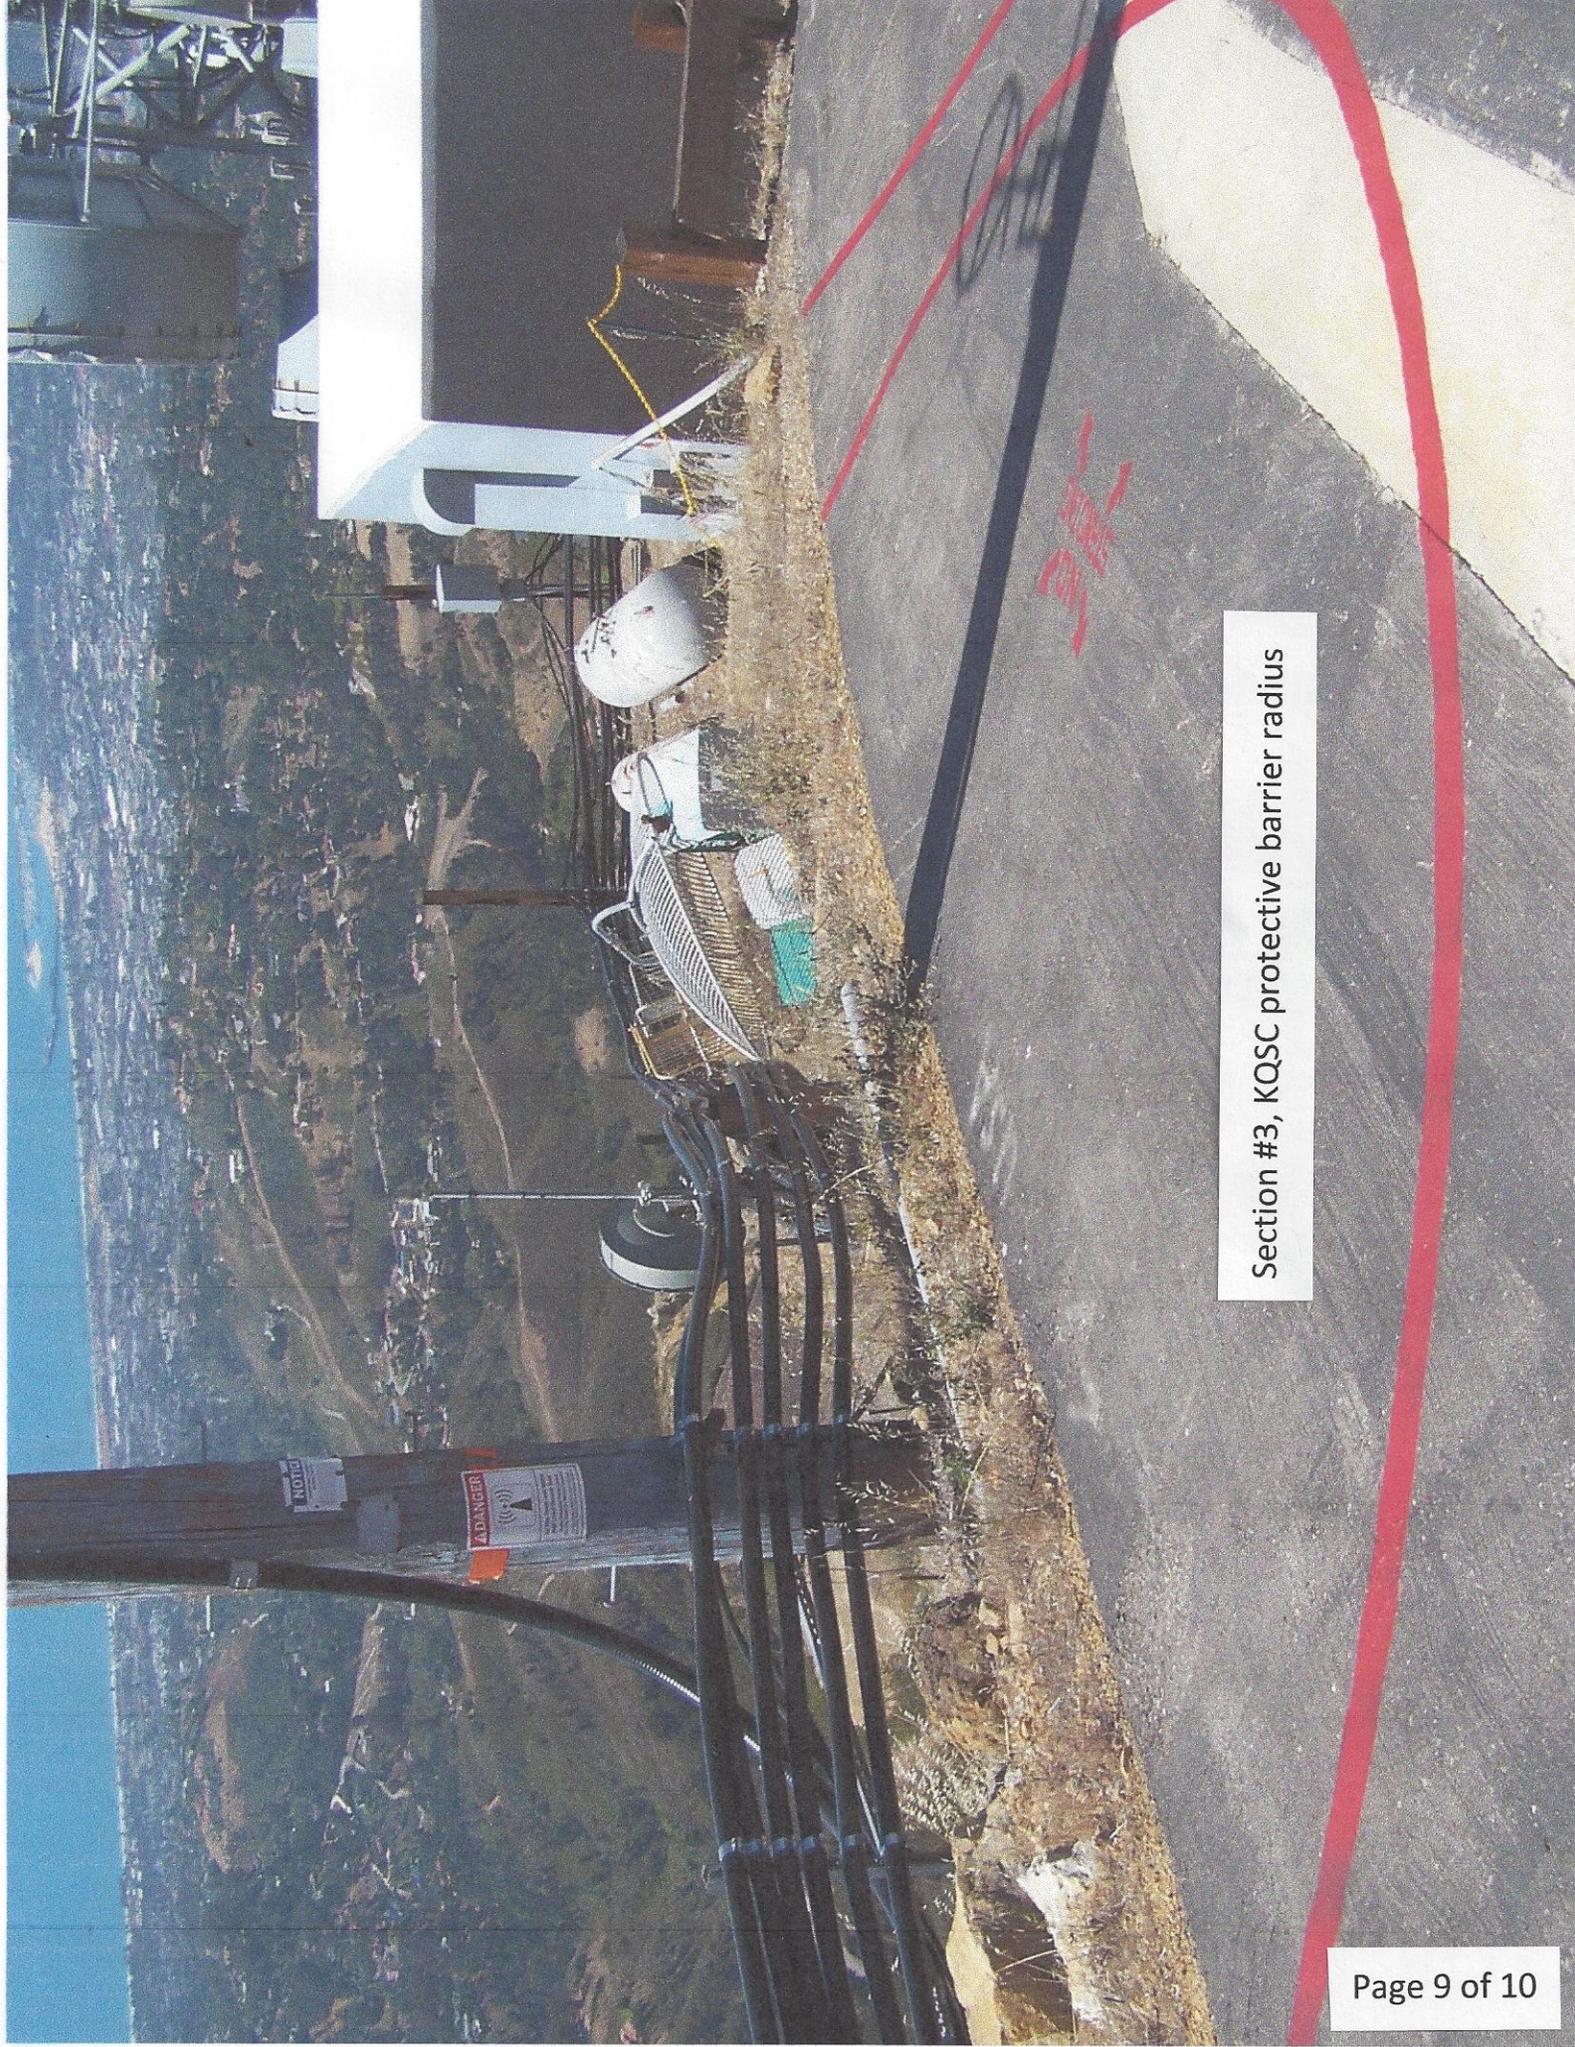
Section #3, KQSC protective barrier radius

On the ground level of the driveway leading to building #4, there are two areas marked with red paint to warn that within those barriers there are points of R.F. energy exceeding Occupational exposure levels.

The first is a red circle barrier on the driveway centered on the antenna mast for KQSC (see photo #4, page 9).

There are signs on both antenna masts giving instructions regarding the antenna masts and R.F. levels. Personal R.F. monitors must be worn while working within any of these barriers or on the masts. KQSC and KDAR must be contacted to reduce power or shut off during these periods if a personal monitor indicates levels exceeding Occupational exposure levels.

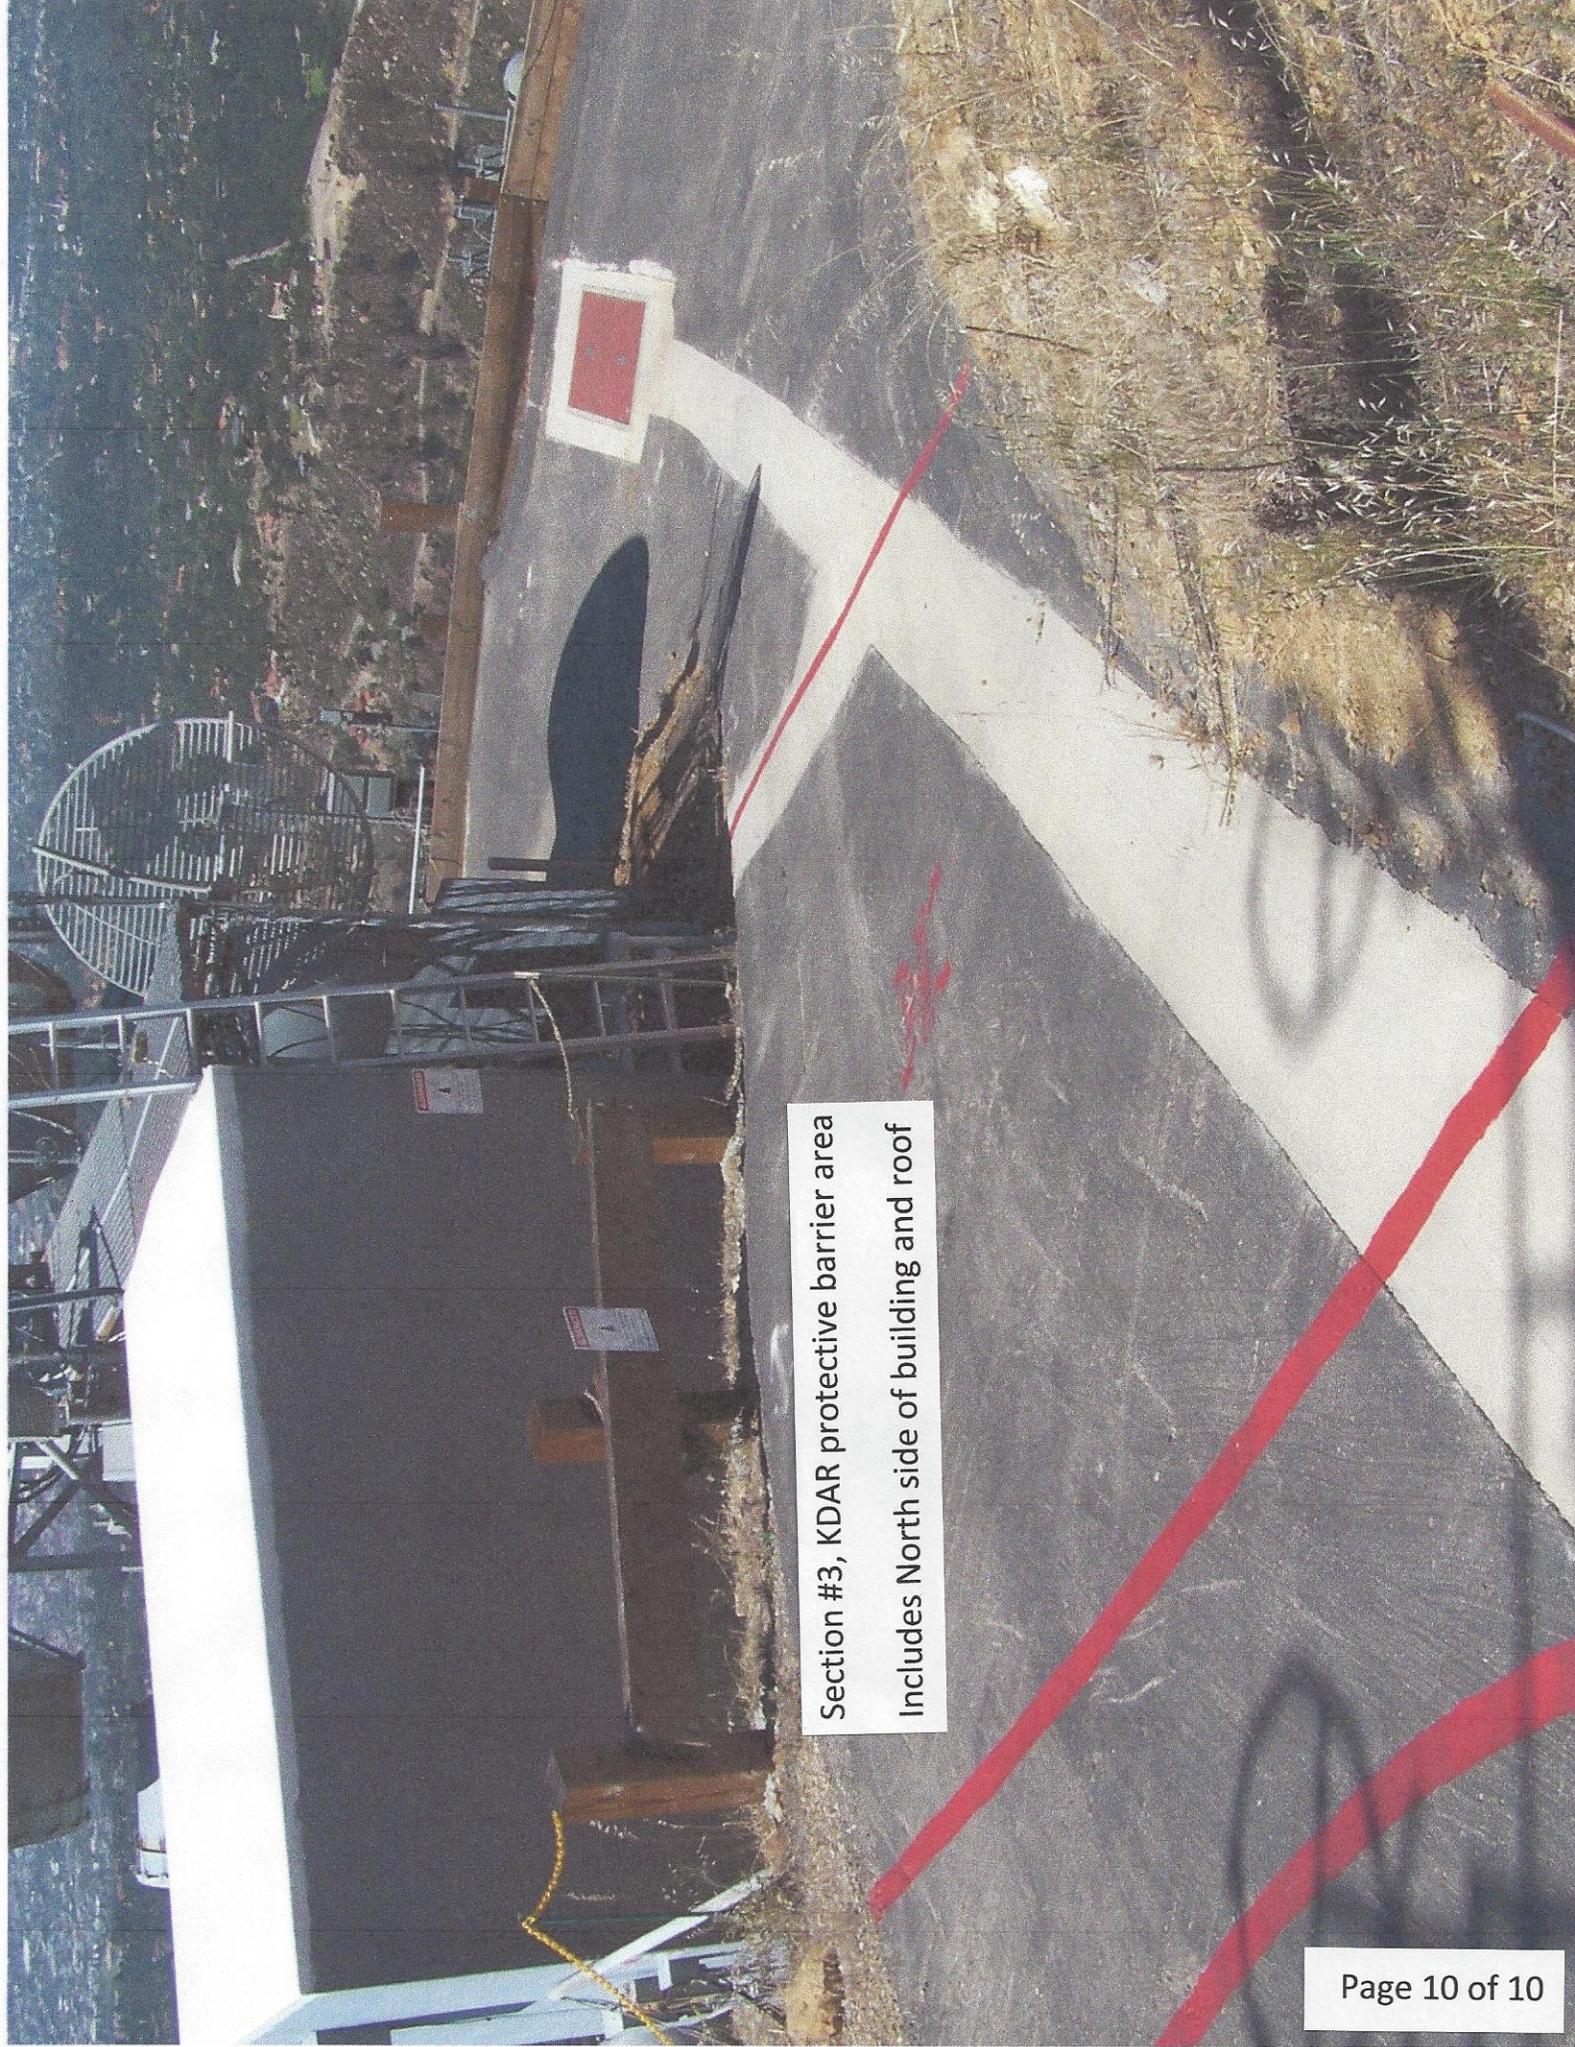
Section #3, KDAR protective barrier area
Includes North side of building and roof

The second red barrier area is two lines which lead to the building and an additional area marked off on the North side of the building. These lines indicate the exposure from KDAR (see photo #5, page 10).

The roof of building #4 has points of R.F. Exposure levels which exceed Occupational levels. Again, personal R.F. monitors must be in use when working on this roof or on any of the antennas immediately beyond the roof line. KQSC and KDAR must be contacted to reduce power or shut off the transmitter if a personal monitor indicates levels exceeding Occupational exposure levels.
