ENVIRONMENTAL COMPLINACE
KCMT 1.10 KW VERP 1342 M AMSL CH. 221
ARIZONA LOTUS CORP.
GREEN VALLEY, ARIZONA

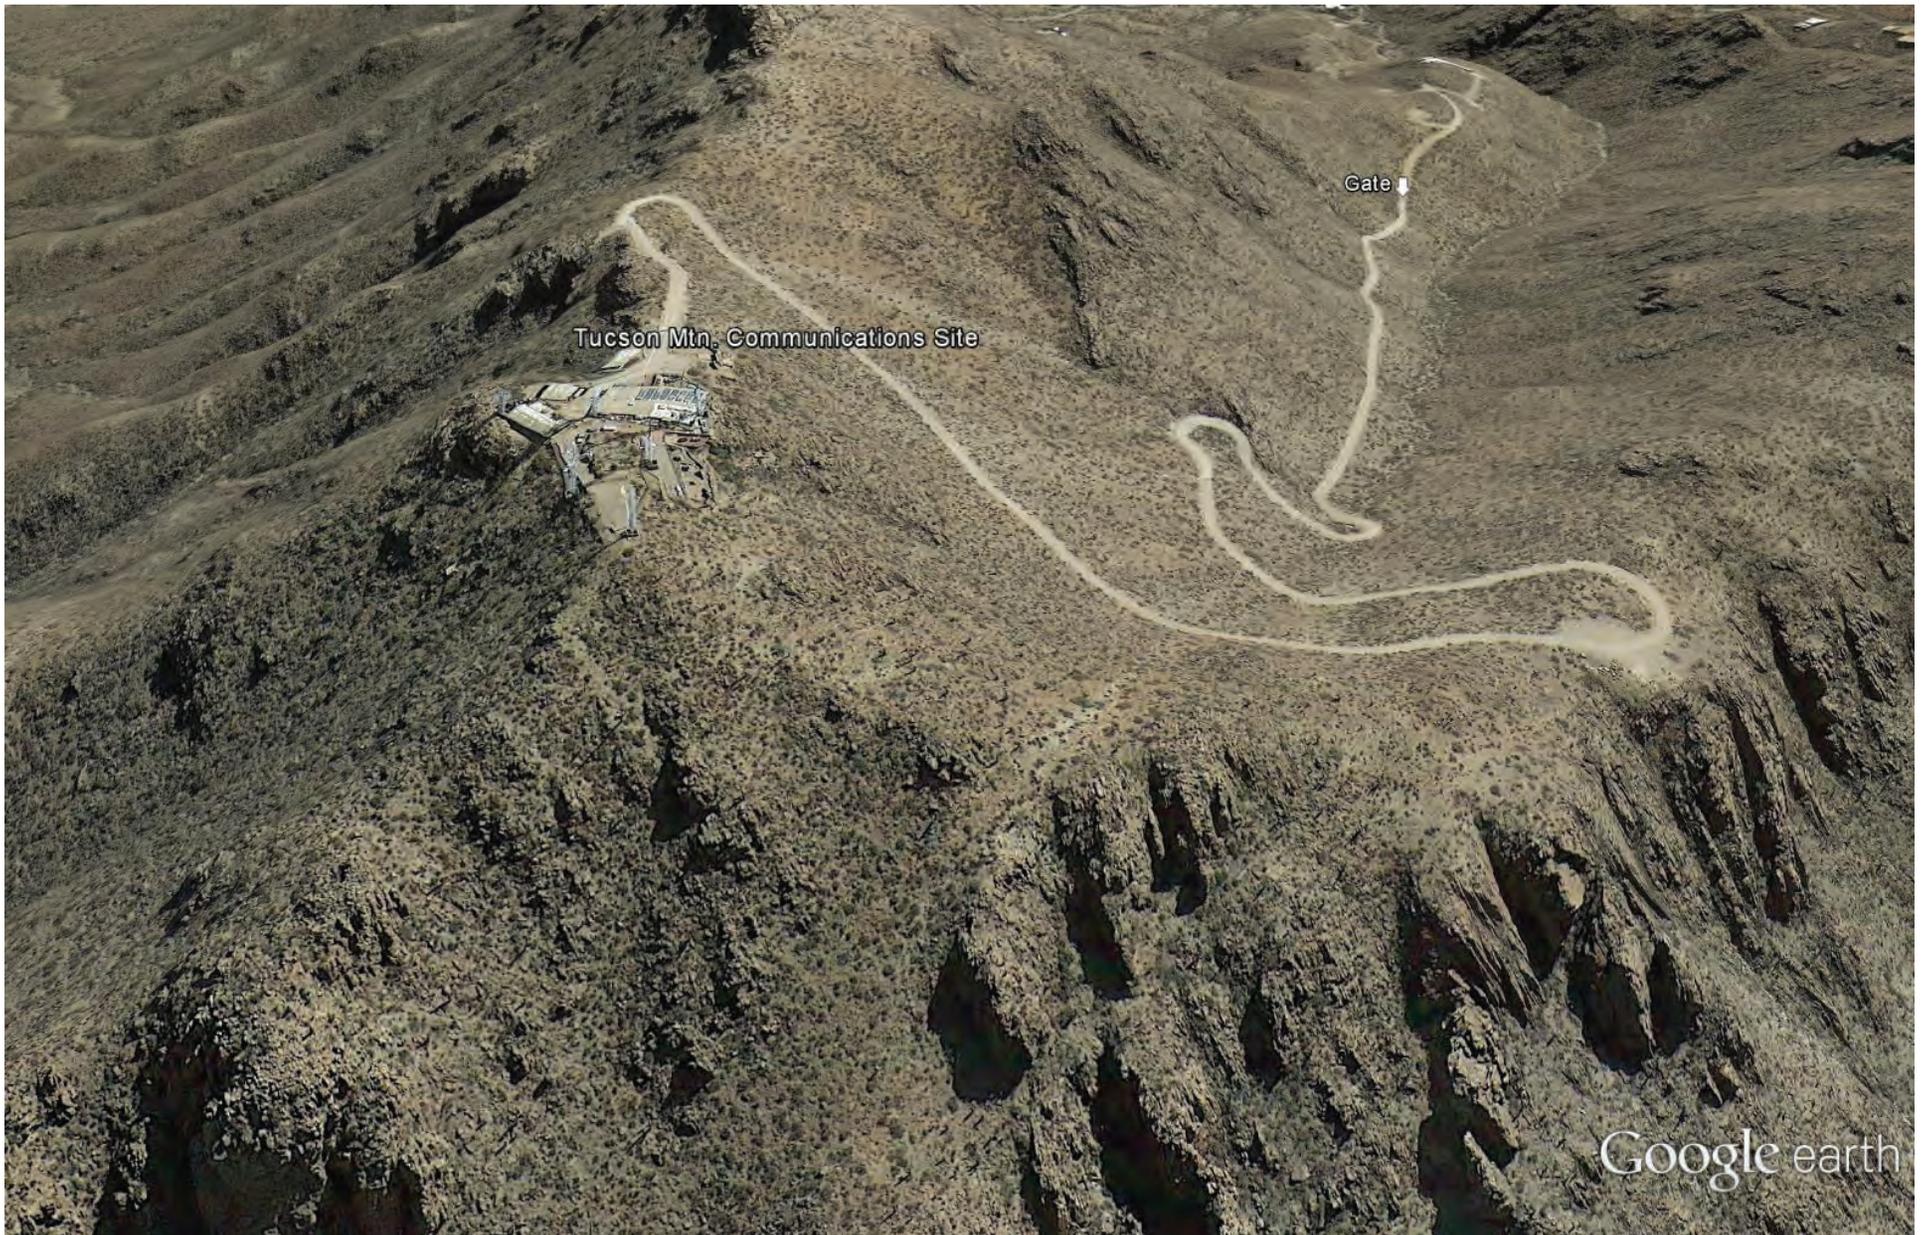
FIGURE 1
AERIAL PHOTO OF THE TUCSON
MOUNTAIN COMMUNICATIONS SITE

The emergency facility for KCMT (Facility ID No. 2746) is located at an established communications site on top of Tucson Mountain. As demonstrated in the aerial photo provided as Figure 1, this mountaintop site is isolated from any populated areas and the only road that provides access is gated. Figure 2 depicts that the gate is locked and a sign is posted to limit access to “authorized four wheel drive vehicles only.” It also shows that RF warning signage is posted at the point along the access road where exposure may exceed the general public limit. In addition to the site having restricted access, warning signs to establish awareness of the potential for general and occupational exposure are posted at appropriate intervals throughout the site. A few examples of the multiple RF warning signs that are posted at the site are included in Figure 3.
