Field Service Report FM Combiner and Antenna System

Chillicothe, OH.
Broadcast Facility
ERI Antenna: LPX-4C-SP
ERI 955-4 "TEE" Combiner
Feedline: 1 5/8" RFS Flex HCA158-50J (155')

WZCP – 89.3 MHz.
WVNA – 90.1 MHz.

ERI Project #30659A

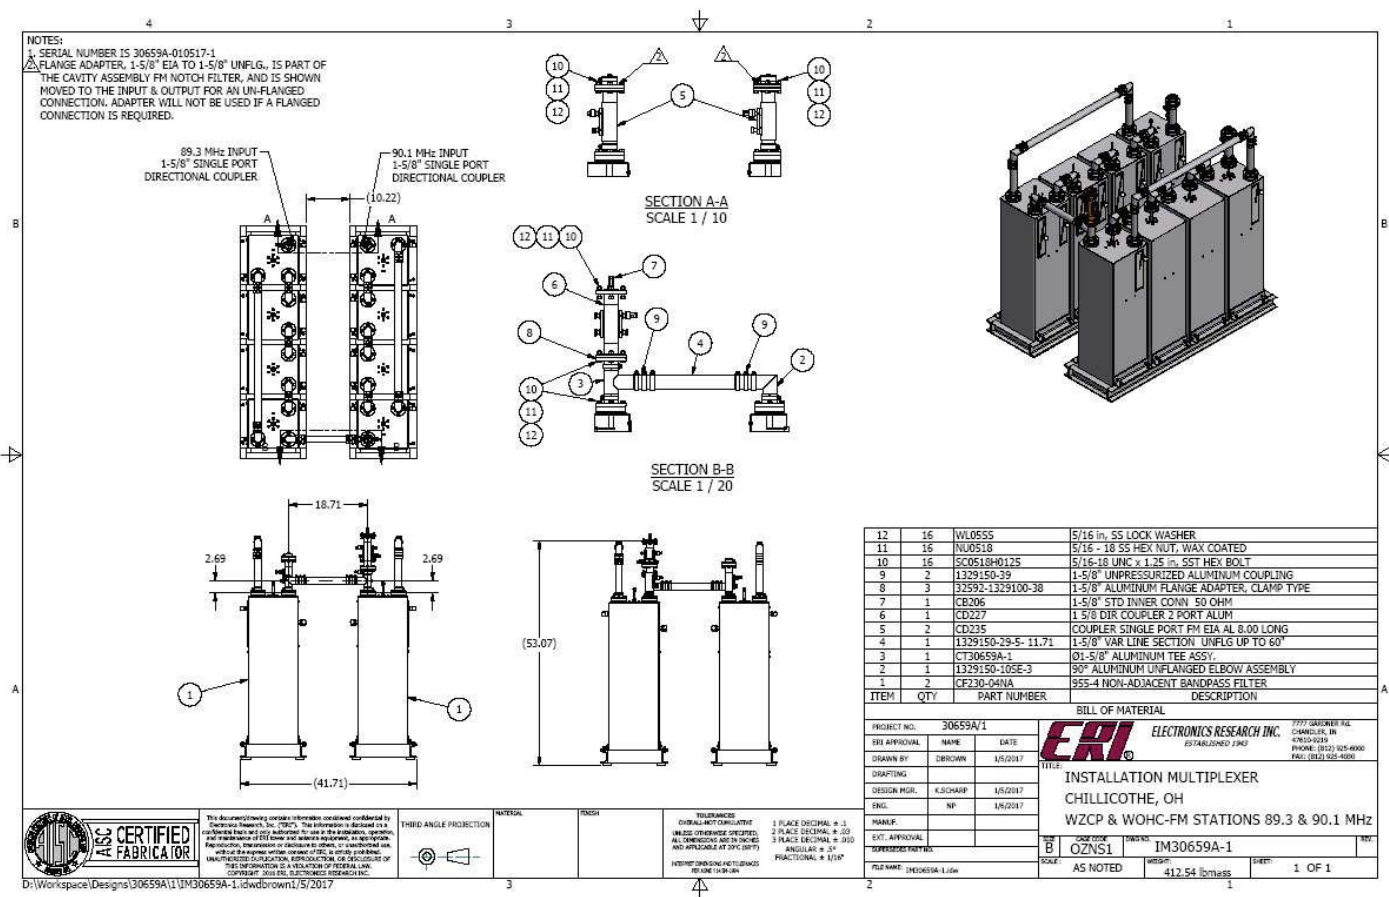
Figure 1: Combiner Drawing*

*The Combiner is actually set up end to end instead of side by side.

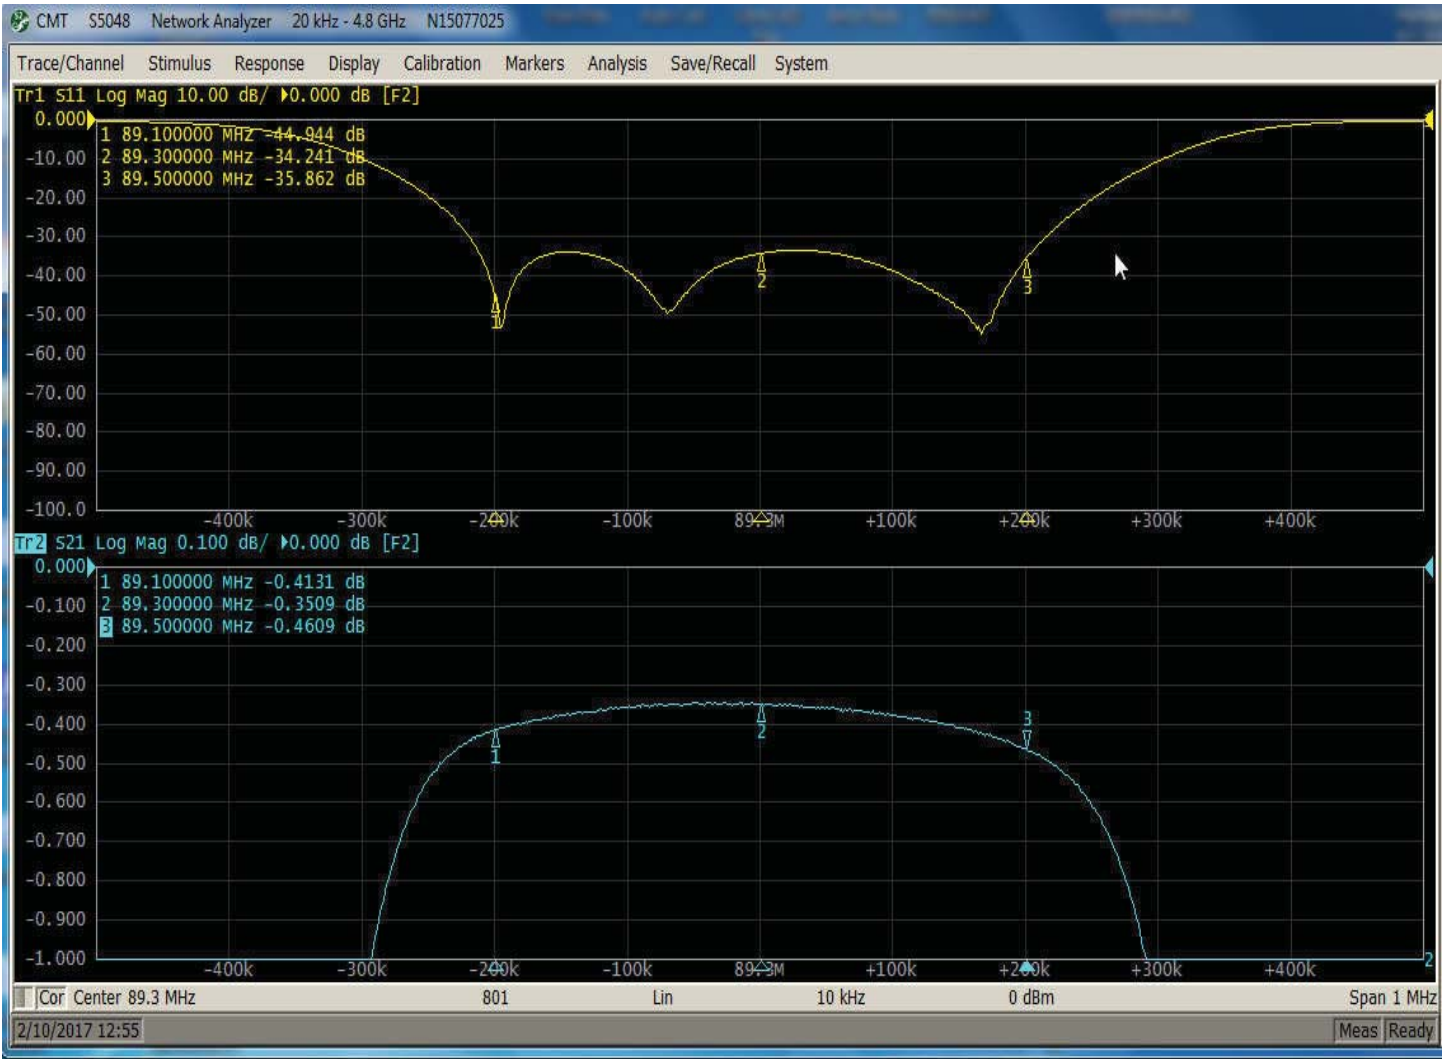
Measurement 1: Match and Insertion Loss of 89.3 MHz.

Final measurements of the T-combiner were no worse than -34.2 dB, (1.04:1 VSWR) @ carrier and no worse than -33 dB, (1.045:1) +/- 200 KHz. of carrier for either frequency.

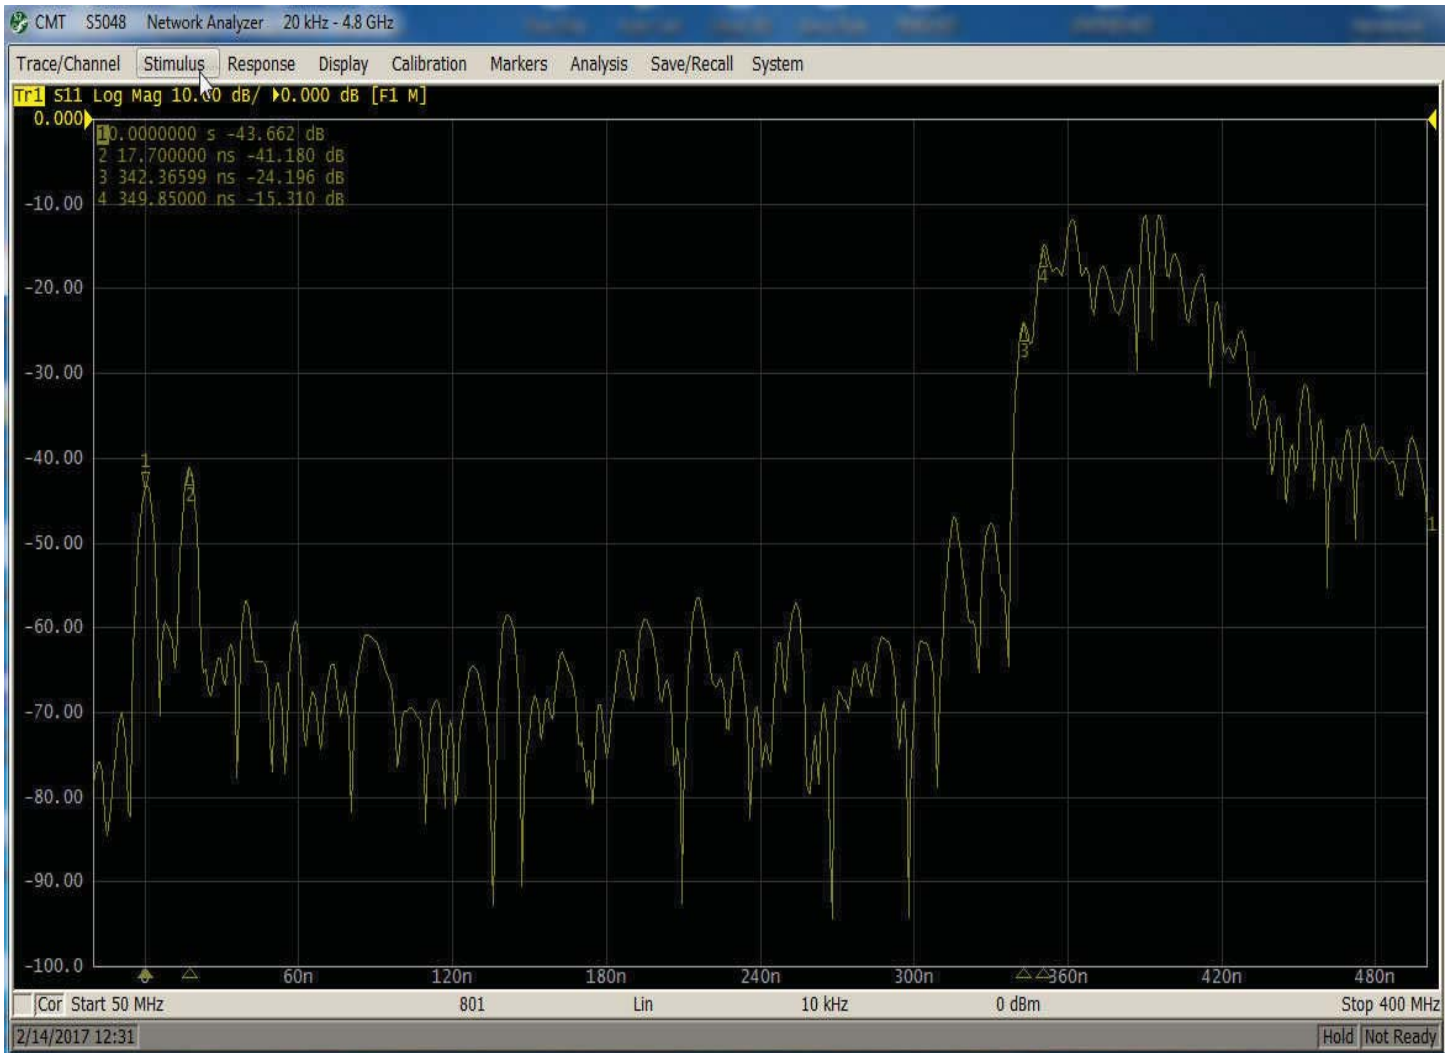
Measurement 9: 50 to 400 MHz. Sweep of Feedline with Antenna as a Load (TDR).

Mkr#1 is Test Transition @ 0 Feet.

Mkr#2 is an impedance miss-match (bend in feedline) @ Approx 8 Feet.

Mkr#3 is the connector/antenna slug @ Approx 155 Feet.

Mkr#4 is the Antenna @ Approx 158 Feet.

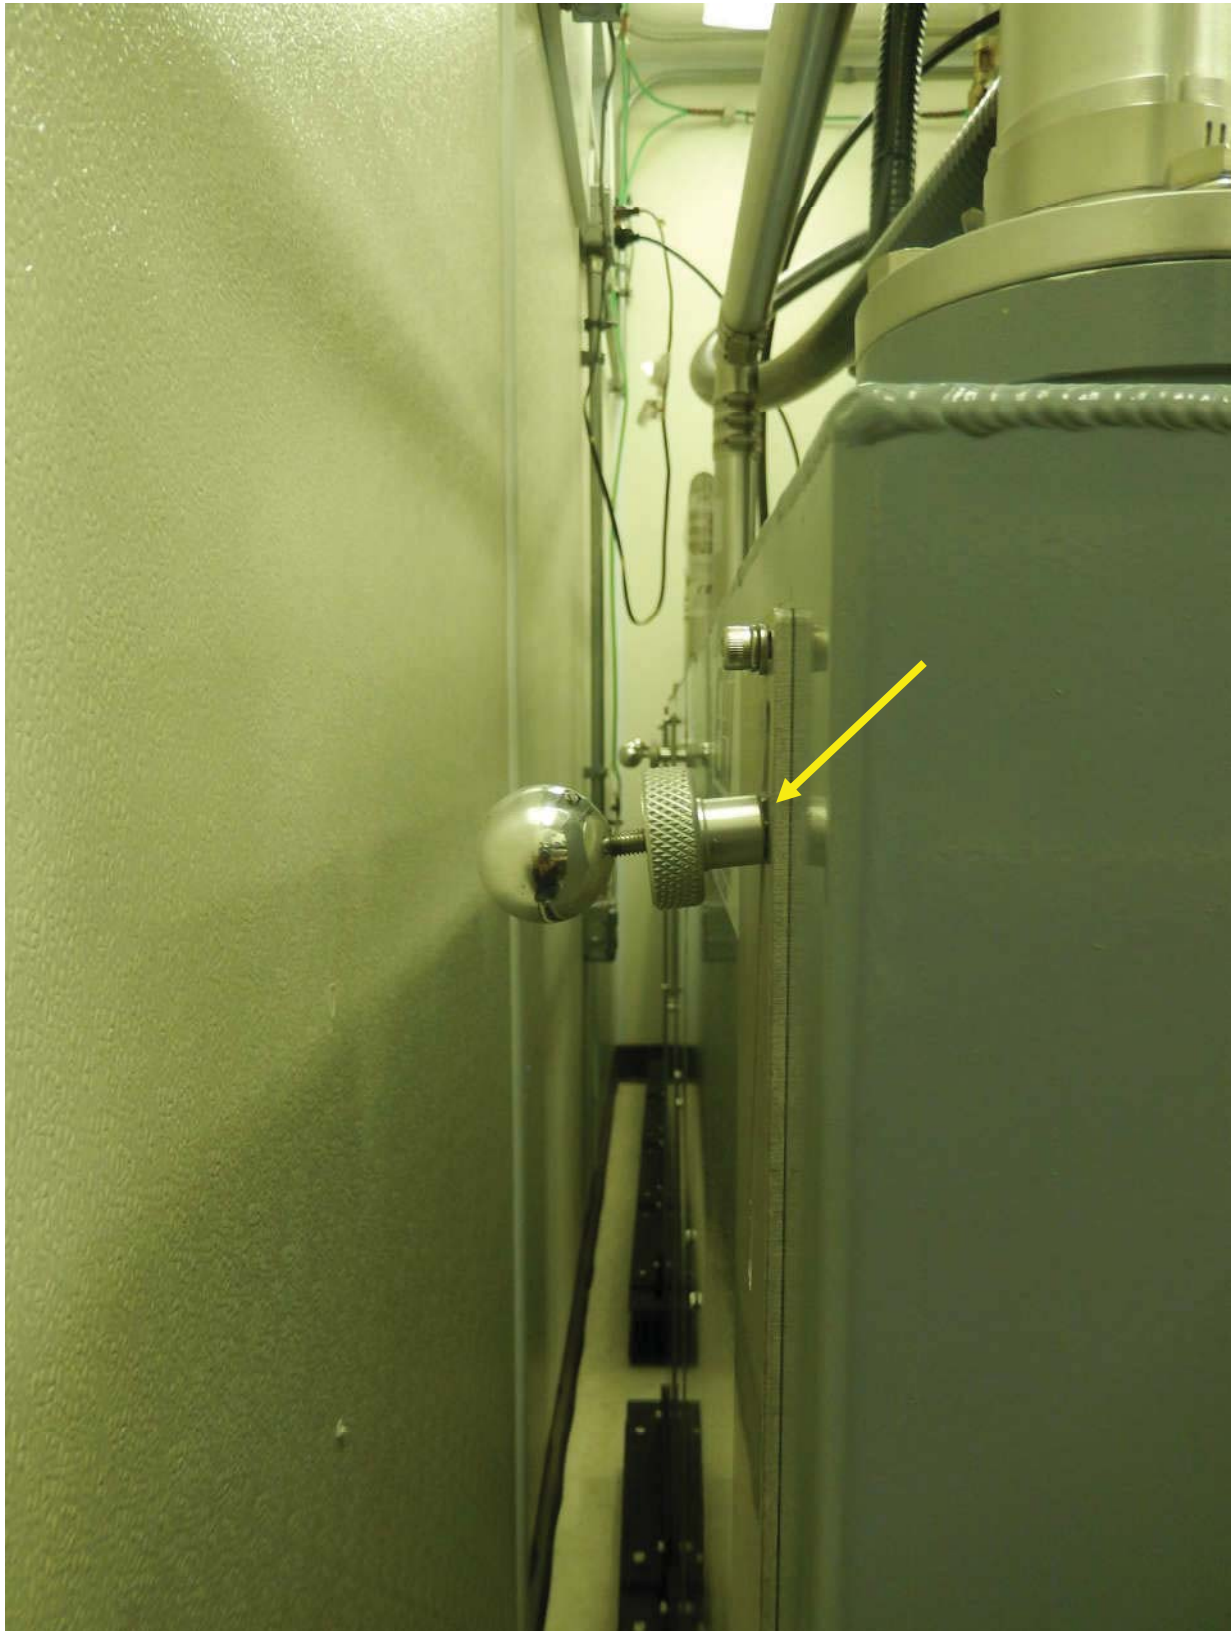
Photo 2: Damaged Loop Adjustment.

Recommend monitoring loop adjustment that was damaged after install. The combiner system passed the proof and the customer was satisfied without looking at the damage loop adjustment electrically.

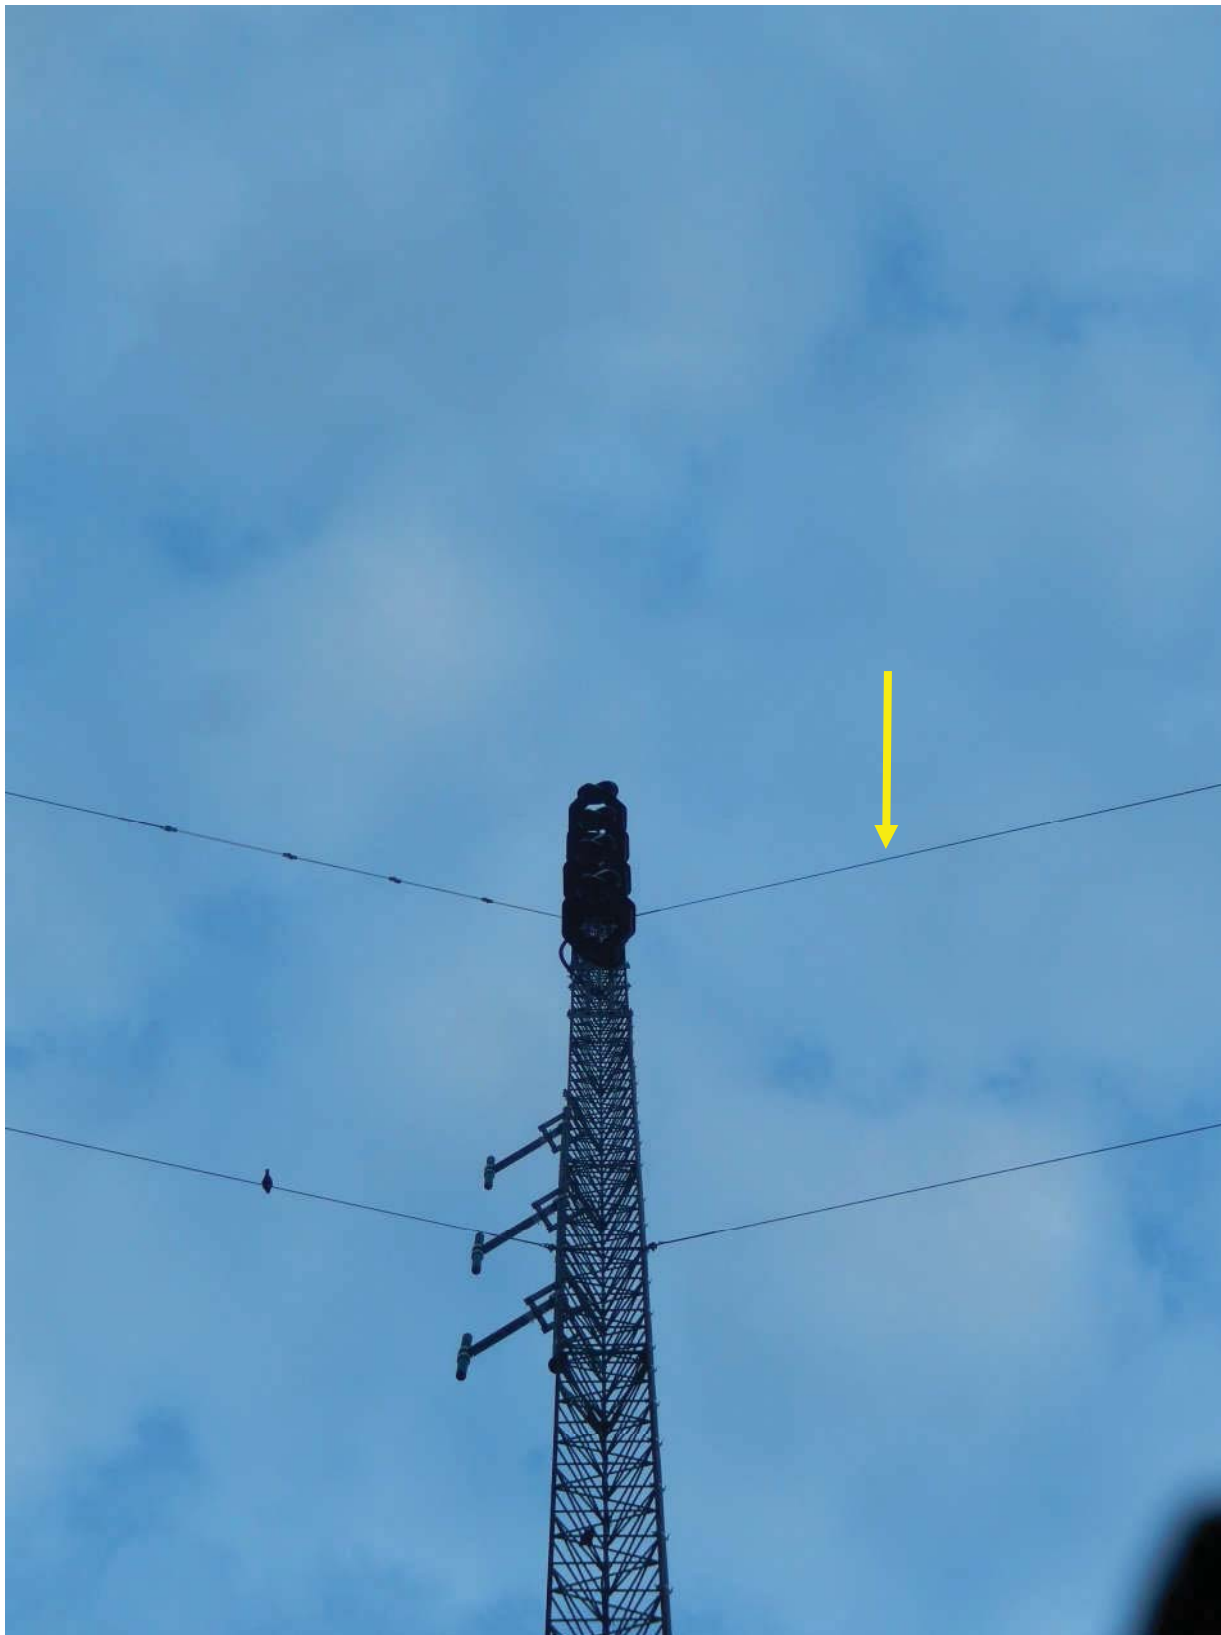
Photo 3: Un-insulated Guy Wire.

Recommend installing insulated wire on the Northwest guy wire that runs through the antenna aperture.
