BROADCAST WORKS!

KRTP NAUTEL TRANSMITTER LOW POWER ISSUE

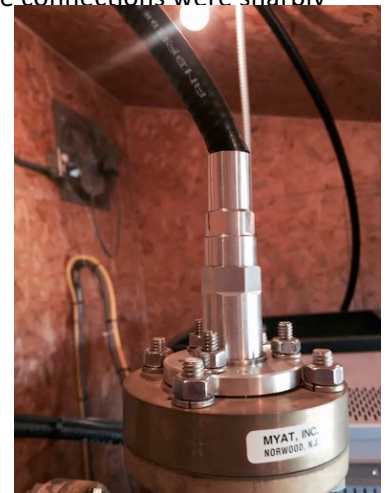
As this trip was for both KRTP and KALP, I began looking KALP over and discovered that whoever made the connections for KALP's transmitter did a very poor job. The connections were sharply bent and crimped in places as in the photo to the right. This causes a change in the electrical properties of the transmission line and directly affects the transmitters output. Bearing in mind that I'm currently talking about KALP, we re-terminated all of the bad connections and got KALP stabilized. Their reflected power seemed to come down some.

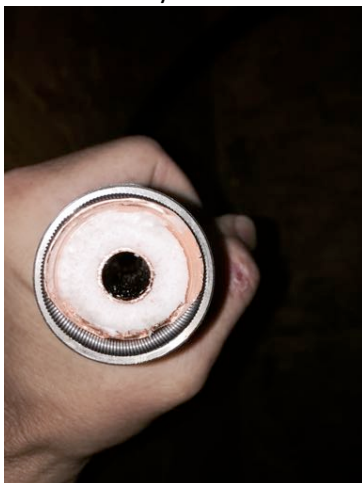
Both stations transmitters pass through a set of bandpass filters to prevent them (or at least mitigate) from interfering with each other as they are only 1Mhz apart. I began tightening all of the connections involved with the filter for KRTP and noticed the reflected power went down some. At that point I decided to disassemble the connector for the KRTP 7/8" transmission line. The connector was improperly terminated and half of it was bent inward. Again, this adversely affects the electrical properties and I made corrections

and re-assembled the connector.

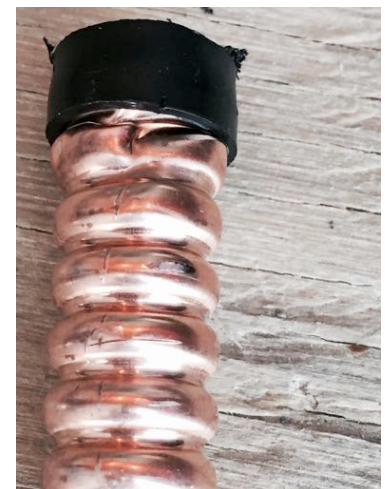
At this point, with KALP at full power, I was able to bring KRTP up to 600 watts forward power yet, the reflected power remained high at approximately 30-40 watts.

Nonetheless it remained stable at 600 watts.
