APPLICATION FOR LICENSE  
AUXILIARY (STAND-BY) ANTENNA  
STATIONS KGU-FM/KCCN-FM/KUCD/KHAI/KINE-FM/KPOI-FM/KKOL-FM  
PALEHUA RIDGE, HAWAII

Technical Exhibit

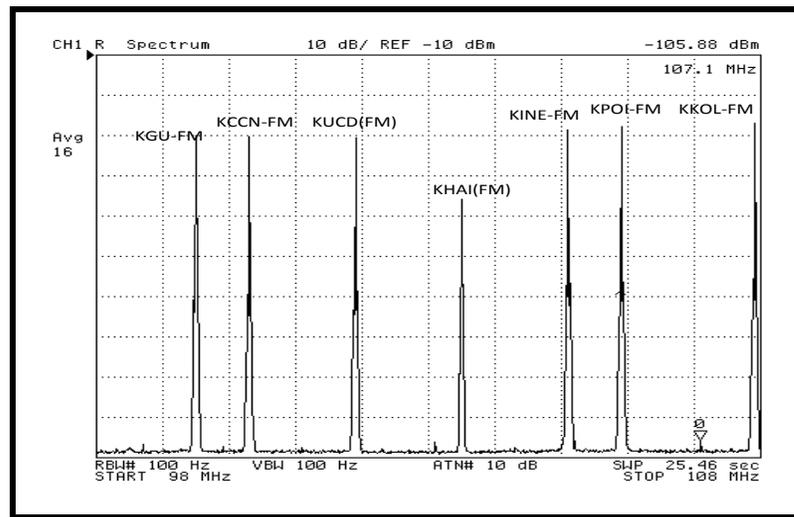
Picture 2. Sample Spectrum Plot at Combiner Output.

Additionally, during the intermodulation tests, the spectrum analyzer was scanned for possible intermodulation products occurring outside the FM broadcast band, such as the 2<sup>nd</sup> harmonic of the fundamental emissions and the FAA aeronautical band. Any nearby full-service FM stations were off-the-air for these measurements to ensure no false intermodulation products were detected.

The results of the measurements are tabulated below:

Based upon these measurements, the aforementioned FM auxiliary transmission system located at *Palehua Ridge* is in compliance with Section 73.317 of the Commission's Rules.

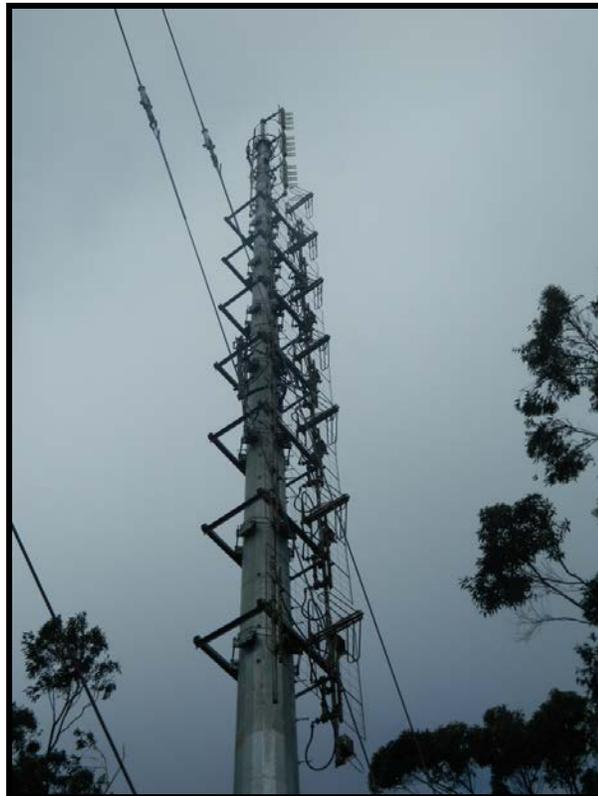
Picture 3. Palehua Ridge Auxiliary Antenna.

Measurements were completed at ground level at and near the transmitter site compound. There are seven full-service FM stations and one full-service television station that operate from this site, including from the auxiliary supporting structure. Picture 3 is a photograph of the new auxiliary supporting structure and installed antennas.

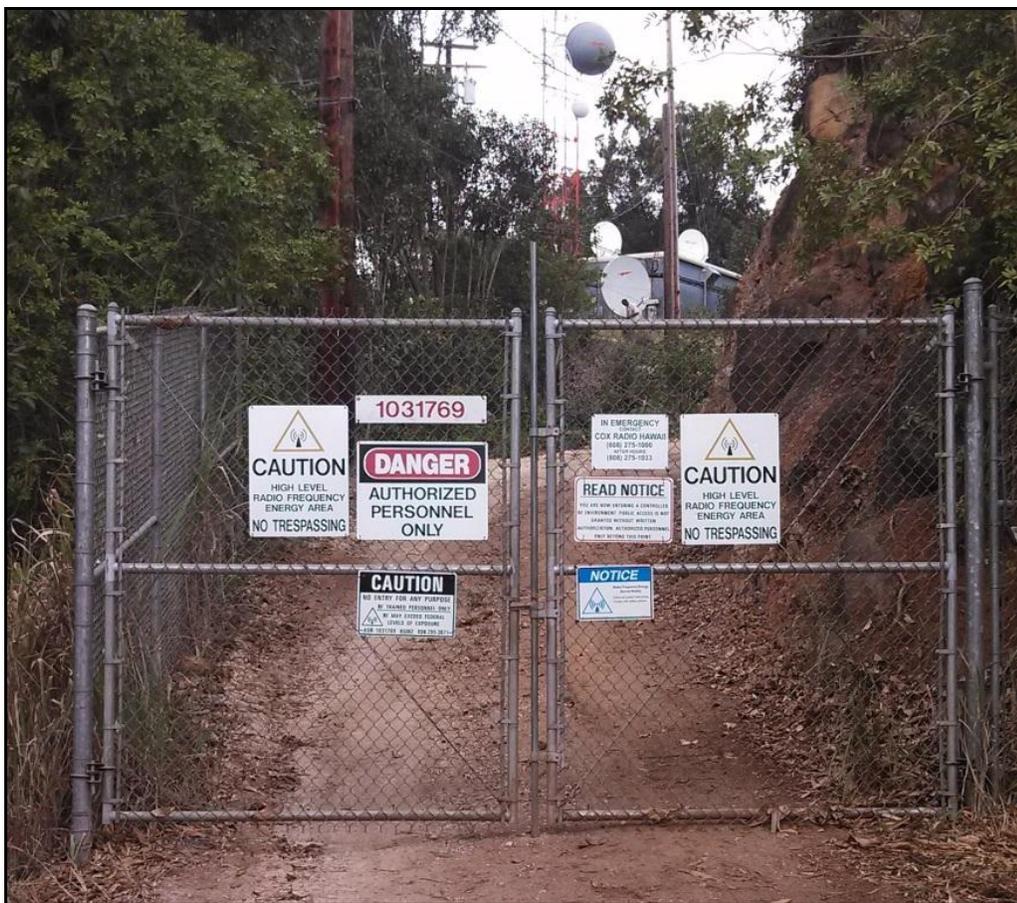
Picture 4. Access Gate to Palehua Ridge Compound.

The facilities were confirmed to be at their proper auxiliary operation power levels during the exposure measurements. All the measurements are with respect to the controlled environment standard. The compound can be classified as a controlled environment as a lockable gate controls access. Appropriate signage indicating the controlled environment designation is provided as shown below in Picture 4.

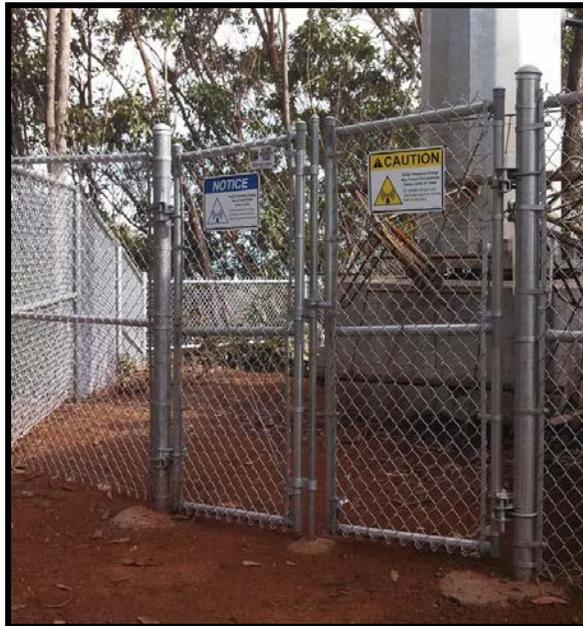
Picture 5. Additional Access Gate to Auxiliary Antenna Tower Base.

Within the compound, when the auxiliary antenna is operational, one area exceeded the Commission's controlled environment standard at ground level. The area is located immediately around the new auxiliary FM supporting

structure. This area is securely fenced which prohibits entry when the auxiliary antenna is operational. This area is also marked with signage stating that no access is permitted when the auxiliary facility is in operation. Below is a picture showing the locations of the areas exceeding the controlled environment standard that is surrounded by the additional fence.
