Engineering Report  
**Survey of Radiofrequency Energy Exposure Levels**  
**Oakbrook Terrace Tower Building**  
19 & 22 May 2017  
Prepared by Univision Communications, Inc.  
WVIX(FM) Lemont, IL

**A. Introduction and Background**

**Univision Radio License Corporation  
WVIX(FM) Lemont, IL  
93.5 MHz 3.5 kW**

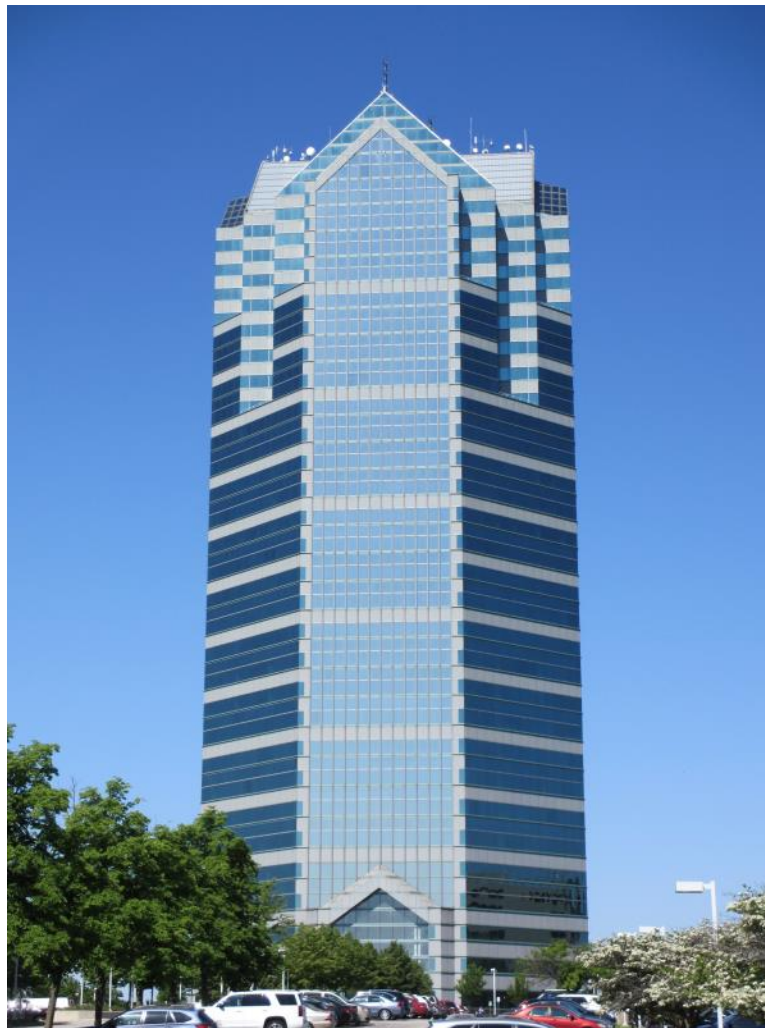
**Photo 1: Oakbrook Terrace Tower, FM Antenna at Top Center**

WVIX(FM)'s new transmitting facility shares the antenna of WJKL(FM), licensed to serve Glendale Heights, IL on 94.3 MHz. the antenna is mounted at the peak of the eastern portico of the Oakbrook Terrace Tower building, with Both stations were operating within 5% of their licensed effective radiating powers at the time of the measurements reported herein.
