Radiotechniques

Exhibit 12 Figure 4
Second and Third Adjacent Interfering Contour
Fred R and Evelyn K Morton
Oklahoma City, OK
June 2004

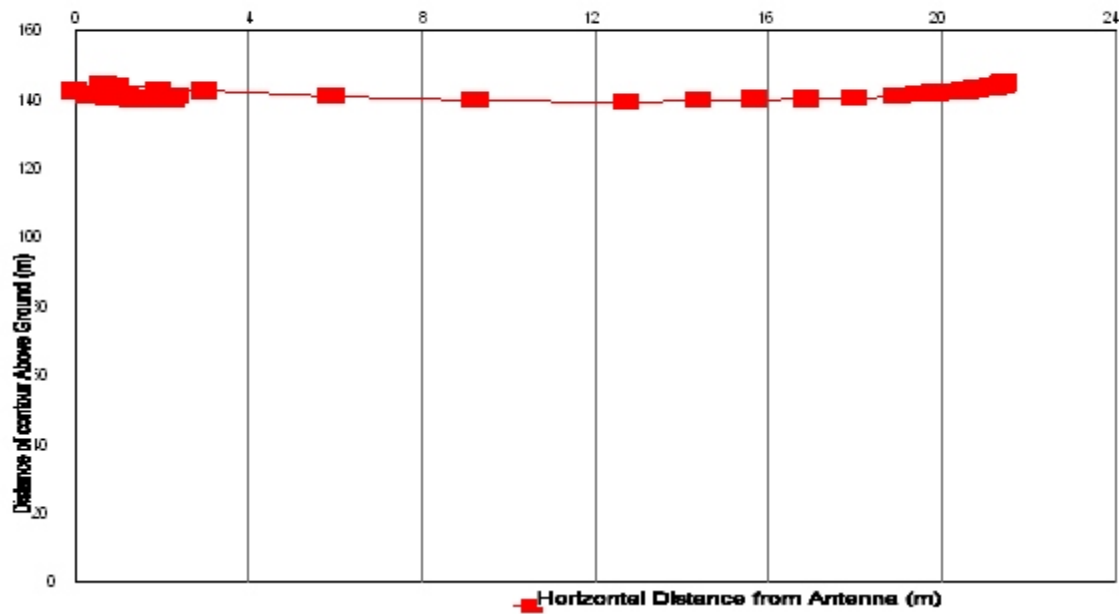
127 dbu Contour Distance Above Ground

No structures above ground on this chart.
