EXHIBIT 1a - Field Strength Measurement Data for KAVP, Colona, CO

File No: BL-20001220ADR Facility ID No.: 82282

Data Collected January 26, 2005

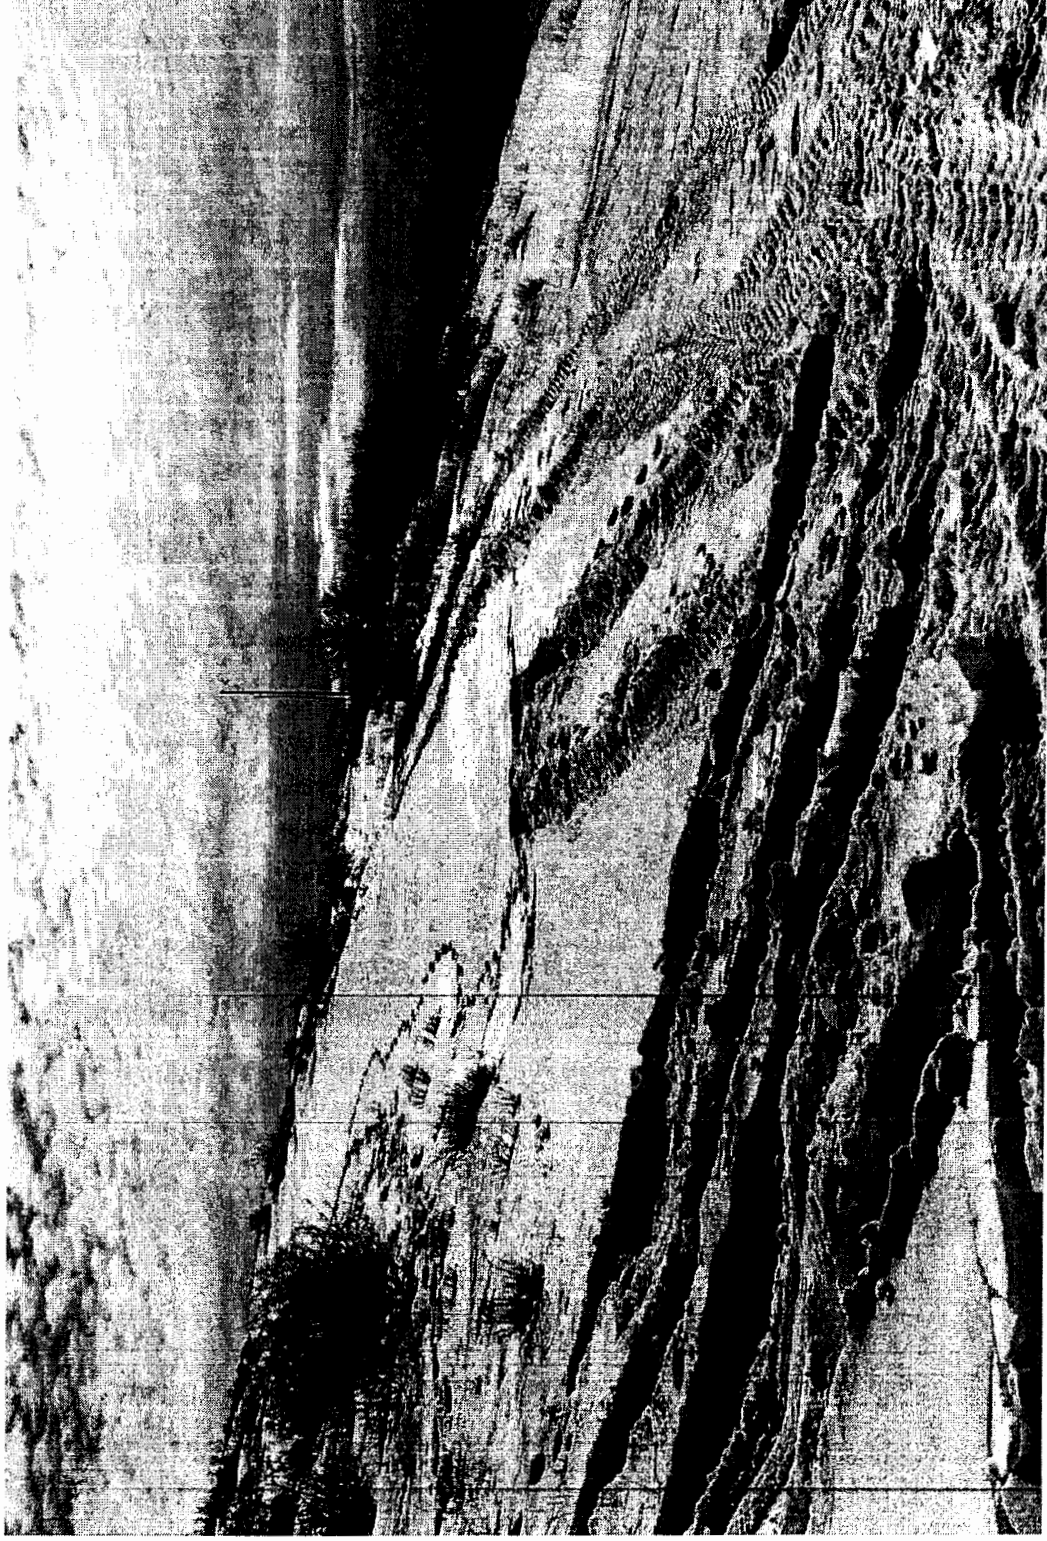
Exhibit 1c -- Site Photo and Conditions

The rugged terrain effectively precludes obtaining 80 signal measurements -- many of the areas on the standard 8 radials are barely accessible in the summer months, even less so in winter. Terrain detail is seen in the 7.5 min. map. The applicant thus respectfully requests that the FCC treat the 30 measurements herein presented as an acceptable pattern study.
