Exhibit 9 Page 1
Christian Ministries of the Valley, Inc.
Environmental Assessment
Big Spring, Texas

Exhibit 9 Page 2
Christian Ministries of the Valley, Inc.
Environmental Assessment
Big Spring, Texas

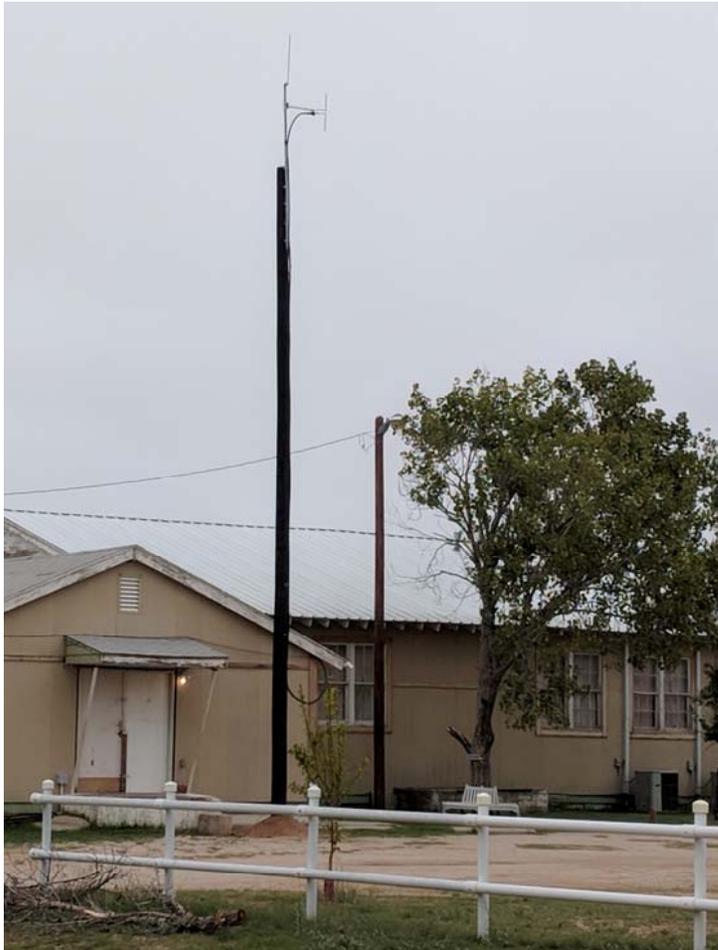
Before

Exhibit 9 Figure 5
Christian Ministries of the Valley, Inc.
Mounted Nicom BKG77
Big Spring, Texas

The proper Nicom BKG77 antenna has been mounted to correct the accidental mounting of an incorrect antenna due to an oversight (see Figure 5).
