Appendix D
Federal & State Government Maps Review

Sketch of the *Tres Haciendas* Irrigation System District

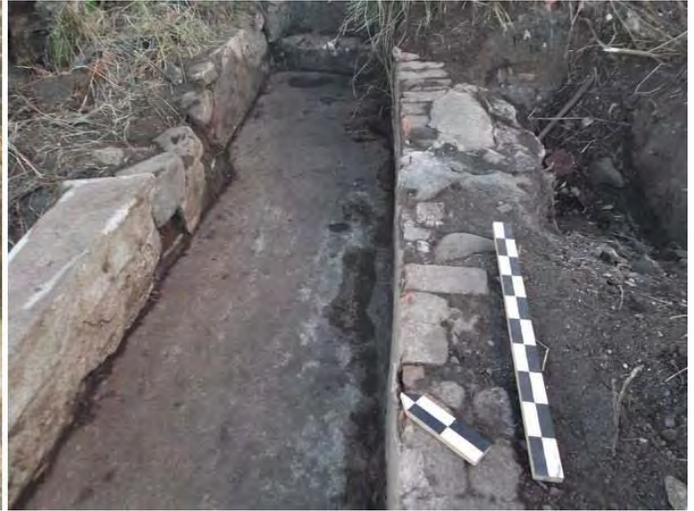
On the left, view of barrel vaulted section of the supply channel, facing south. Right; view of the partially buried open channel of the Hacienda Destino, facing north.

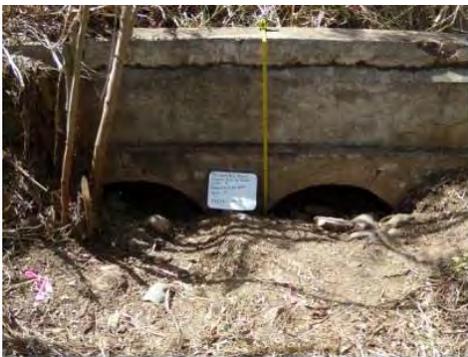
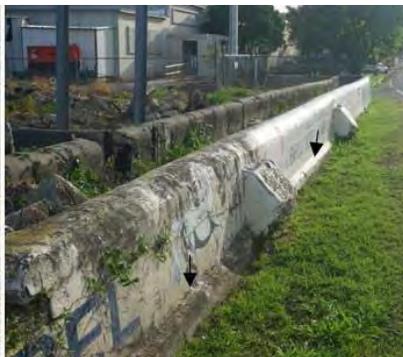
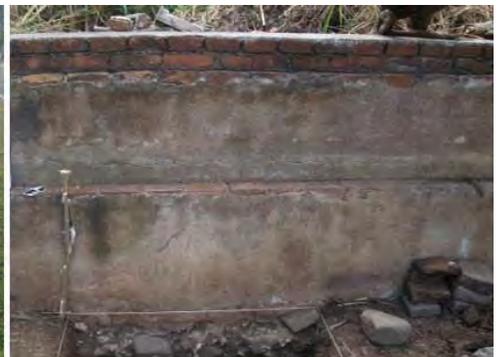
Left; Channel of the Hacienda Florida, raised on arches. Center; Channel of the Hacienda Florida, elevated on a base (note black arrows). Right; Channel of the Hacienda Florida, raised using a staggered base.

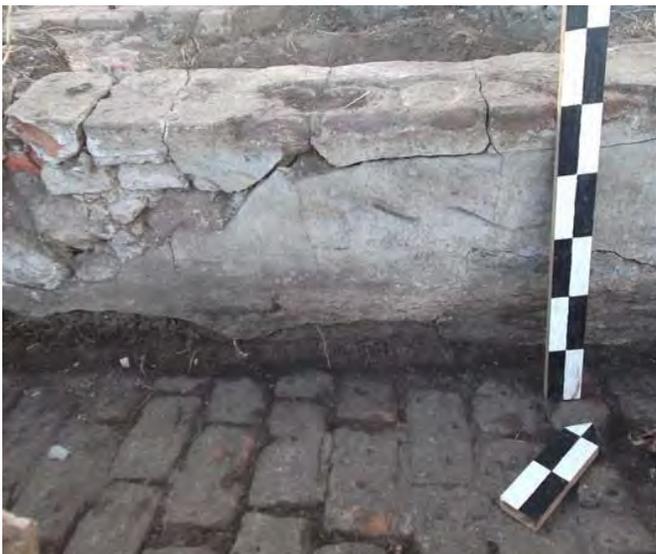
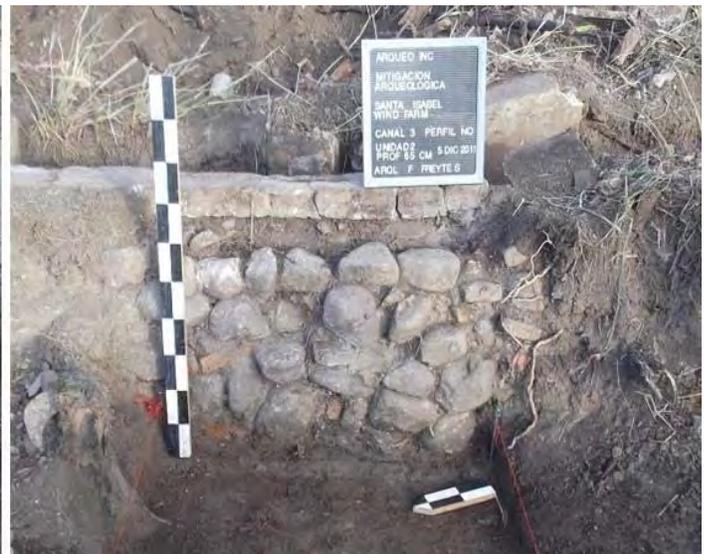
Detail of the makeup and construction method for the Hacienda El Destino Channel. Left, the inside of the west wall of the channel, covered with concrete, with some exposed bricks. Note that the floor has lost its concrete plastering. On the right, exterior view of the same wall segment.

The materials and method of construction for the components of the irrigation systems were thoroughly detailed in the Spanish legislation. For this reason, the entire construction of the *Tres Haciendas* Irrigation System is similar. The building materials that were used are ordinary brick, limestone or igneous river stones, masonry mortar composed of three parts sand and two parts lime for the foundations and walls, and concrete - made from hydraulic mortar with brick chippings or fine gravel in equal parts. The construction technique used for walls and floors consists of ordinary brick and stone masonry consolidated with lime mortar, and coated on the inside with concrete; and for the foundations, stone and well-compacted fragmented brick masonry, with or without mortar.

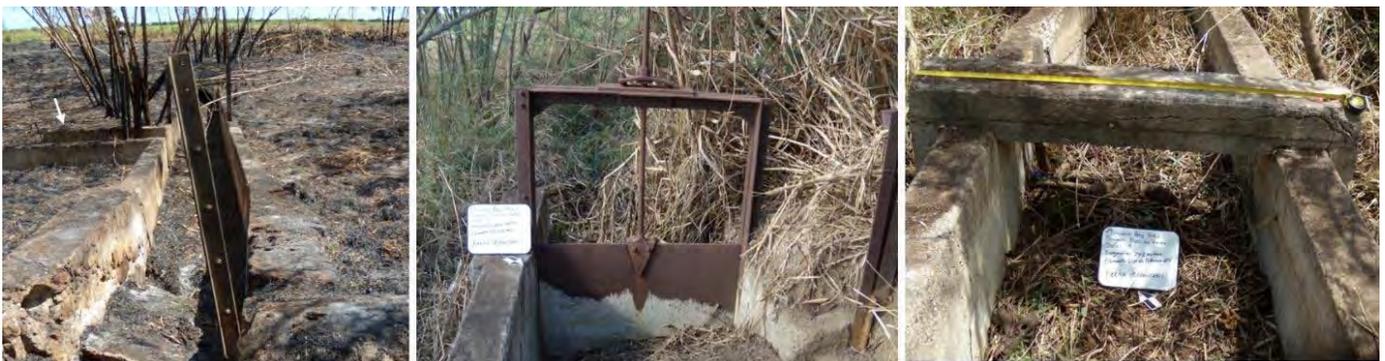
On the left, view of the *Hacienda Destino* channel, facing west. White arrow shows a channel that was added when it became part of the Irrigation District. In the center, detail of added sluice gate. Right; reinforcement beam added to the *Hacienda Florida* Channel.

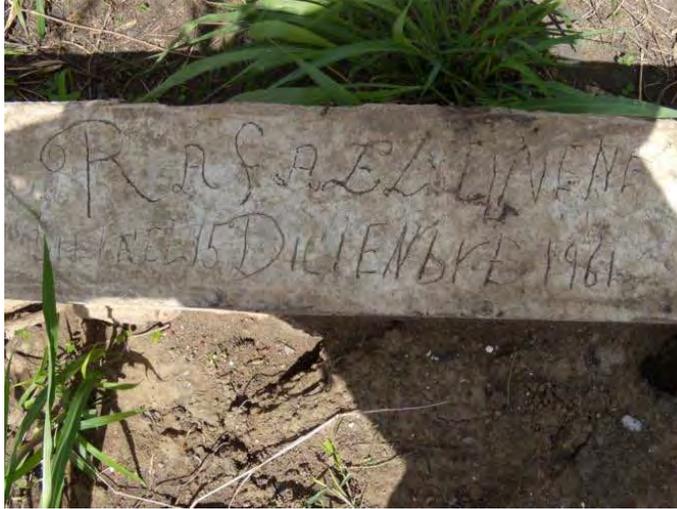
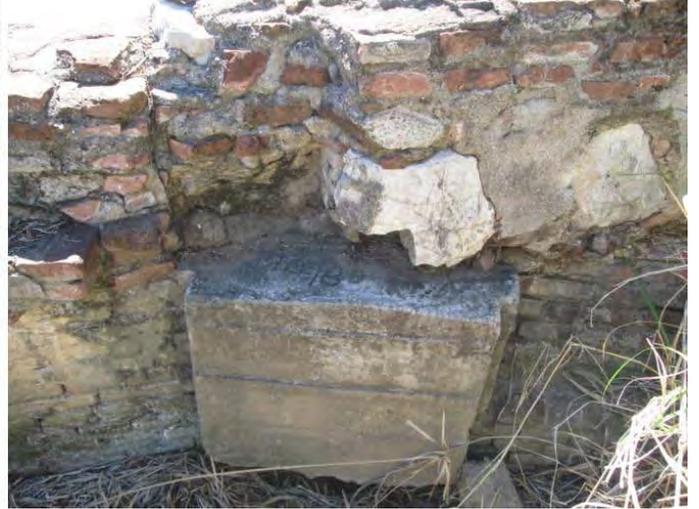
Repairs with date inscriptions. On the left, repair on the supply channel dated 1961 and to the right, repair to the low and torrential waters modules, dated 1980.

The *Tres Haciendas* Irrigation System was partially in use until the 1990s, when it was abandoned. For its full length, repairs that were performed throughout its period of usefulness can be found. Some repairs include inscriptions with the dates in which they were made, such as December 15, 1961 or December 16, 1980.

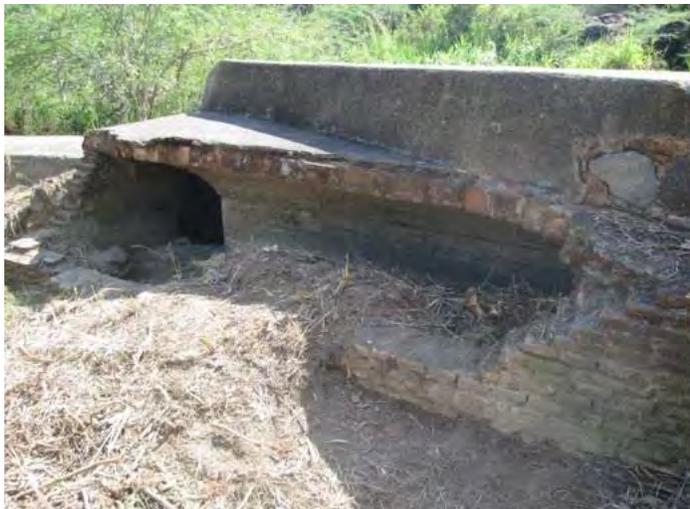
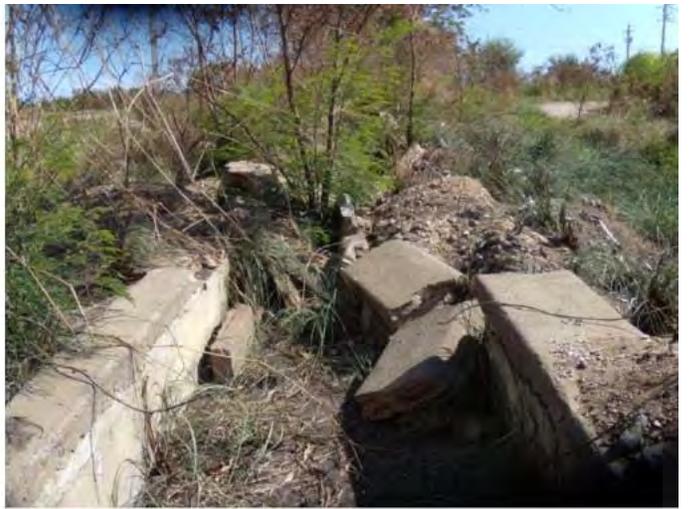
On the left, collapsed section of the torrential waters inlet channel, looking southwest. On the right segment of the supply channel with side impact caused by agricultural machinery.

After its abandonment, the irrigation system has deteriorated. Some segments of the vaulted channel have collapsed, as have walls of the open channels affected by agricultural activities. In urbanized areas, open channels have been filled with earth or covered, using sheet metal on which a layer of concrete was poured (Photo 8). In rural areas, open channels are hidden by the vegetation, filled with soil, or buried under mounds of dirt and even rubble.

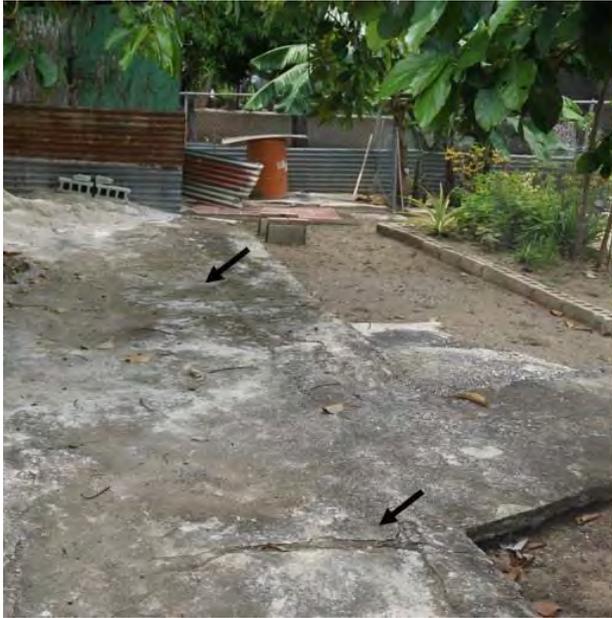
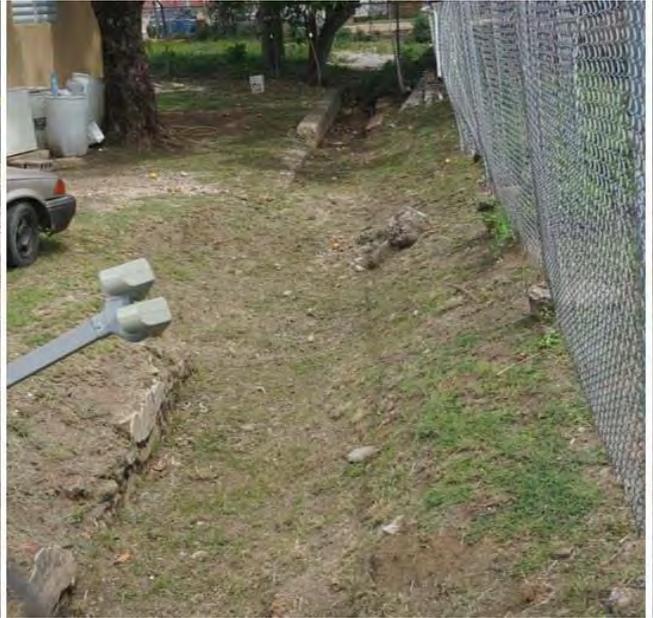
On the left, section of the supply channel covered with corrugated metal sheets and a slab of concrete. Arrows indicate the channel's route. To the right, supply channel in a backyard, filled with earth.

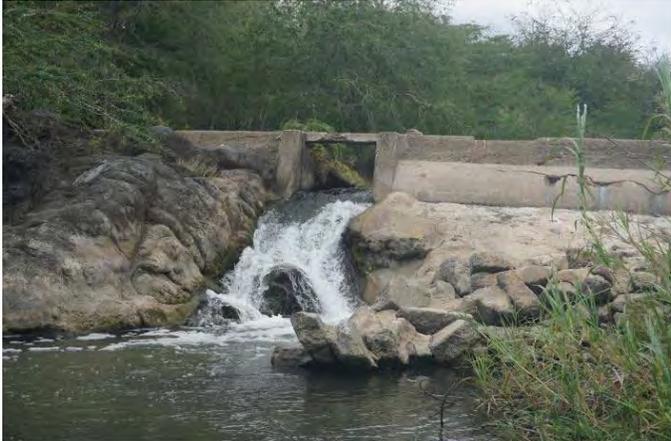
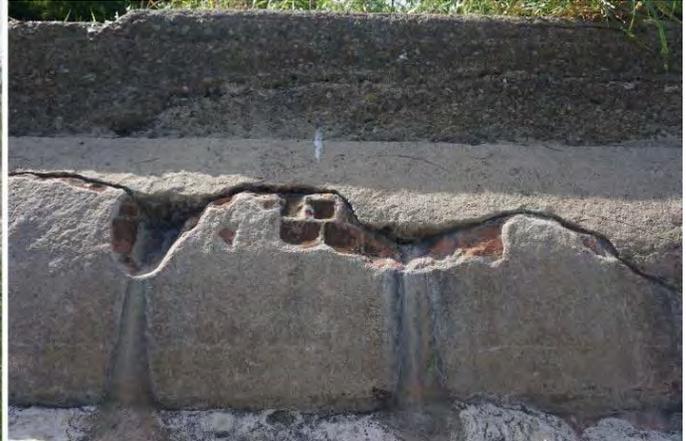
On the left, view the central area of the dam with the added opening for the sluice, seen upstream from the east bank. On the right; detail of the two construction phases of the structure: lower part built from brick masonry in the 19th century, and 20th century upper part of reinforced concrete.

with a height of 30 cm. Also during the 20th century, a sluice gate was added to the dam, it measures 1.5 m wide by 90 cm high. The frame for sluice gate was constructed of reinforced concrete, leaving a molding in which, according to local residents, wooden planks would be slid in to control the flow from the reservoir. This part of the dam does extend to the west bank of the river, with a total length of 27 m.

The dam shows some deterioration, such as cracks and spalling. However, it is still in good condition, to the point that staff of the Division of Irrigation of the Electric Power Authority has shown interest in putting it to use again (personal communication; Eng. Estremera, April 2015). An important aspect of this component of the *Tres Haciendas* irrigation system is that it unequivocally conveys its historic significance at first sight.

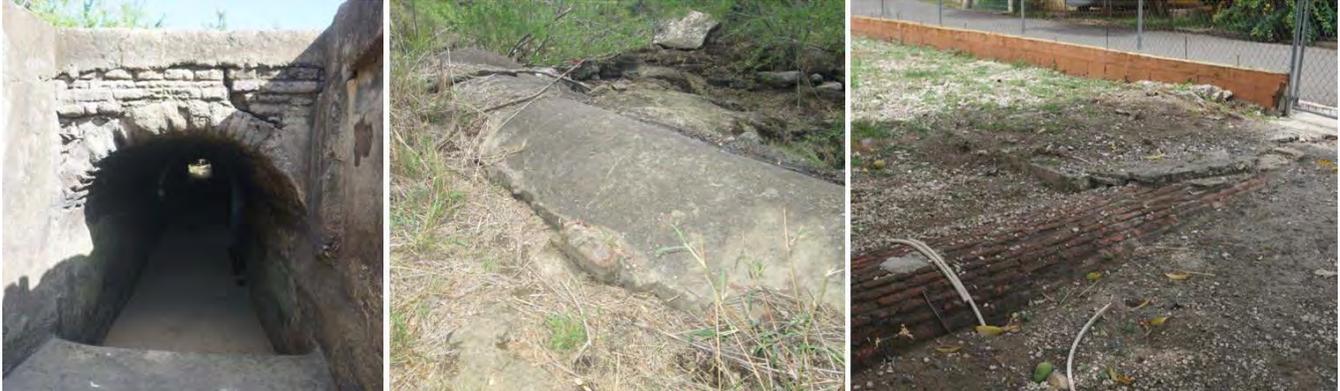
On the left, entrance to the Supply channel at the low-waters module, looking south from within the inlet. In the center, vaulted segment of the supply channel that runs along the surface in the area of the dam. Notice the concrete plastering over the vault. On the right, view of the channel as it emerges to the surface, in the backyard of a property of the *El Ojo* Community. Note that the vault does not have plastering.

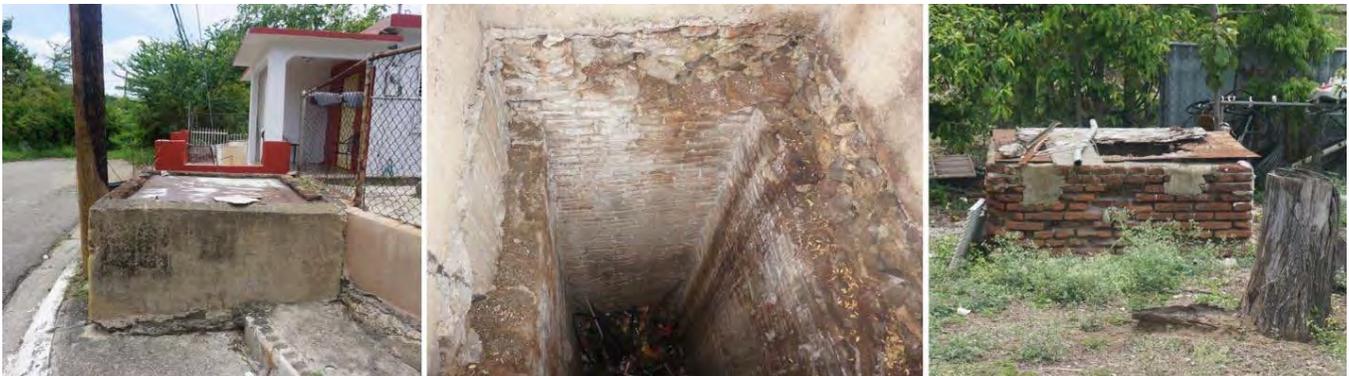
On the left, service manhole to the supply channel, located on a sidewalk of the *El Ojo* Community. In the center, detail of the service shaft inside a manhole. Right, manhole which features an advanced degree of damage by erosion, located in the backyard of a house.

the manholes varies, with an average of 1.8 m long by 1.7 m wide. Six of this structures were located, found in a vacant lot and on the sidewalks and backyards of the *El Ojo* Community. Most of them are in good condition, although partially filled with dirt, debris, and garbage. Only one such structure, located in the backyard of a house, presents a severe erosion of the bricks, both inside and outside. Some had their walls raised by using reinforced concrete. Their exterior height ranges from 63 cm to 1 m above the surface. It is estimated that many more of this manholes are yet to be identified.

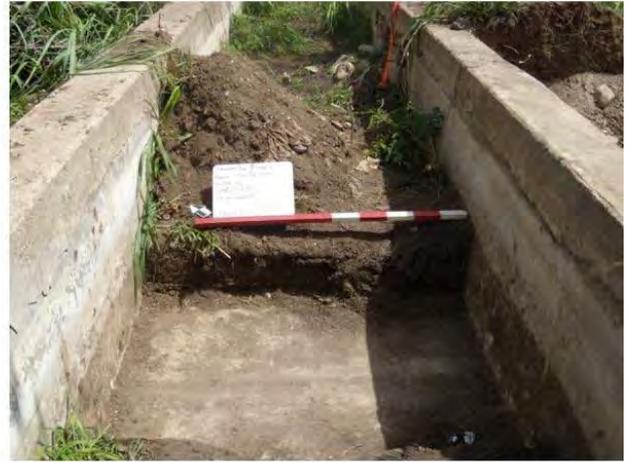
Outline of the open supply channel (from Meléndez Maíz 2011, drawing no. 7) and interior view.

The open section of the supply channel begins partially buried, with the top of the walls at ground level, and gradually rises over the surrounding terrain until set completely above the surface. It has straight sides and a flat bottom. Its average inner width is 1.2 m and its interior height measures up to 77 cm. The foundation was documented in several excavation units, where it reached 30 to 90 cm deep below the bottom of the walls, and projected from 4 to 9 cm from their exterior sides.

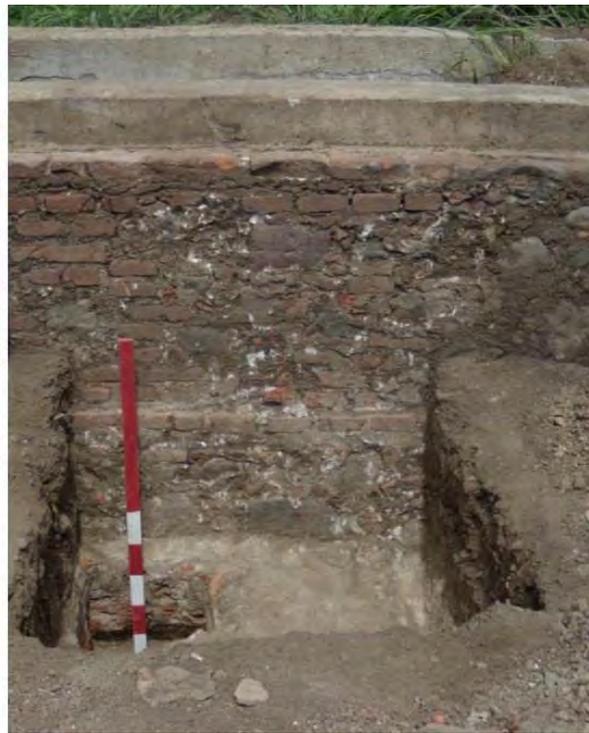
Left, detail of outer side of the west wall and foundation of the supply channel, in an area where the open channel is buried. On the right, detail of outer side of the west wall and foundation, in an open section where the channel is above the surface.

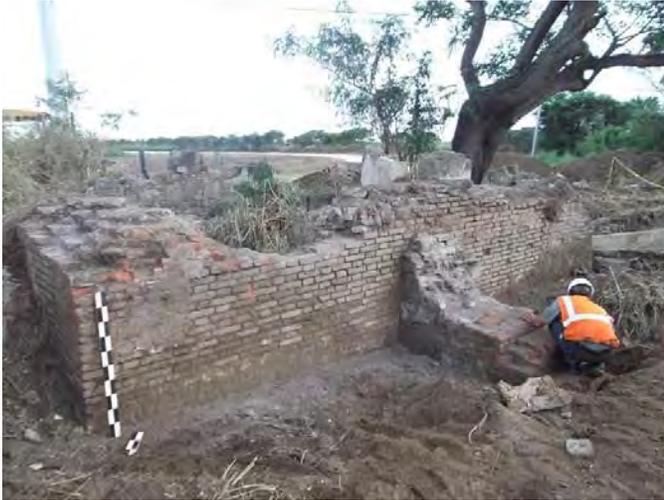
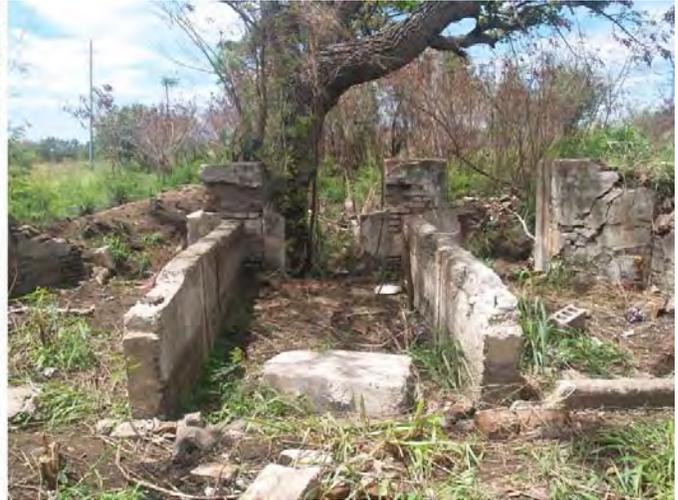
On the left, general view of the distribution module, during archaeological documentation works performed in 2012, looking south. On the right, view of the structure in 2011, looking northeast.

The supply channel ends south at the distribution module, from where the water was divided and distributed through three branching channels, which were responsible for delivering the water to the fields of the *Santa Isabel*, *El Destino* and *Florida haciendas*. The structure was designed to withstand weight and lateral forces, since it was built on a foundation of stones, fragmented brick and lime mortar that was 60 cm deep and protruded 35 cm from the exterior of the walls. It had walls 60 cm wide and a buttress 94 cm wide by 1.80 m long.

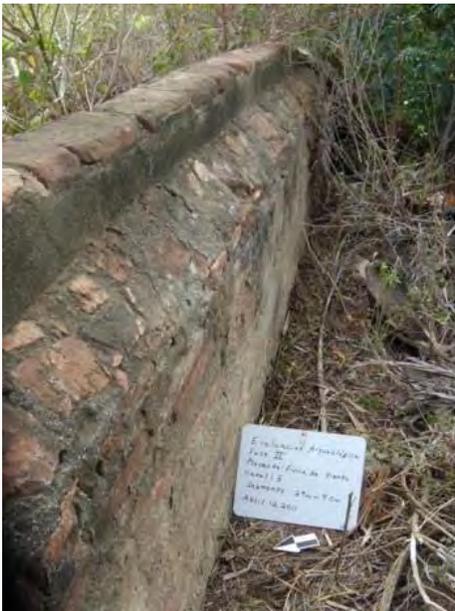
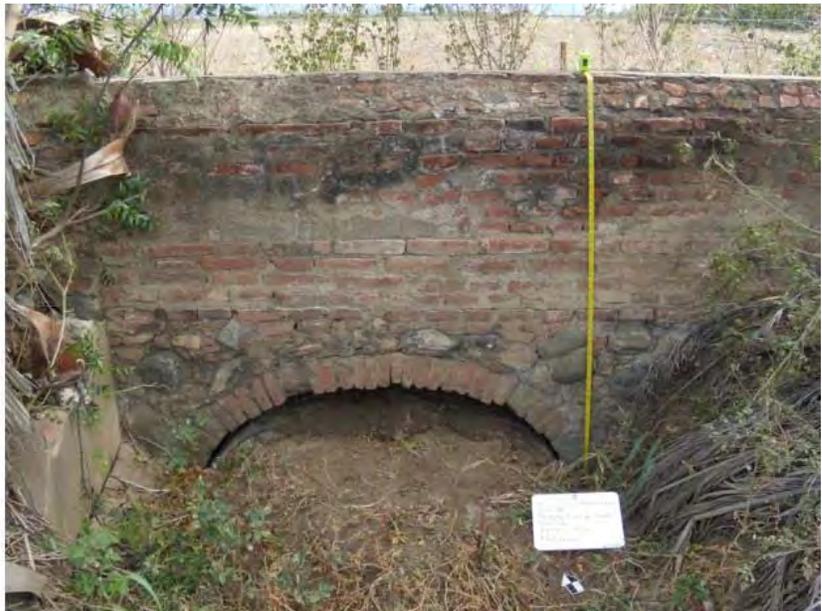
On the left, a segment of the *Santa Isabel Hacienda* channel, with setback feature. Right; arched bridge.

The *Santa Isabel hacienda* channel, or Channel 2, transported the water from the distribution module a distance of 2.3 km to the fields of the *Hacienda Santa Isabel*. For 1.7 km, the channel runs southwards. In most of this stretch of its route, the top of the walls is level with the surface, with an inside depth of 50 cm. The only alteration observed in this segment is the addition of four reinforced concrete buttresses to the east wall.

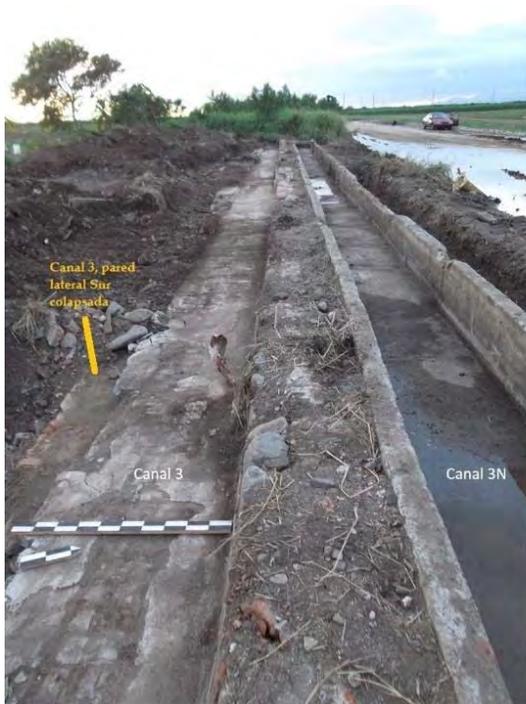
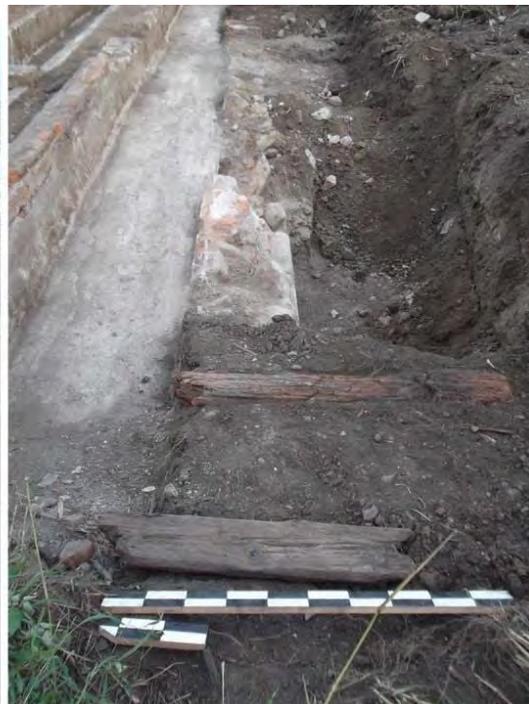
Left; view of channels 3 and 3N, looking west. The remains of the *El Destino hacienda* channel is seen to the left, with its south wall flattened to ground level and channel 3N alongside, constructed soon after. In the right photo, detail of sleepers of the railway line, in situ, resting on the footing of the south wall of channel 3.

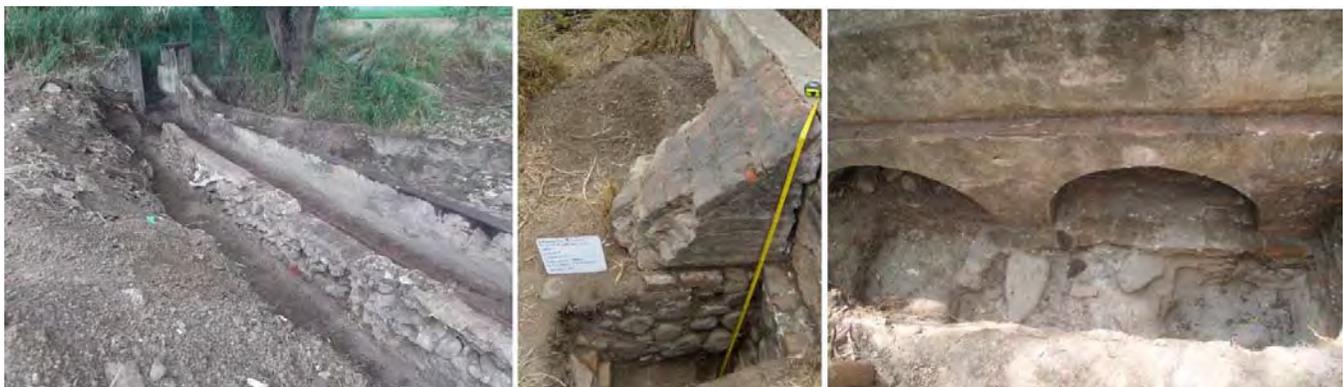
Left; view of the *Hacienda Florida* channel at its origin as it left the distribution module, facing northeast. Center; Detail of an abutment. Right; segment of the channel on arches. Note the stone pavement under the channel.

From the north, the channel begins partially buried, with the top of the walls level with the surface. It is 48 cm deep inside. From 163 m to 213 m from the starting point, Channel 4 is entirely above the surface, and even elevated on a masonry base. At a section located between 435 m and 595 m from the start, the channel is raised above the surface and supported by abutments located on both sides of the structure at 30 points. They are located at an interval of 4 to 7 m, with variable dimensions, and consist of triangular structures built with the same materials and construction technique as the channel. Here the channel is 68 cm deep. Between 635 m and 700 meters from the start, the channel rises again on a massive foundation. In this section, the channel walls feature a setback step formed by two rows of bricks coursed at a stretcher bond. Meanwhile, the cement has two levels: an upper level to 25 cm tall, made of stone and bricks bound with lime mortar, and a lower level measuring 30 cm, built of stones and fragmented bricks with no consolidating material. Between 666 m and 686 m from the start, the channel is elevated on four arches - one simple and three double arches. The area surrounding the arches is paved with stone to prevent soil erosion. The base continues to be massive and with staggered sides.

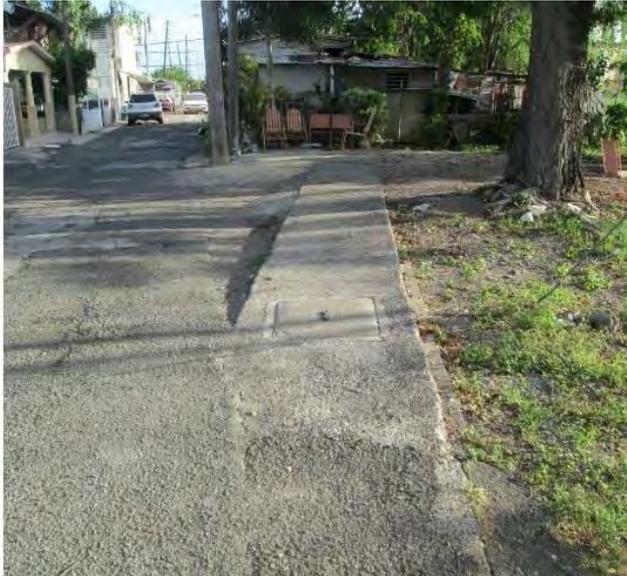
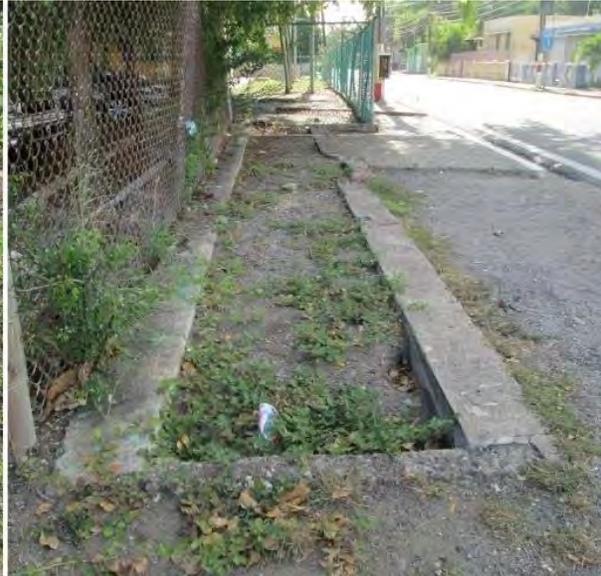
General views of the *Hacienda Florida* channel in the urban area of Santa Isabel. Left; covered channel through vacant lot and under a dwelling. Right; the channel as it appears along the south sidewalk of road PR-1, facing west.

The channel's condition in the urban area is unknown, since it is mostly below structures. At the final stretch, the channel is in fairly good condition, though full of trash and with some cracks that show attempted repairs with tar. The biggest impact in this area is caused by a gigantic *Ficus* tree that grows within the structure.

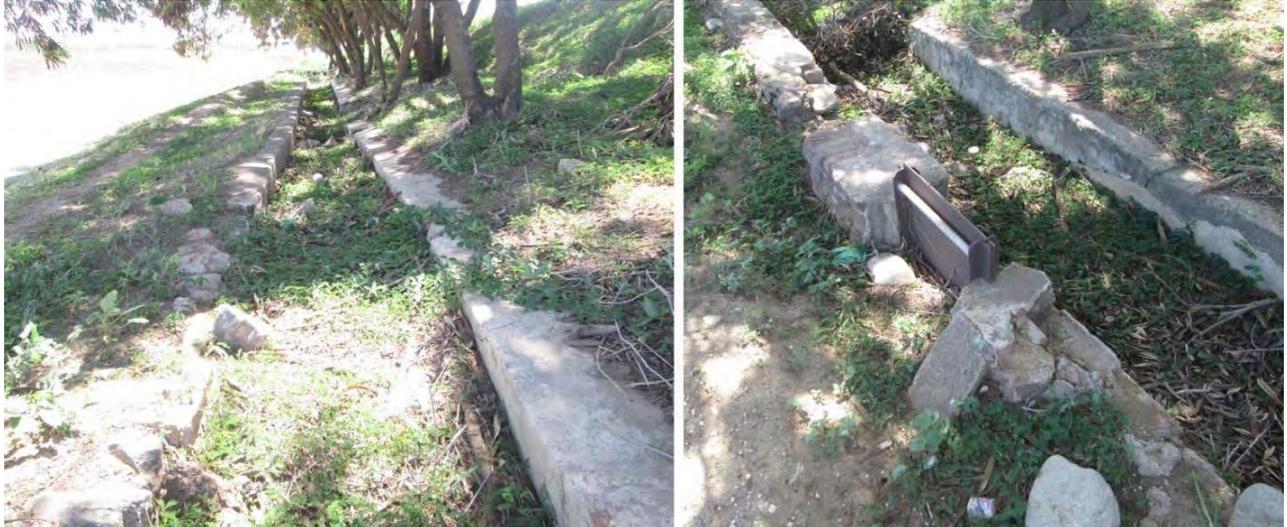
Left; view of the sub-branch, or Channel 5, facing west. Right; detail of the sluice gate.

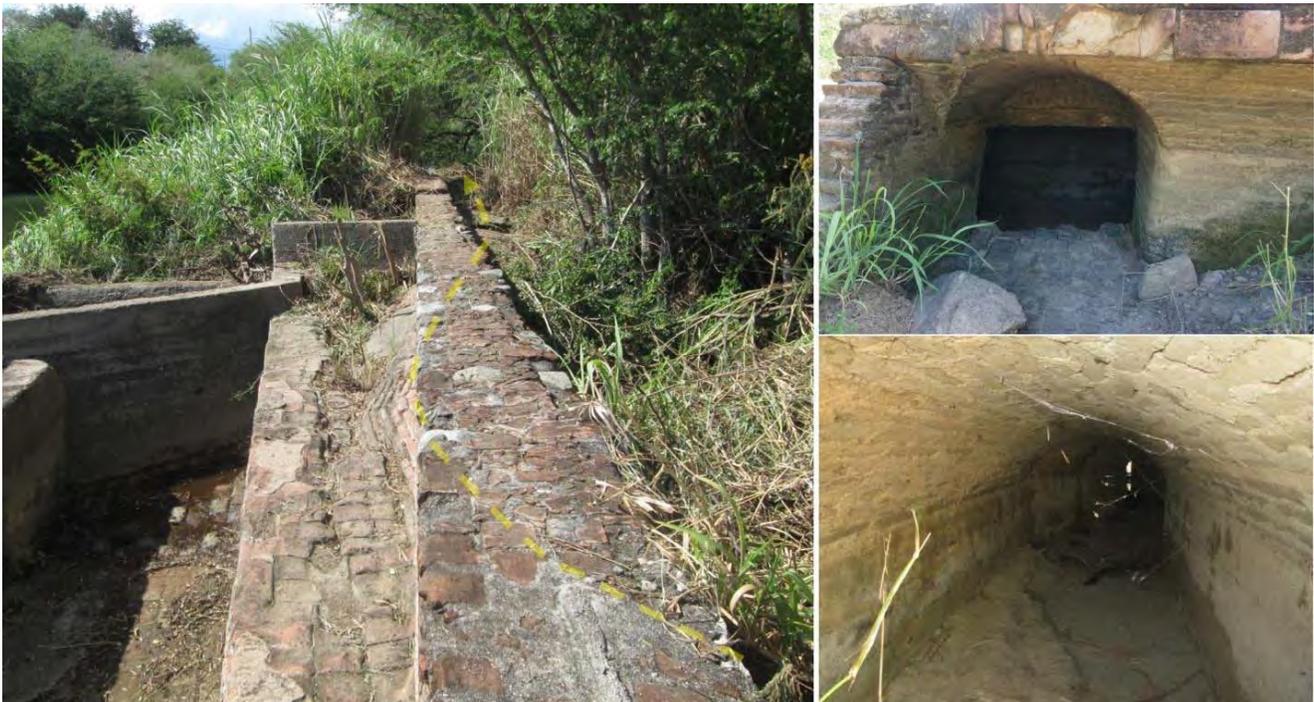
Views of the torrential waters channel. Left; General view of the channels route, marked by the yellow dotted line. Right top; entrance into the supply channel facing west, and inside view of the torrential waters channel looking south.

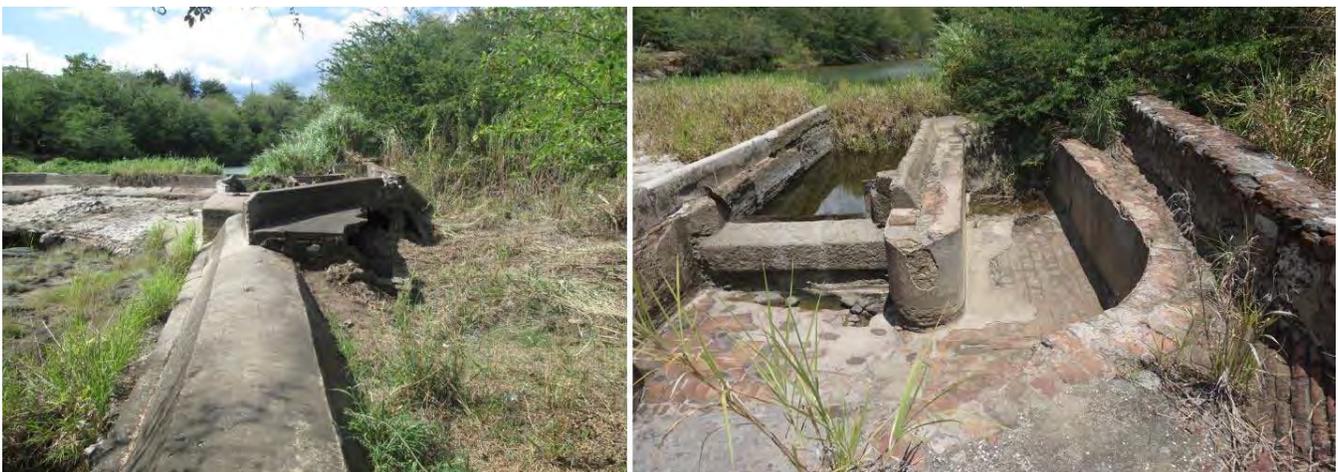
Left, general view of the area of the low waters and seasonal waters modules. In the foreground we see the supply channel, with the module and the dam in the background. Right, view of the modules, showing the low waters module full of water on the left and the seasonal waters module on the right of the photo, facing north.

The structure was modified in the 20th century. The height of the walls was elevated by adding reinforced concrete walls. The *estacionales* (seasonal) water module was bypassed by demolishing a section of the central wall and the construction of a diagonal wall that closed the intake above the module. The waters from the two sluice gates at the reservoir now entered a single module. Several parallel rods were installed facing the inner sluice gate of the *aguas estiales* module to make a garbage trap. Finally, the two sluice gates facing the reservoir were walled up. The current condition of the area where the dam, module, storm water intake and supply channel begins is depicted on Figure 8.

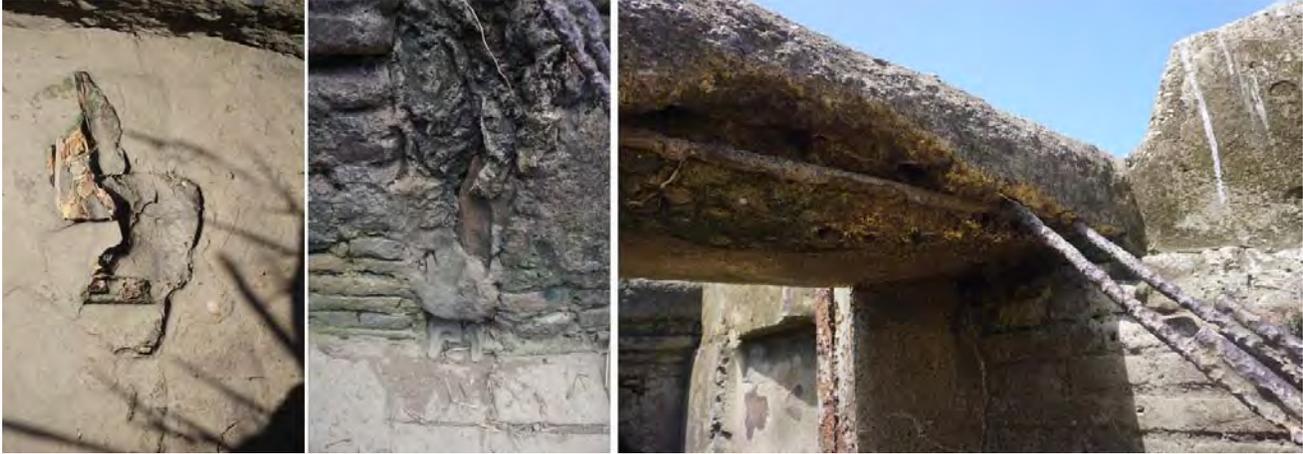
Left and center; remnants of the wood frame of the inner sluice gate of the low waters module. Left; detail of the inner gate of the module, with part of the metal sluice and metal bars that created a garbage trap.

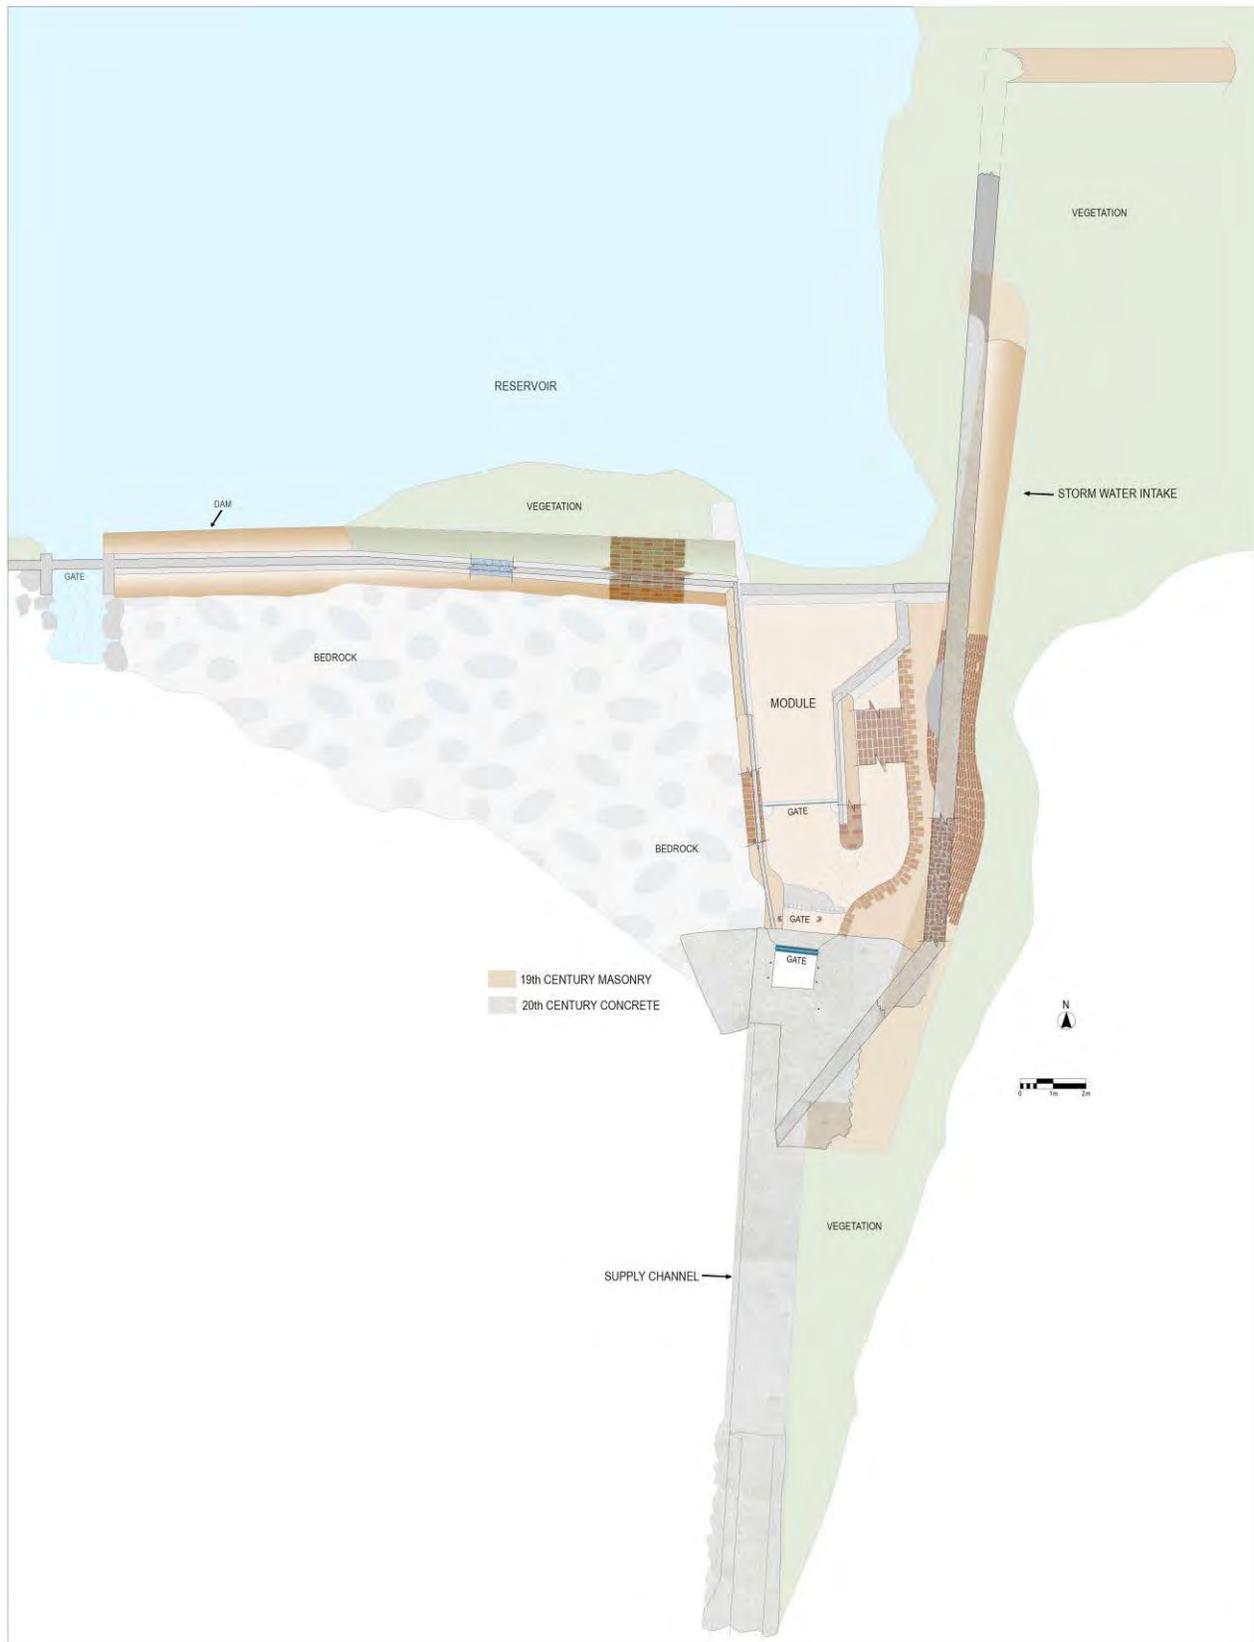
Drawing of the dam and modules of the *Tres Haciendas* Irrigation System

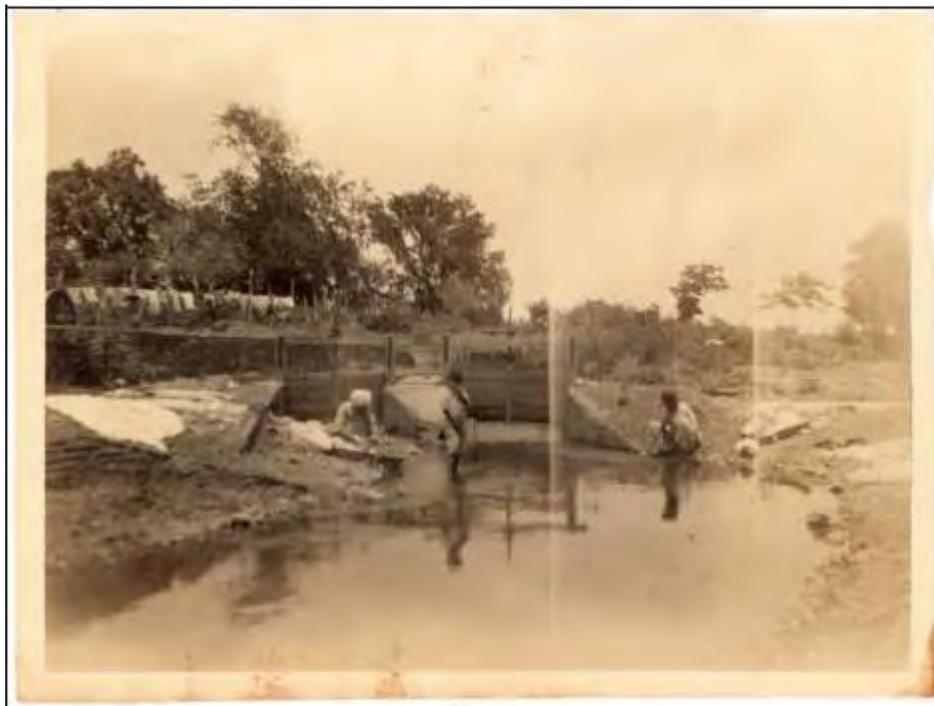
Photo of the main intake for the Florida, Santa Isabel and Destino *Haciendas* or *Tres Haciendas* at the junction of the main canal and the Coamo river, 1913, AAA (from Meléndez Maíz 2011).
