Figure 3

DA Inquiry

du Treil, Lundin, & Rackley, Inc., Sarasota, Florida

Antenna Pattern: Antenna ID: 800106

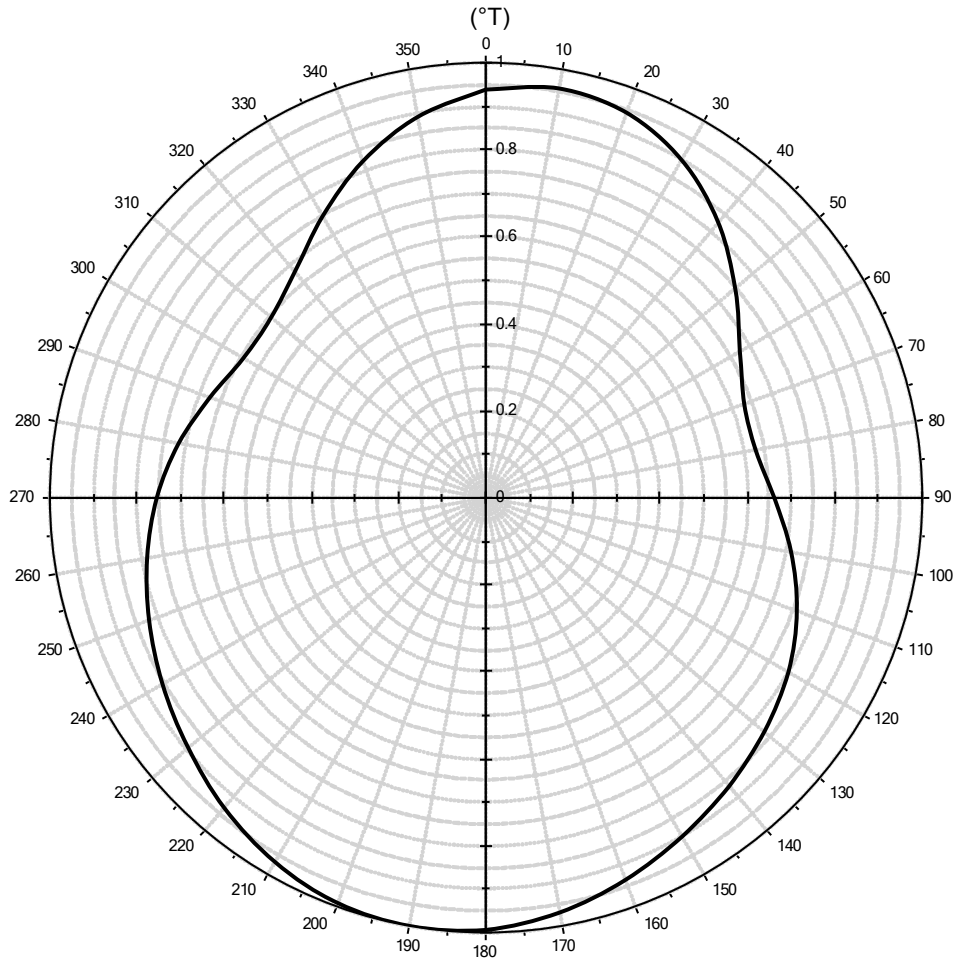
Note: display reflects rotation of 0.00°

Antenna Make: ERI

Antenna Model: ALP16M3-HSOCX-18

| 0° | 0.938 | 60° | 0.673 | 120° | 0.801 | 180° | 0.993 | 240° | 0.856 | 300° | 0.642 |
| 10° | 0.956 | 70° | 0.630 | 130° | 0.834 | 190° | 1.000 | 250° | 0.821 | 310° | 0.643 |
| 20° | 0.942 | 80° | 0.628 | 140° | 0.866 | 200° | 0.992 | 260° | 0.788 | 320° | 0.680 |
| 30° | 0.897 | 90° | 0.661 | 150° | 0.899 | 210° | 0.967 | 270° | 0.755 | 330° | 0.748 |
| 40° | 0.828 | 100° | 0.711 | 160° | 0.935 | 220° | 0.932 | 280° | 0.715 | 340° | 0.824 |
| 50° | 0.747 | 110° | 0.759 | 170° | 0.968 | 230° | 0.892 | 290° | 0.673 | 350° | 0.891 |
