Engineering Exhibit – STA Operation
W275AT Four Corners, NJ
Facility ID No. 138571

This exhibit is to support an STA request for Fill-In Translator W275AT with modified facilities so that it can resume operation. On October 30 2012, the guyed tower that supported the antenna was destroyed by Hurricane Sandy and has been silent since that time. Subsequent to that date, the licensee filed for and was granted a construction permit for new facilities, file number BPFT-20130109AEY. However, the new facilities have not yet been constructed. It is therefore requested to return to the air with modified facilities at the presently licensed site.

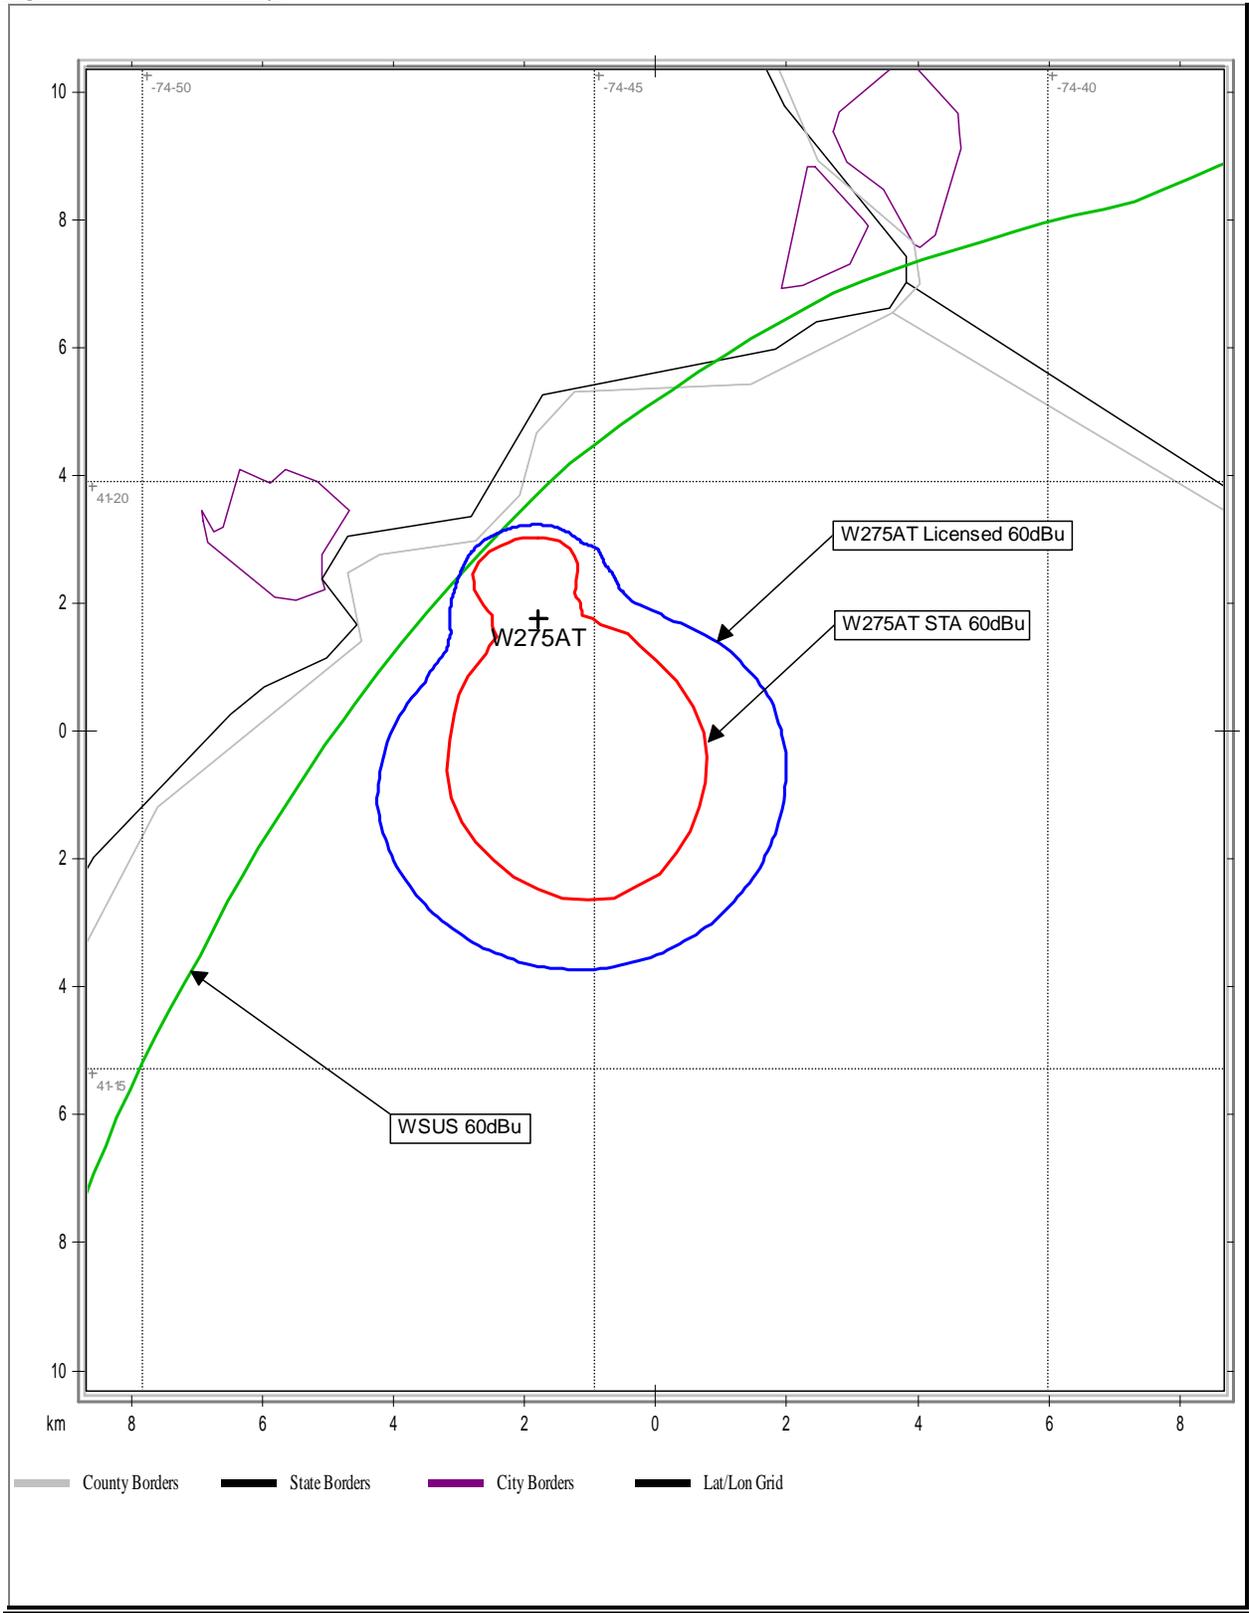
Figure 1. Contour Map

Below as Figure 1 is a contour map showing the F(50,50) contours of the primary station WSUS along with the W275AT licensed and STA contours. As can be seen the STA 60dbu contour does not exceed the presently authorized translator 60dBU contour or the Primary station's 60dbu contour.
