RFR STUDY

The following RFR measurements were collected by the undersigned on October 14, 2011, at the Hogback Mountain, Montana, high-powered communications site which is home to the following broadcast facilities:

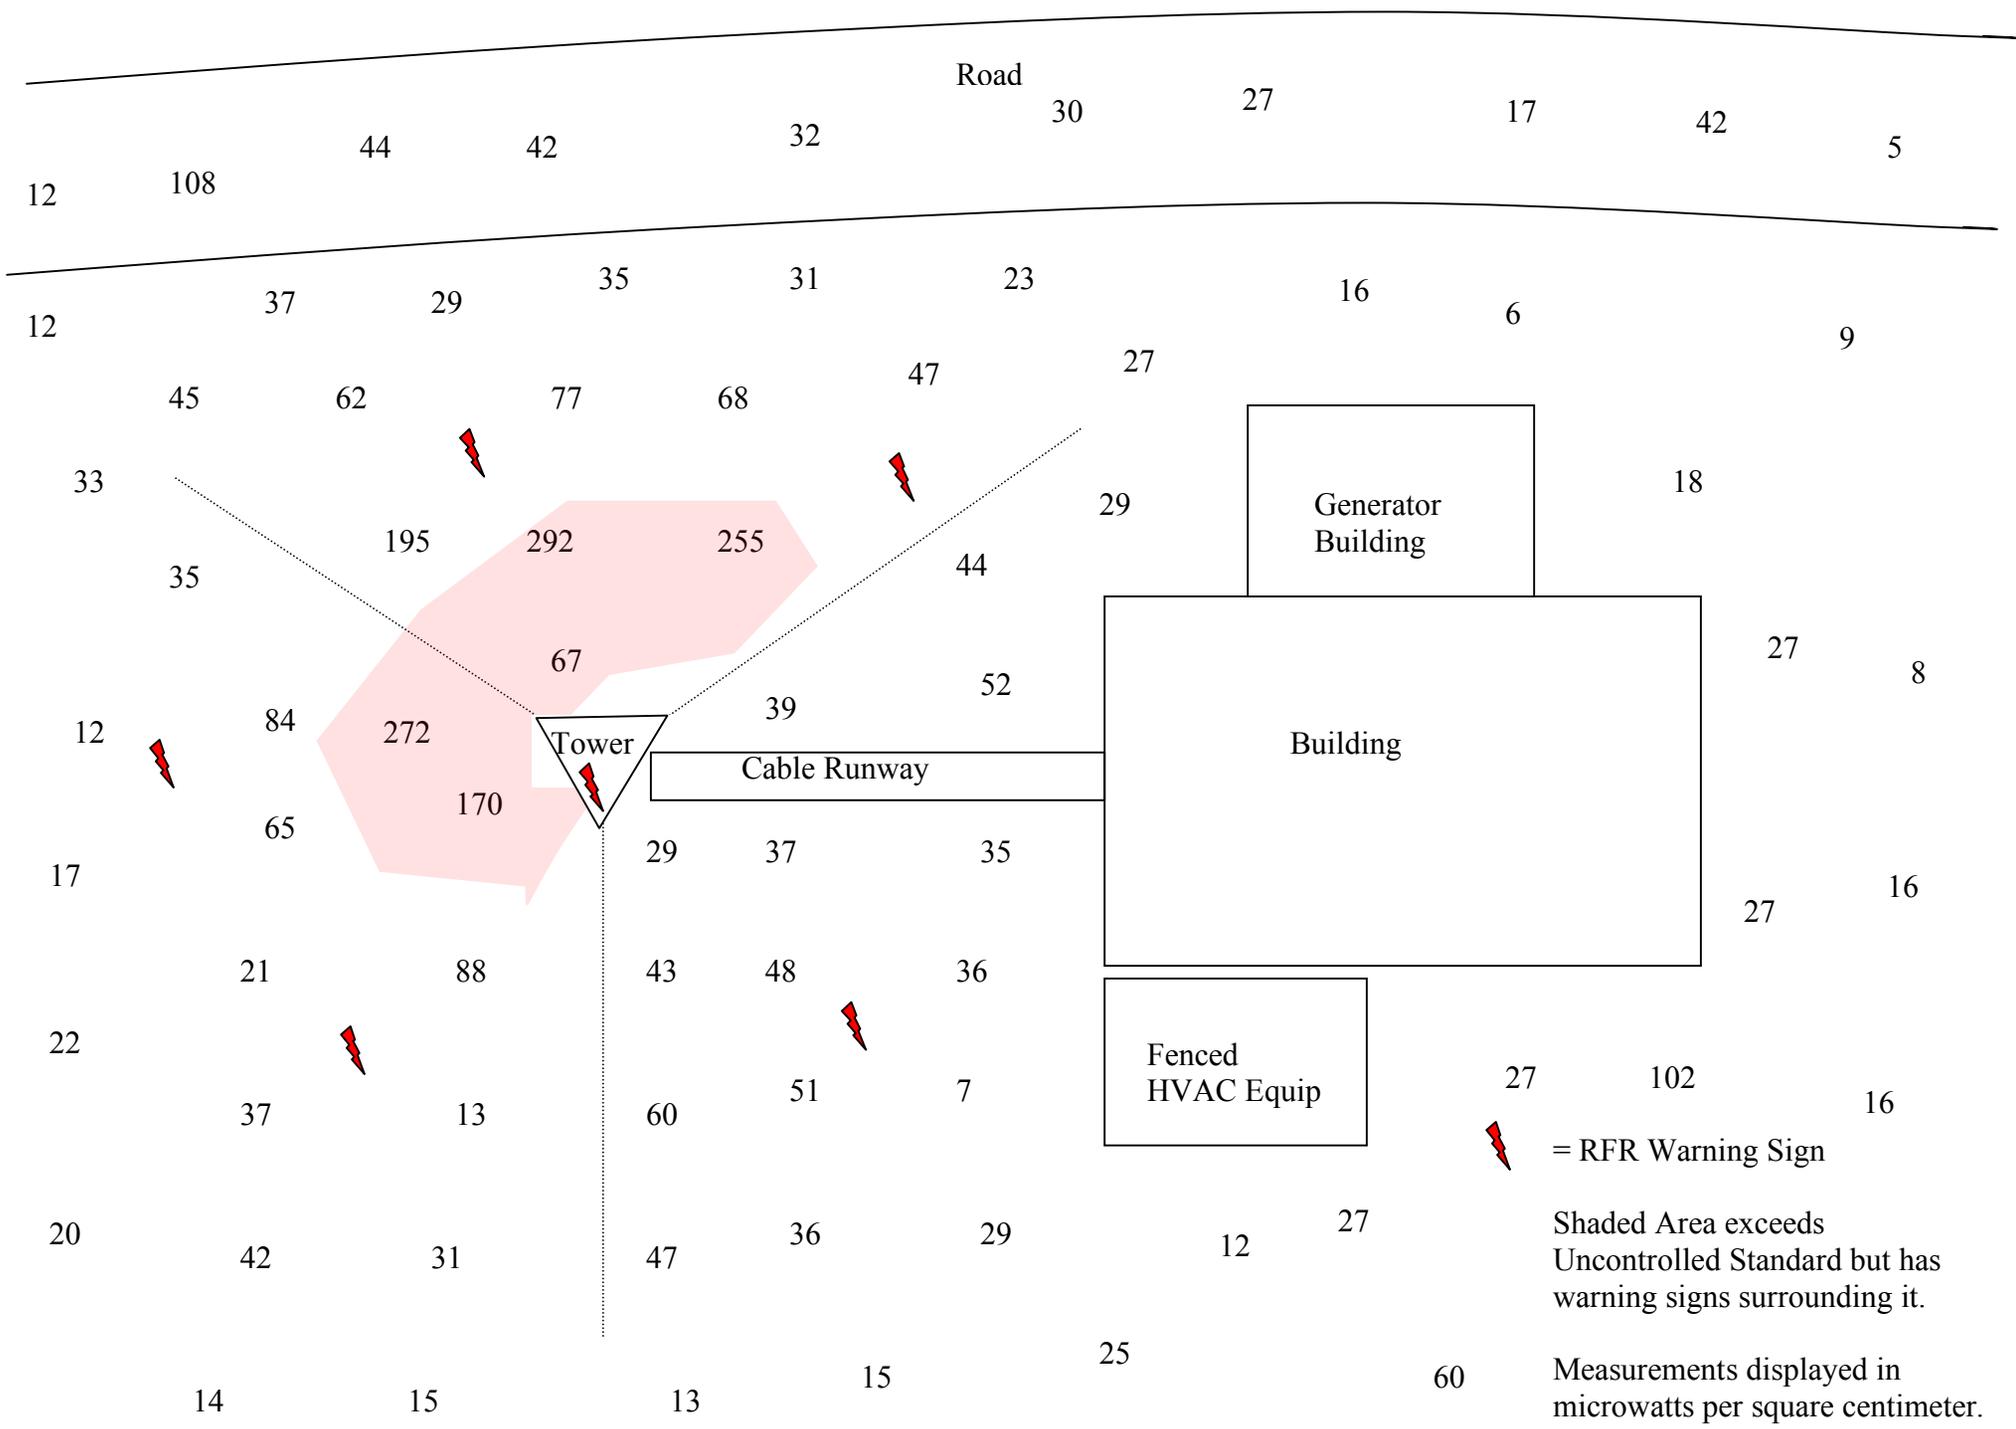
As can be shown by the data on the following page, most areas comply with the Uncontrolled Standard, or 200 micro watts per square centimeter. However, there is an area within 15 feet of the tower below its northeast face that exceeds the Uncontrolled Standard. The highest measurement recorded was 292 micro watts per square centimeter, which is 46% higher than the Uncontrolled Standard.

The permittee/licensee has installed warning signs encircling the area beneath the tower where RFR levels were measured in excess of the Uncontrolled Standard. The attached sketch of the antenna site’s RFR measurements includes the locations of the various warning signs. The permittee/licensee certifies that the antenna site is located on a remote mountain top. The nearest house or structure is located some 14 miles from the antenna site. The site is inaccessible to car from November through July due to snow. Also, there is no evidence of the public spending any time at the antenna site where the Uncontrolled Standard is exceeded (no litter, fire rings, camp sites, parking areas). Therefore, the facility complies with the Bulletin with regard to RFR exposure.
